Mystery of Mosul Dam the Most Dangerous Dam in the World: Karstification and Sinkholes

Nadhir Al-Ansari¹, Nasrat Adamo², Issa E. Issa³, Varoujan Sissakian⁴ and Sven Knutsson⁵

Abstract

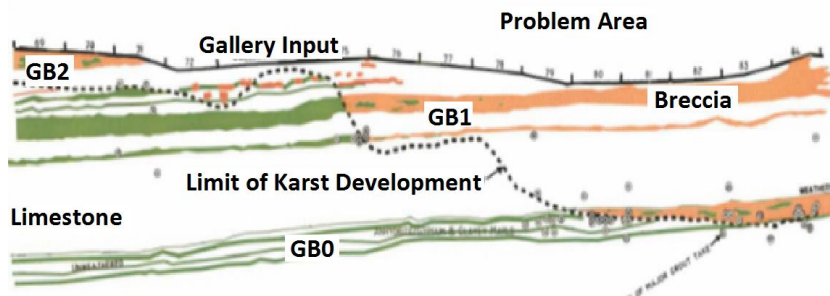
At Mosul dam site, major dissolution occurs at the “karstic line”, where anhydrite converts to gypsum and this unit is subsequently dissolved and eroded by seepage (Fig. 4). This phenomenon of evaporites dissolution by groundwater and the void is generally filled with collapse breccias from the overlying beds (Fig. 5) [11].

Figure 4: Major Grout Takes in Sections 69-84 [7].

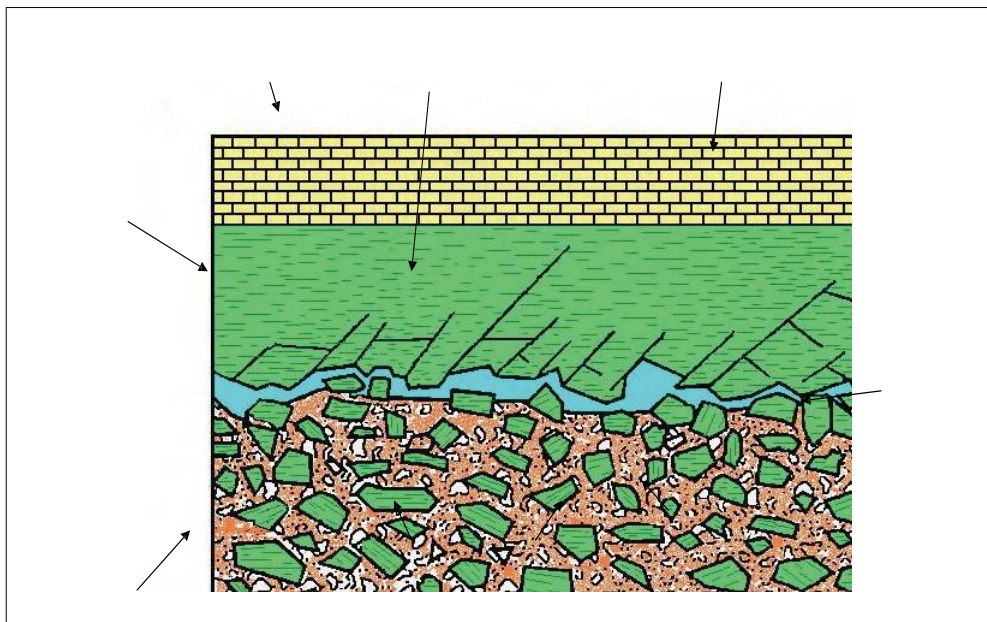
Figure 5: Development of breccia within a layer of gypsum [11].

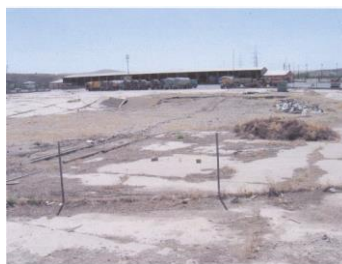
First appearance of the sinkholes on the right bank down-stream was not until approximately six years after beginning of the reservoir filling (Fig. 6). The surface expression of the sinkholes suggests that they are caused by an under-ground collapse. Concentric tension cracks appear to have developed around the central void as the sinkholes have developed progressively [7].

The majority of karst forms are sinkholes (Fig. 6) (dolines), developed in gypsum and/ or limestone; however, many other forms are developed too, such as Karren, shafts, channels. Downstream sinkholes are most likely related to fluctuations in the tail water level of the main dam during operation of the dam and the down-stream regulating reservoir [13].

Figure 6: A sinkhole appeared during the 90's at the downstream right bank near the contractor yard.

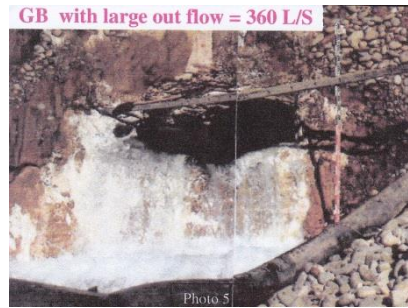
These sinkholes may be connected to an aquifer on the right bank of the reservoir because before the reservoir was impounded, substantial flows of order of 360 L/sec were encountered from a gypsum layer found during excavation of the tailrace tunnel for the pumped storage scheme; the water had a high sulphate content which was different from the reservoir water (Fig. 7). The karst line also denotes the transition from the interbedded lime-stone-anhydrite/gypsum beds to the less permeable Jeribe limestone (Fig. 8) [12].

Figure 7: Spring of discharge 360l/sec which is connected to the ground water aquifer connected to the reservoir

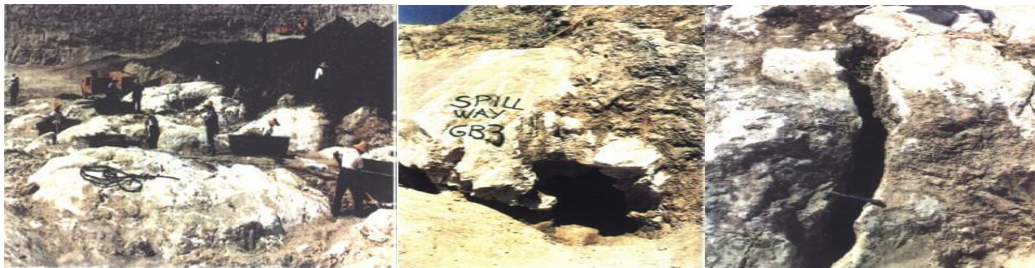
Figure 8: Karstified gypsum in the foundations of the dam (left and middle), Solution crack (right).

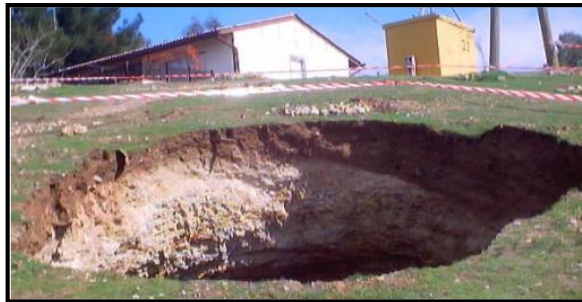
Surface cracking and ground settlement initially developed followed by appearance of sinkholes on the right abutment. Sinkholes on the left flank of the reservoir (in the local tourist village) appeared without warning and developed rapidly with 15 m of settlement and a 15 m diameter depression overnight in February 2003 (Fig. 7). The sinkhole was dry, located on a slope on the northern side of a valley feature. The deposits at the surface standing vertically appear to be superficial silty soils, with perhaps bedded marls below. Although the initial sinkhole was filled with 1200 m³ of loose sandy gravel material and fenced off, but the settlement continued. A further 3000 m³ of material was required to fill the settled surface of the sinkhole in two separate filling operations in May 2003 and October 2004. By March 2005 there were been a smaller settlement of the ground surface of about 0.5 m.

During the drilling of a piezometer hole near the sinkhole, a rod drop occurred. There was no water encountered in the hole so the piezometer was not installed, and the hole was grouted, taking 250 tons of grout. The suggestion was been made that the sudden appearance of the sinkhole is related to seepage water passing through the left abutment of the reservoir and the sinkhole lies close to the end of the left extension of the original

Figure 9: Left photo show the Ground settlement before the full development of the left bank sinkhole.

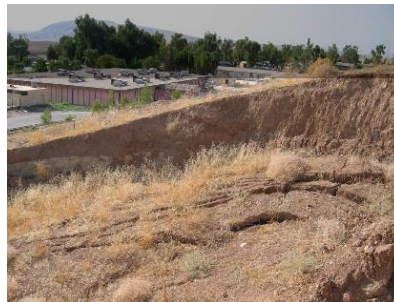
Figure 10: Soil failure.

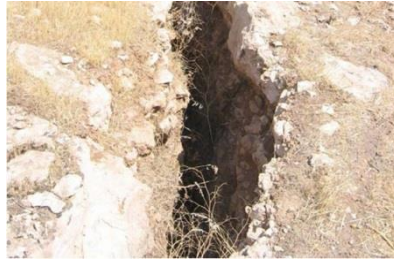
About 100 m up-stream from the dam, on the right abutment of the reservoir, a dipping limestone bed near the margin of the reservoir shows ground settlement. This movement could be partly related to sloping failure and translation of the rock beds as a result of fluctuating reservoir levels and residual high pore pressures in the slope. However, a sinkhole feature seems more likely (Fig. 9). Although tested for, no connection has been established between this upstream sinkhole and those downstream [6]. It is believed that in some cases soil failure takes place (Fig. 10), which could be initiated due to over saturation of the soil by rain water. In addition slab failure (Fig. 11) was also recognized, most probably due to fluctuation of the water level in the reservoir.

Figure 11: Upstream right abutment, open fissure resulting from slab sliding.

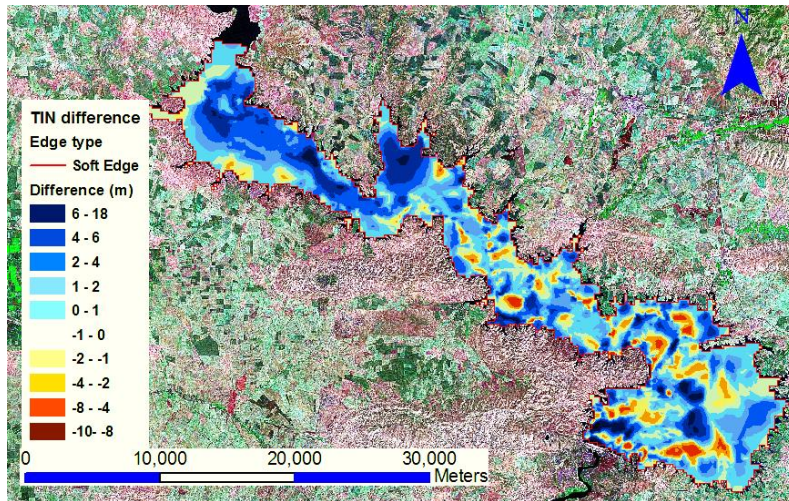
Al-Ansari et al. and Issa et al. [16,17] conducted a bathymetric survey during 2011 and concluded that "After 25 years of the dam operation following; the thalweg bed slope of the River Tigris had changed from 0.65 m.km^{-1} before dam construction to 0.71 m.km^{-1} . The sedimentation rate in the upper section of the reservoir where the River Tigris enters the reservoir was greatest and gradually decreased toward the Mosul dam site. The greatest deposition thickness was 17.6 m in the upper zone of the reservoir. Furthermore, there are many areas like the middle and lower parts of the reservoir that are exposed to erosion (Fig. 12). This is believed to be due to the dissolution of gypsum and limestone beds forming sinkholes that might reach about 20 m in diameter and 9.6 m in depth. The conducted survey also confirms the presence of sinkholes and other karst forms within the reservoir, which are active, and continuously increasing in size, and exerting hazards to the Mosul Dam.

Figure 12: Holes noticed at the bed of Mosul reservoir [17].
