Mystery of Mosul Dam the most Dangerous Dam in the World: Problems Encountered During and after Impounding the Reservoir

Abstract

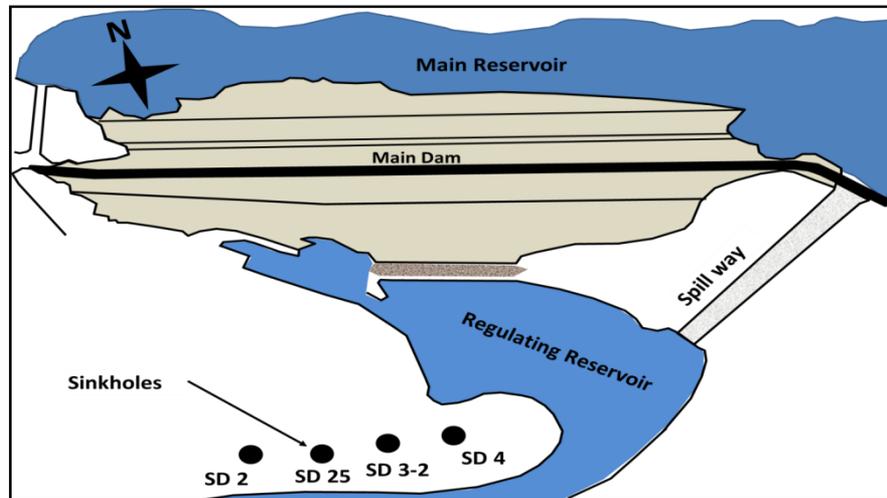
After Impounding of the reservoir, it seems that the sinkholes were developed after a considerable time downstream of the dam. Sinkholes were observed on the right bank about 900 m downstream of the toe of the embankment. Four sinkholes have appeared in a linear arrangement (Fig.1): SD2, SD2S, SD3-2 and SD4 (the largest). The sinkholes are not circular and have a characteristic elongated shape with a maximum dimension of up to 70 m and about half that in the normal direction. The longer dimension is aligned in the general line of the sinkhole alignment which is approximately parallel to the dam axis in a northwest-southeast alignment.

Figure 1: Sinkholes Downstream Mosul Dam –Right bank.

The sinkholes seem to be developed and appeared in 1992 and settled at a consistent rate until about 1998, when reduction in the settlement rate was observed to around half or less of the initial rate. The maximum measured settlement was about 5m, and generally it was between 3 m and 3.5 m. In areas where the sinkholes are located beneath the concrete pavement, the deformed concrete may be bridging over settled ground at a lower level (Fig. 2). The average annual settlement was about 0.25 m per year, although for SD4 the average annual settlement was 0.38 m per year.

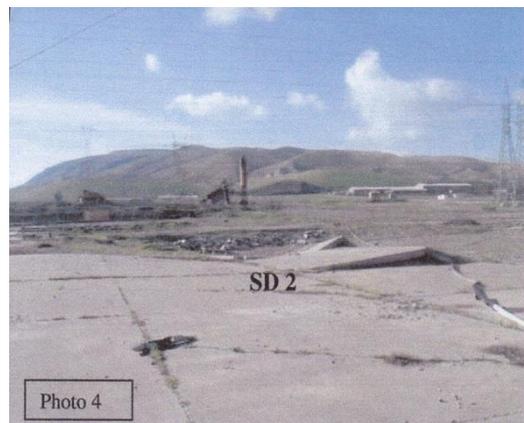
Figure 2: Sinkholes located beneath the concrete pavement.

The surface expression of the sinkholes suggests that they are caused by underground collapse. Concentric tension cracks appear to have developed around the central void as the sinkholes have developed progressively.

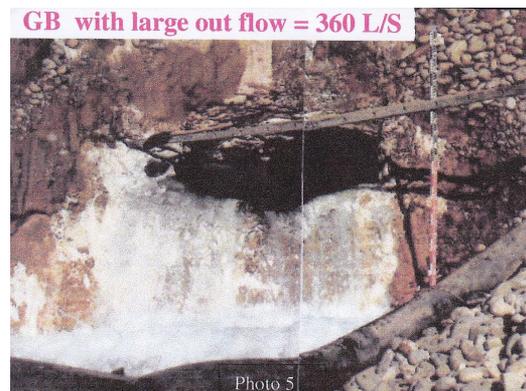
The appearance of the downstream sinkholes is most likely related to fluctuations in the tailwater level of the main dam during operation of the dam and the downstream regulating reservoir. It has been suggested by the site engineers that the sinkholes may be connected to the Darmellah aquifer on the right bank of the reservoir because before the impounding of the reservoir, substantial flows on the order of 360 L/sec were encountered from a gypsum layer found during excavation of the tailrace tunnel for the pumping storage scheme to the west (further right) of the known sinkholes (Fig. 3); the water had a high sulphate content (which was different from the reservoir water).

Figure 3: Flows with order of 360 l/sec were encountered from a brecciated gypsum layer found during excavation of the tailrace tunnel for the pumping storage scheme to the west.

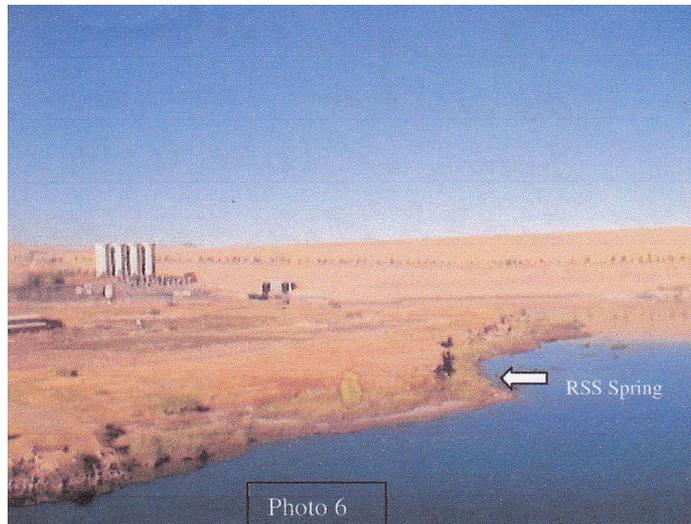
It also appears that the karst features within the bedrock may be better developed on the right side of the valley. Further evidence for connection of the sinkholes to the Darmellah aquifer is suggested by the appearance of a spring on the right side of the river channel. This spring, referred to as the right side spring (RSS) (Fig. 4), is in line with the sinkholes and appeared after erosion of the right bank during operation of the main spillway. The erosion has removed the alluvial deposits of unconsolidated silts and gravels; about 4 m thick overlying cemented conglomerate. When the conglomerate was initially exposed a spring appeared issuing from a fissure in the rock. The spring water had high sulphate content, and a flow estimated at 360 L/sec, similar to the spring that issued from the gypsum bed in the tailrace tunnel. The water chemistry was very different from the reservoir water and the existing springs on the left bank. The spring is reported to be generally not visible as it is below the water level of the regulating reservoir. For its approximate location refer to the arrow in figure 4 below.

Figure 4: spring on the right side of the river channel.

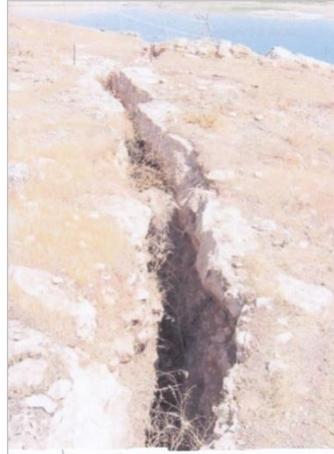
Some 100 m upstream of the dam right abutment and on the slope above the end of the launching ramp (Fig. 5), the ground surface shows clear fracture. This fracture is caused most probably due to a subsurface karstification and cavern development. However, a slope failure may show same fracture, but then the fracture should be in crescent shape, not a straight one, as it is the case, as a result of fluctuating reservoir levels and residual high pore pressures in the slope. The concrete foundation for the steel fencing is also buckled and deformed. The only performed monitoring in this area was for vertical settlement; no measurements were performed that would indicate lateral movement of the existing three survey markers. The maximum cumulative settlement recorded was 2.46 m. Dye tracer tests did not establish a connection between the upstream depression and the downstream sinkholes.

Figure 5: Open fissure resulting from slab slide upstream right abutment of the dam.

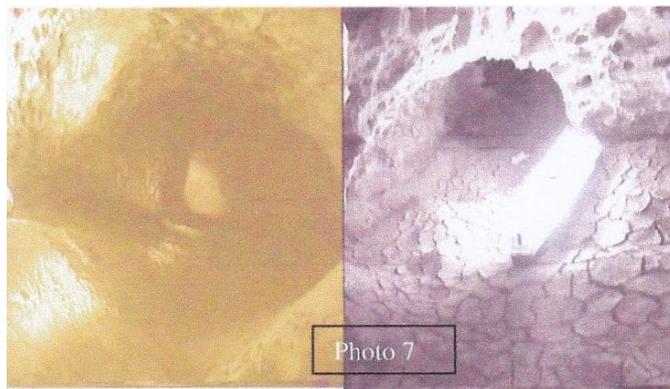
Further upstream, on the next promontory on the right side of the reservoir a large conduit (small cave) was found in March 2002 within a gypsum/anhydrite layer, which crops out in the reservoir; it is unclear whether it is the GB1 or GB2 horizon. The maximum height of the cave is 1.3 m and it has clay infill on the floor (Fig. 6). The elevation of the cave floor is approximately 315 m a.s.l. compared to a normal top water level of the reservoir at elevation 330 m a.s.l. Both the cave inlet and outlet are within the reservoir pool and are normally submerged from January each year for about 8 months of the year.

Figure 6: Large conduit (small cave) was found in March 2002 within a gypsum/anhydrite layer on the right side of the reservoir.

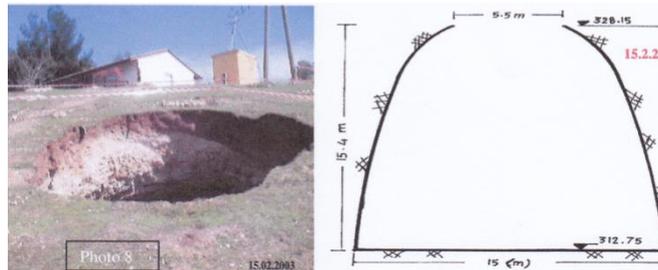
with perhaps bedded marls below. Although the initial sinkhole was filled with 1200 m³ of loose sandy gravel material and fenced off, the settlement was continued. A further 3000 m³ of material was required to fill the settled surface of the sinkhole in two separate filling operations in May 2003 and October 2004. By March 2005 there has been a small settlement of the ground surface for about 0.5 m.

Figure 7: Sinkhole at left bank of the reservoir.

The surface expression of the collapse with the absence of concentric tension cracks and sudden appearance suggests that the collapse resembles a crown hole. It was reported that during the drilling of a piezometer hole near the sinkhole a rod drop had occurred. There was no water encountered in the hole so the piezometer was not installed and the hole was grouted, consuming 250 tons of grout. The suggestion has been made that the sudden appearance of the sinkhole is related to seepage water passing through the left abutment of the reservoir and the sinkhole lies close to the end of the left extension of the original grout curtain. Though possible, an increase in infiltration of surface water, perhaps from heavy rain, could cause a collapse into an existing void by destabilizing the ground. Since the appearance of this sinkhole the grout curtain has been extended eastwards but the grout consuming was not high.

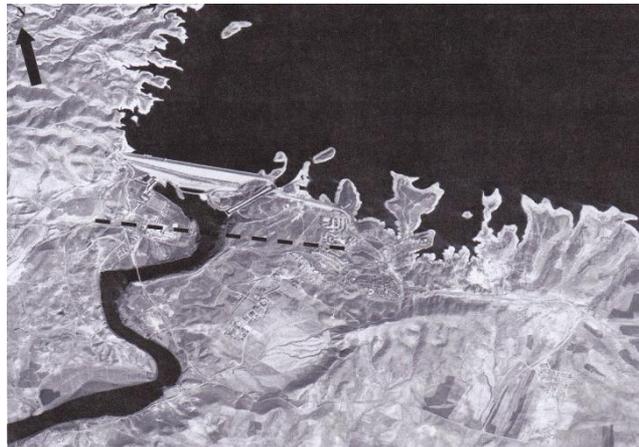
The locations of all sinkhole suggest a linear arrangement crossing the valley downstream of the dam (Fig. 8), although it has yet to be determined what that feature might be. The site

Figure 8: Mosul Dam, the dashed line shows approximate alignment of the sinkholes.

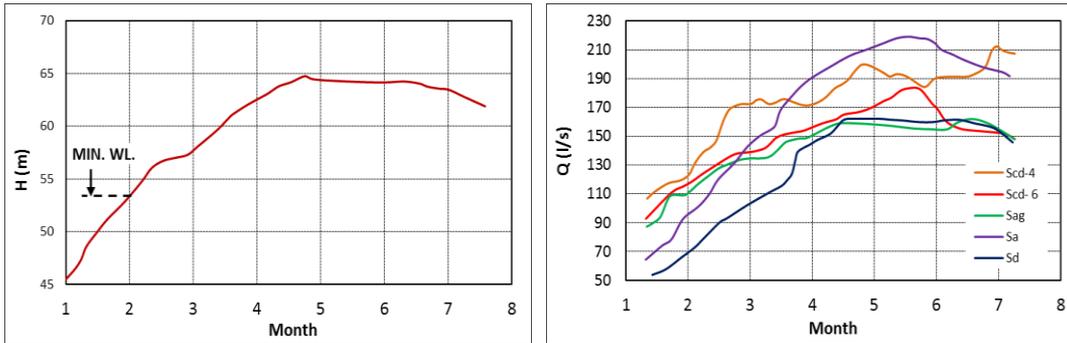
m to 65 m .Springs (Sa) and (Sd) in the left bank alone had increased from 150 L/s to 900 L/s (Fig.9).The submerged springs at the river channel showed an increased transmissibility by 40% during the same period (from 630 m³/day to 880 m³/day) [6].

Figure 9: Left: Spring discharge and Right: nReservoir water level for the period February-August, 1986.

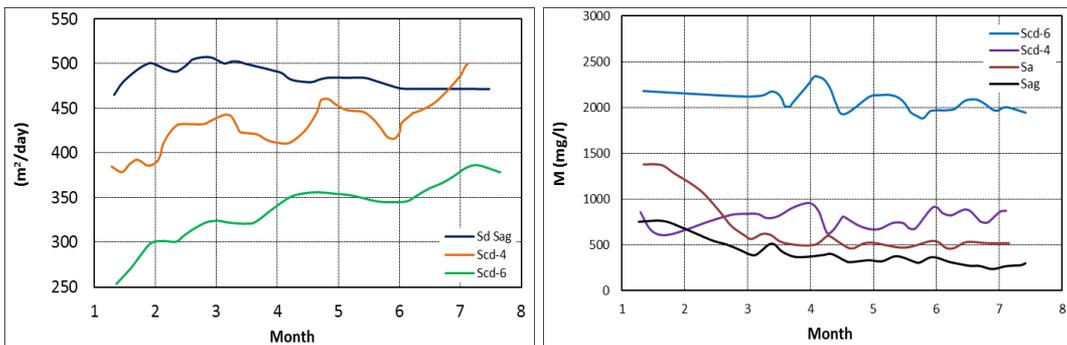
Dissolution of minerals from Dam foundations was established through the difference in the content of dissolved minerals in seepage water in relation to the water in the main reservoir (amounting to 250 mg/l as the average). The total mineral content of the seepage’s water by individual spring zones is presented in (C) and (D) of Fig.10). Analysis of these results yielded that 13 000 tons of minerals were leached from the dam foundations at this period and that 70% of this quantity originates from the submerged springs. The dissolution intensity ranged from 42 to 80 t /day.

Figure 10: Left: Spring transmissibility and Right: Soluble salt concentration for the year 1986.

These chemical analysis results pointed out to significant dissolution of gypsum and anhydride followed by noticeable increase in the permeability and leakages through foundation. Analysis of mineral content of seepage water pointed out to the Gypsum and anhydride and other minerals were being washed out from joints and fractures crossing insoluble rocks and it was expected in view of the repeated maintenance grouting that all gypsum present in joints would be washed away from the zone of grout curtain. Bearing in mind that some of the rocks in the foundation are erodible then this dissolution of gypsum

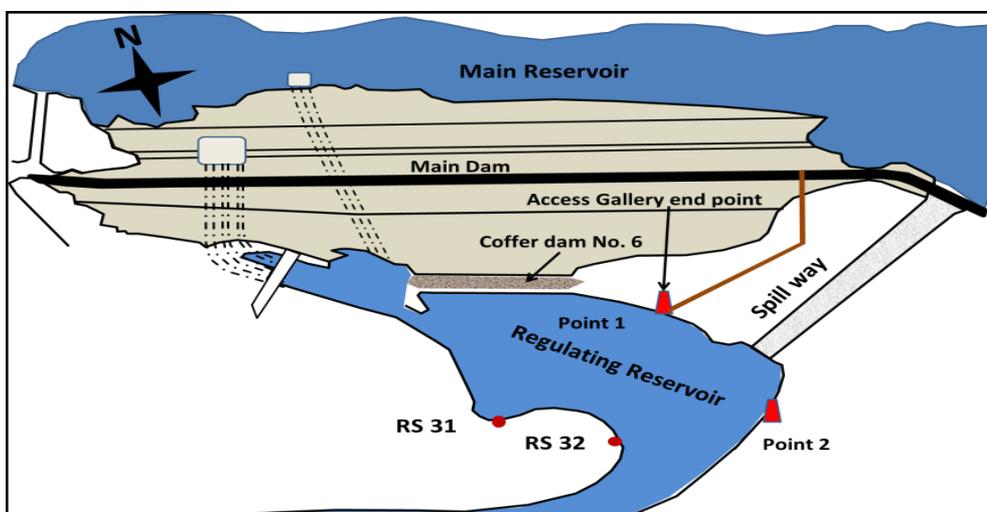
- Point (1), at the right side of the spillway at the end of a collection channel which collects seepage water from under the spillway that seems to originate from left side.
- Point (2), at left side of the spillway collects springs between seepage from under the dam further left and around the left side.
- Access Gallery end point collects seepages from under main dam from the river section to the spillway.
- Coffer dam no.6 measuring pond measuring seepage under the deep section of dam.

Figure 11: Seepage water Collection Points at Left Bank and cofferdam no.6 Measuring pond [7].

The deep grout curtain also received its share of attention and works were intensified in an attempt to improve its quality which remained an open question up to now. Other minor works were also performed such as collecting the flow of the springs in thee measuring points, (Fig. 11), in addition to the coffer dam number 6 measuring pond, and covering seeps and wet areas by filter material. From figure 11, it can be noticed that:
