Dams Safety and Geology

**Nasrat Adamo¹, Nadhir Al-Ansari², Varoujan Sissakian³, Jan Laue⁴
and Sven Knutsson⁵**

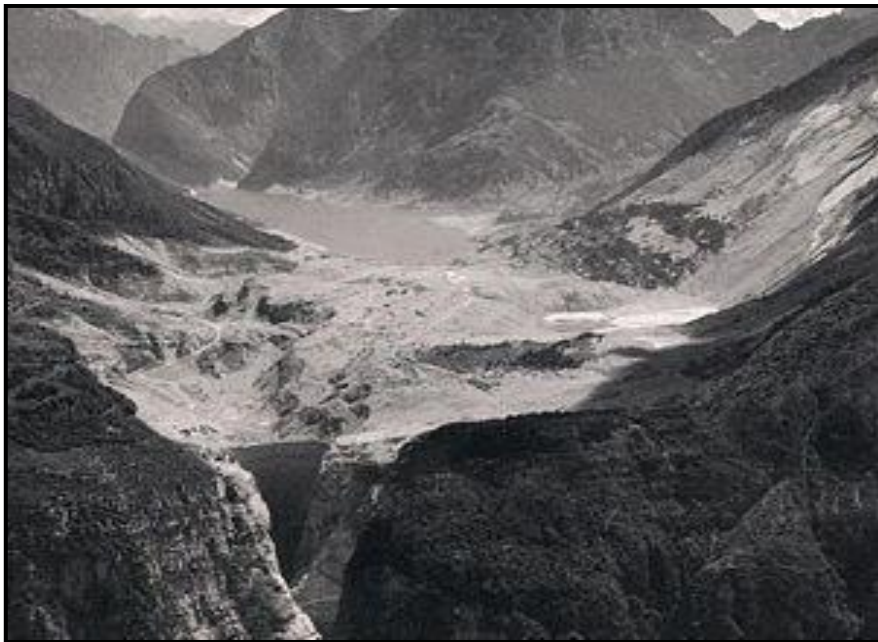
fell into the reservoir of the Vajont Dam, producing an enormous wave of at least 50 million cubic meters of water. The dam completed in 1959 and one of the biggest in the world at the time did not suffer any serious damage. However, flooding destroyed several villages in the valley and killed almost 2,000 people. A third of the population of Longarone, the largest village downstream from the dam, perished [4], refer Figure 2. Post-failure investigations showed that low strength clay layers existed between the limestone beds. It was surmised that rainfall on the mountains above the reservoir was conveyed through solution features to the reservoir slopes where it became trapped by the impermeable clay layers. A review of the landslide survey data showed that movement accelerated with a high reservoir level following periods of heavy rain. Thus, it was the combination of high reservoir level, which unweighted the toe of the slide, and heavy precipitation which increased the pore pressures in the rocks of the slope, that lead to triggering of the slide on weak clay layers. This was confirmed by limit equilibrium analyses that considered side constraint afforded by a fault on the upstream side of the landslide mass [5] and [6].

Figure 2: View of the Vajont reservoir after the landslide (1963) [4].

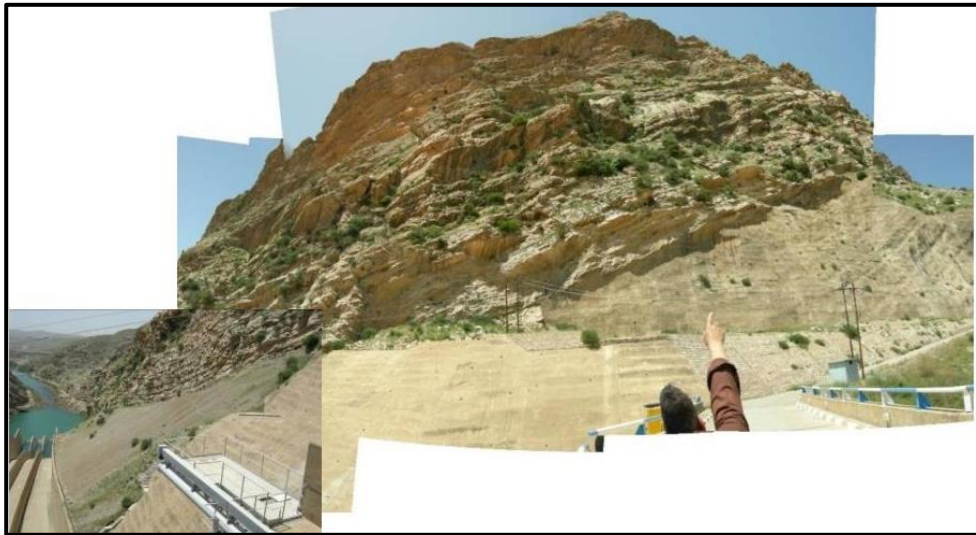
The reservoir impounded by the dam had a total design capacity at the normal operating level (El. 485.00m a. s. l) of 3,000 Mm³, of which 2,500Mm³ is live storage and 500Mm³ being dead storage. The current storage volumes will be less than this due to almost 60 years of sedimentation. The reservoir is controlled by a gated spillway structure located on the right bank and comprises three tainter gates installed on an ogee shaped overflow section followed by a steep chute terminating in a deflector bucket. Dividing walls separate the discharges from each of the three gate openings. The maximum discharge capacity of the spillway at the normal operating level (El. 485.00m a.s.l) is 5,700m³/s and 11,400m³/s at design flood level (El. 493.50m a. s. l). There are two low-level outlet tunnels (6m and 9m diameter) connected to steel conduits, which discharge water through three irrigation valves. The conduits also originally supplied water to two small turbines for the service generating station and are now connected to the three large turbines of the new powerhouse. An intake tower for the irrigation outlets is located between the spillway approach channel and dam embankment. The intake tower houses three vertical lift gates, gate No. 1 serves the 6 m diameter tunnel; gates No. 2 and No. 3 serve the 9m diameter tunnel. Construction of the dam started in 1956 and was completed in summer 1961. Five years after first impounding of the reservoir, slip failure of an area of the right bank some 300m upstream of Derbendikhan Dam was identified in November 1967. The affected area, consisting of about 2Mm³ of material approximately 350m in length and 200m wide, moved 1.5m downwards at reservoir elevation 455m following 126mm of rainfall over a period of 7 days, refer Figure 3.

Figure 3: Rock cliff above right abutment overlooking spillway chute at left, and landslide area at right lower part of the picture.

Additional settlement of the right bank slip area occurred between November 1969 and January 1970. A further failure of this slip mass represents a threat to the safety of Derbendikhan Dam as it could potentially cause the following:

- a. Unloading of the slip area by excavation and removal of slip material above elevation 488m a.s.l.
- b. Surface protection of the slip area by a drainage system and by landscaping to minimize the infiltration of rainwater
- c. Construction of 9 wells with horizontal drains at the bottom, equipped with pumps to lower the phreatic surface within the sliding zone (deep drainage)
- d. Restriction of the reservoir drawdown to a minimum level of 460m.

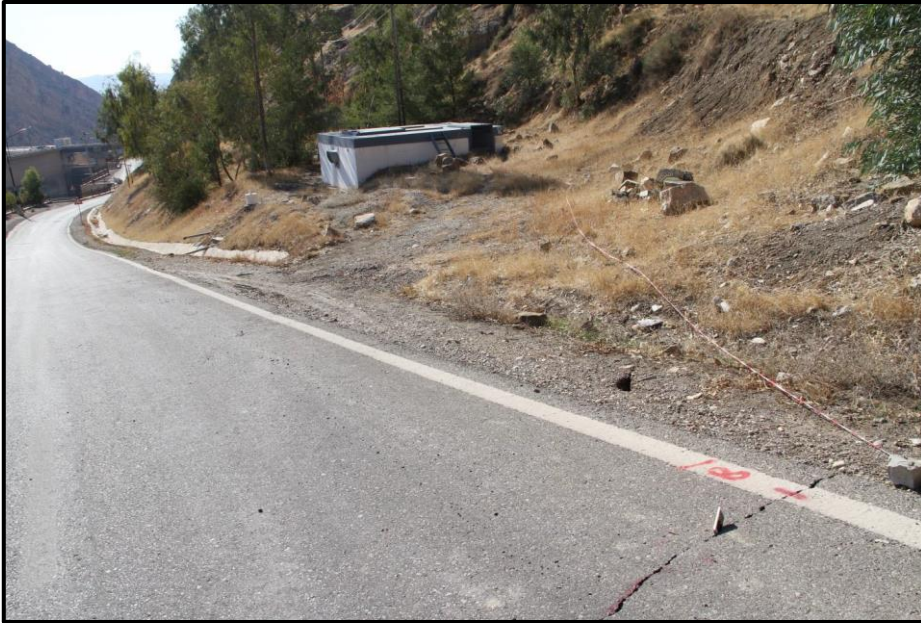
The dam was previously evaluated to be seismically safe under a maximum probable shaking of Mw 6.5, and no study is done for the seismic stability of the landslide. Furthermore, it was reported, however, that there was further concern about the landslide in the right bank upstream of the dam and rock falls from the high cliff in the left bank. The deformation of the dam body after the earthquake is visually apparent, and the State Commission on the Survey of Iraq observed several fissures on the crest soon afterwards. In the following months, this region exhibited 53 aftershocks with Mw > 4 [9]. A preliminary inspection was carried out by a team from the Ministry of Water Resources, which documented the cracks in the dam body and one new crack in the area above the limits of the landslide shown in Figure 4, but it seems that this team did not check new cracking in the landslide area which is located below the access road to the dam [10].

Figure 4: Location of a crack along the area above the landslide area (Crack is marked by red and white rope) and then extends down across the paved road down into the landslide area.

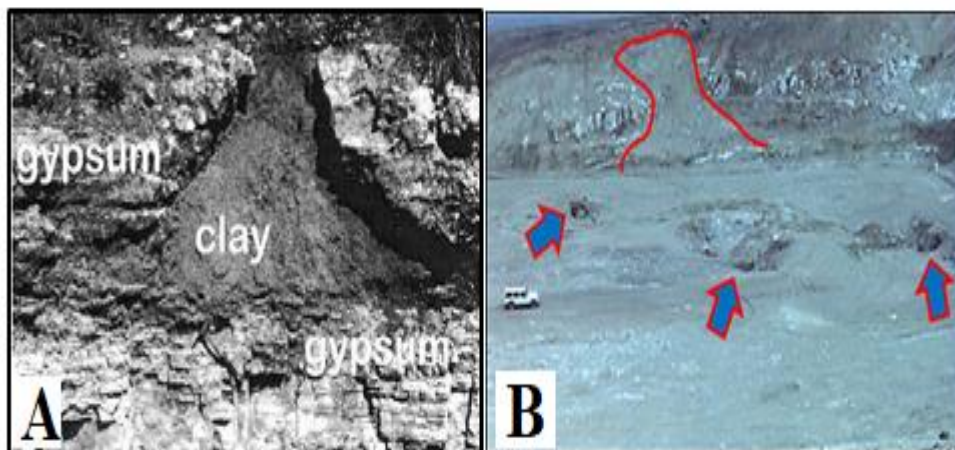
Figure 6: A) Gypsum- karst opening, now filled with clay deposited from through-flowing waters. Site is in the impoundment area of the abandoned Upper Mangum Dam. Image area is 2m wide [16]. B) A site 30km east of Mosul Dam. Clay filled karst in gypsum.

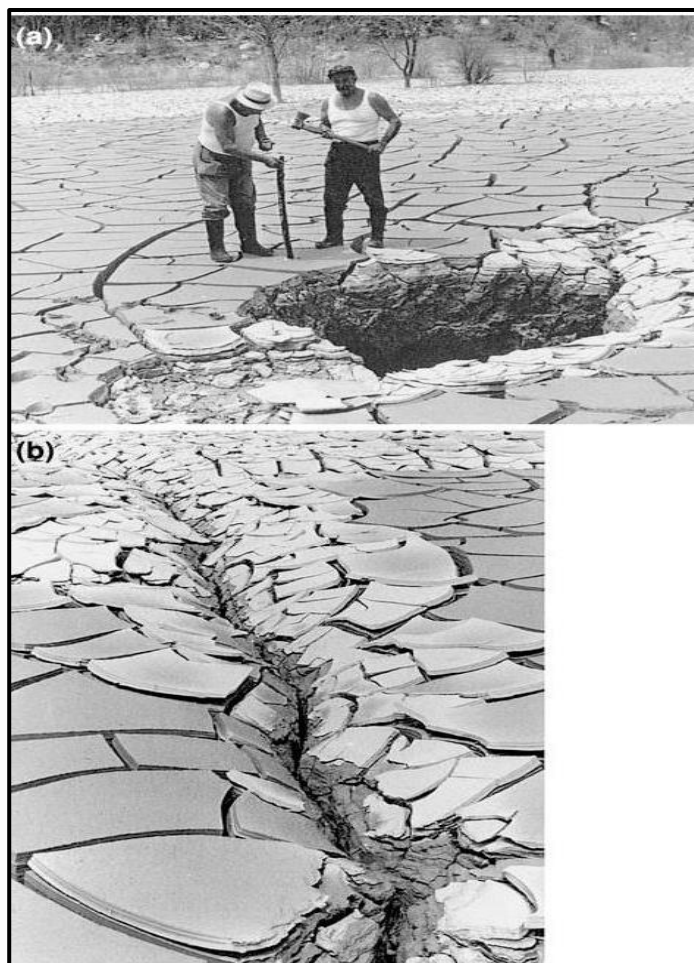
The minimum sinkhole's elevation is 75m a.s.l., while the maximum reaches 89m a.s.l. The photographs of Figure 11a and 11b show two different shapes of covered collapse sinkholes. It is obvious that they serve as swallow holes, i.e. water quickly flows through them to the karst underground. It should be stressed that after each filling and emptying of the reservoir new covered collapse sinkholes appeared. Two different shapes of covered collapse sinkholes at the bottom of the Boljunčica reservoir are shown in Figure 11.

Figure 11: Photograph of two different shapes of covered collapse sinkholes at the bottom of the Boljunčica reservoir.

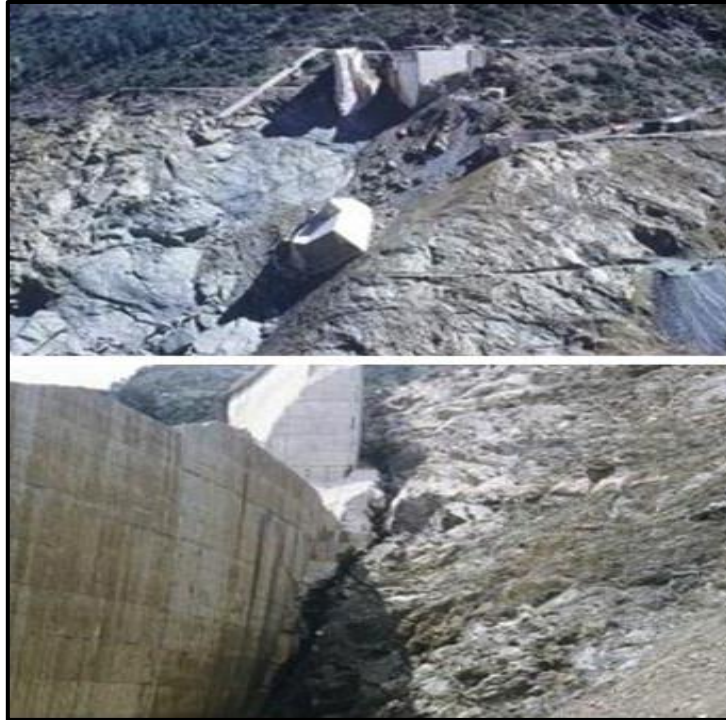
Figure 14-Top: the “dihedral” excavation with half of the thrust block fallen after the flow. Bottom: a wide crevice is open just upstream of the concrete arch, wider at the base and closing more higher [24].

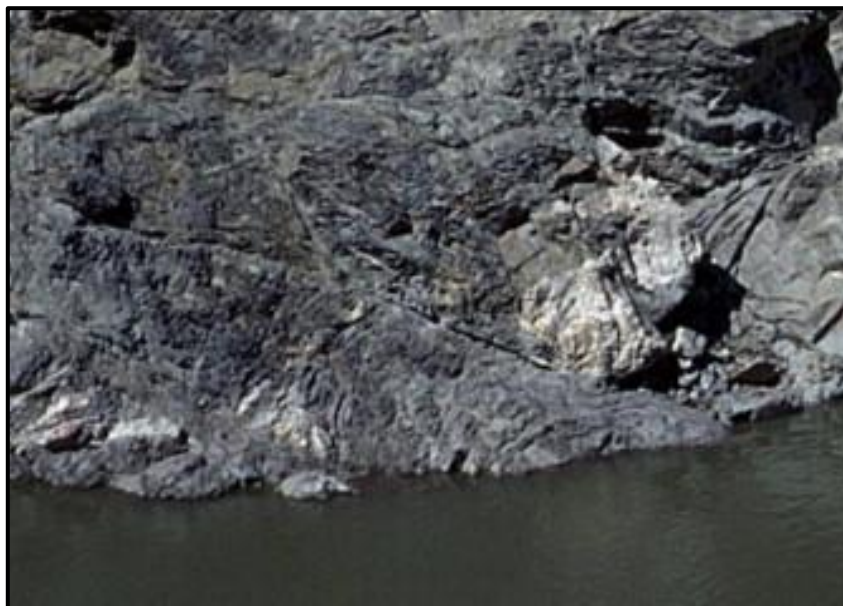
received from the dam; the continuity of rock foliation had not appeared either, within the so heterogeneous structure of the gneiss. So, a geometrical trap was in place, waiting for a force susceptible to move the block, which will appear later. The cleaning action of the flow made the fault path visible on the right bank and daylighted its cross section at either bank toe, refer Figure 15.

Figure 15: Close view of a cross section of the main fault on right bank. The finely crushed borders of the fault zone are well visible.

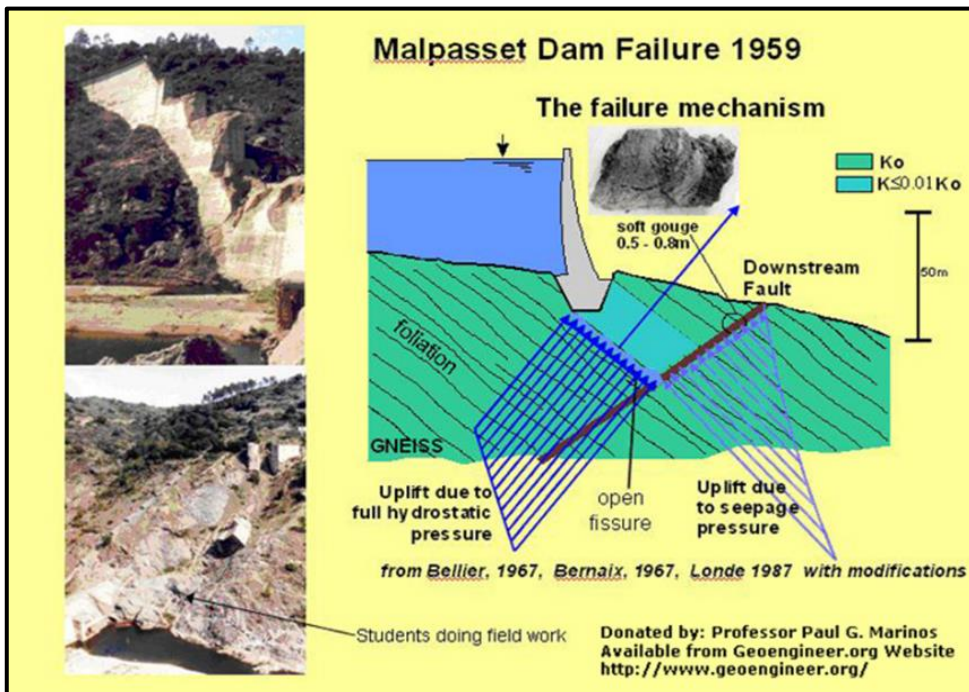
Figure 17: Malpasset Dam Failure Mechanism [27].

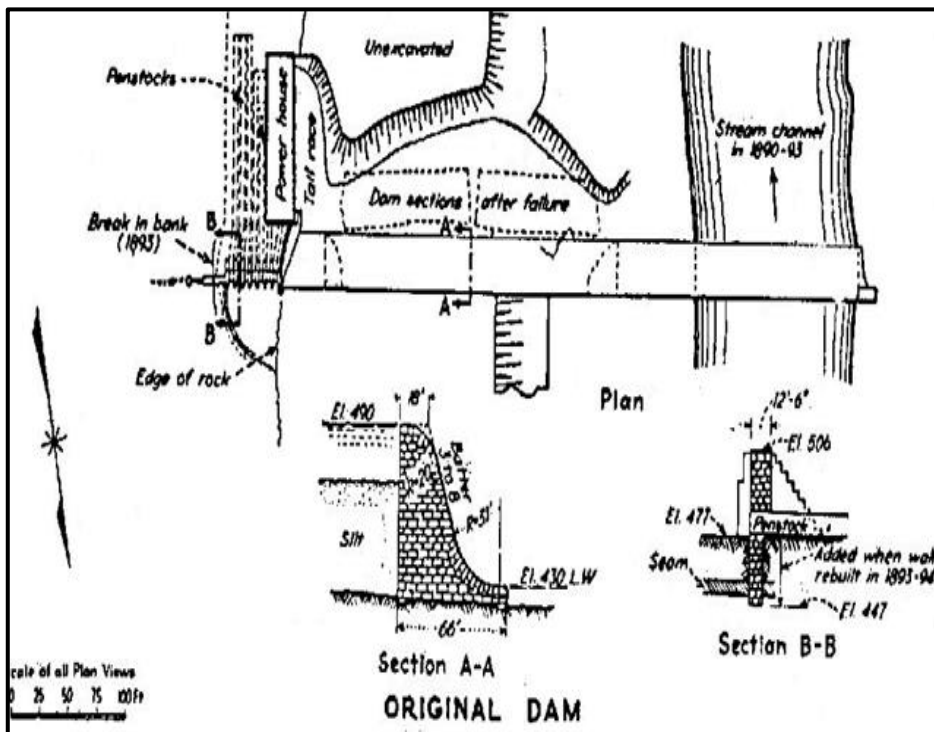
The Austin Dam, also referred to as “The Great Granite Dam” failure was a catastrophic dam failure near Austin, Texas that killed several dozen people in 1900. The destruction of the dam drained the Lake McDonald reservoir and left the city of Austin without electrical power for a number of months. This masonry gravity dam was constructed on the Colorado River, Texas, about 4 km upstream of Austin. The dam was 19.8m high, 342.9m long, and had a total base width of 20.1m. It was constructed of limestone masonry and faced with granite blocks. The mortar of the masonry core had a compressive strength of 16.00MPa. A powerplant was constructed downstream of the left abutment, and the central section had an ogee-type shape to allow water to flow over the dam during flood events. The dam is founded on interbedded limestone that dips downstream 3 or 4m per 100 m. The beds are up to a few feet thick and alternate between hard and soft layers. The rock is extensively fractured and contains much open or clay filled seams. A shallow 1.2m deep cutoff trench was excavated at both the upstream and downstream foundation contacts into the rock. Flowing springs were encountered in both the riverbed and abutments during construction, Figure 19. Because the dam was faced with granite blocks, it was named at the time the “Great Granite Dam”. Shortly after completion in 1894, problems were encountered at the powerplant head gate structure due to water flow along a fault beneath the structure. The structure was badly damaged (exact failure mode unknown), necessitating costly repairs. On April 7, 1900, a heavy rainstorm resulted in 3.4m of water going over the crest of the dam. At that time, about 134.1m of the left side of the dam slid downstream about 12.2 or 15.2m. This section of the dam maintained its line and vertical position. It then broke into two pieces, which remained intact for about 1 hour before breaking up and washing away, refer Figure 21. The water flowing over the structure had eroded the toe and exposed daylighting bedding planes. The strength of these planes was insufficient to resist the loading [29].

Figure 20: Austin Dam, Texas, plan and sections showing conditions after flood (1900) [29].

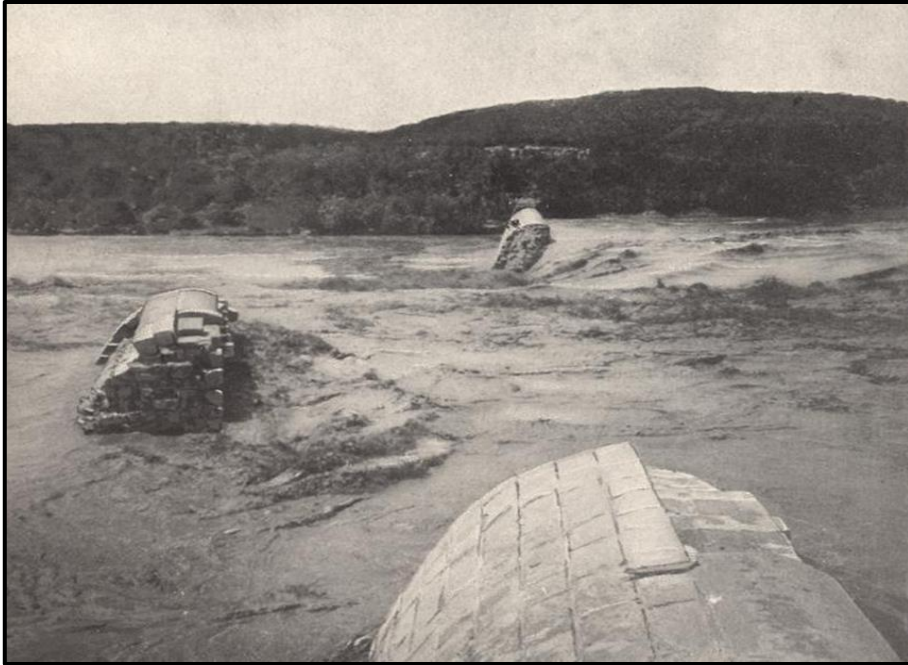
Figure 21: A view of the dam one hour after break [32].

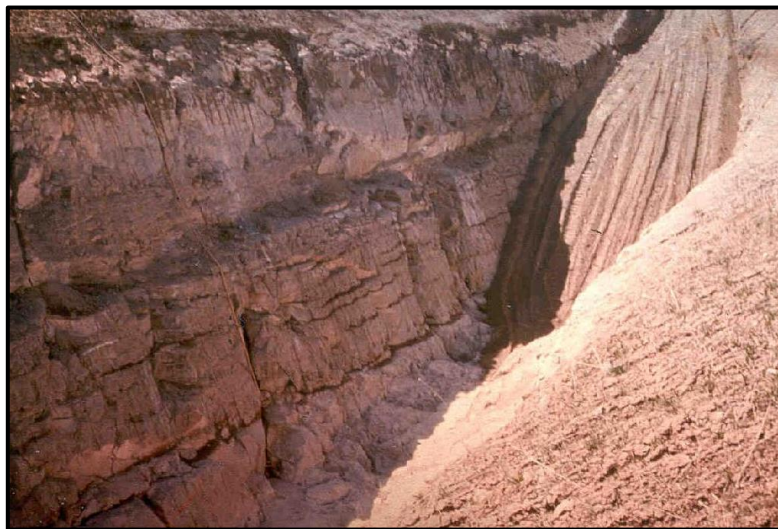
Extensive site exploration was performed prior to construction. Percolation tests and pumping tests revealed that the joints were capable of transmitting volumes of water over 100 gallons/min. These investigations indicated the presence of an extensive interconnecting system of joints, which made the rock extremely permeable and indicated the need to seal the joints in order to reduce the leakage to acceptable quantities. In order to investigate the possibility of sealing the upper foundation rock by grouting, an extensive pilot-grouting program was conducted on the left abutment. After the pilot grouting, the area was core-drilled, and water pressure tested. Since the amount of grout needed was a tremendous amount, it was concluded that it would be more economical to remove the top 70ft. rock in the abutments above El. 5100ft and incorporate a deep key trench to prevent seepage. Continuous high-angle joints in the right abutment have been traced for lengths of as much as 200 feet, but most are between 20 and 100 feet long. The aperture of most high-angle joints is less than one-half inch, but many joints are as much as several inches wide and some are several feet wide. Examples of the jointing can be seen in Figures 28 and Figure 29.

Figure 28: A view of the right abutment key trench showing the jointed nature of the foundation [34].

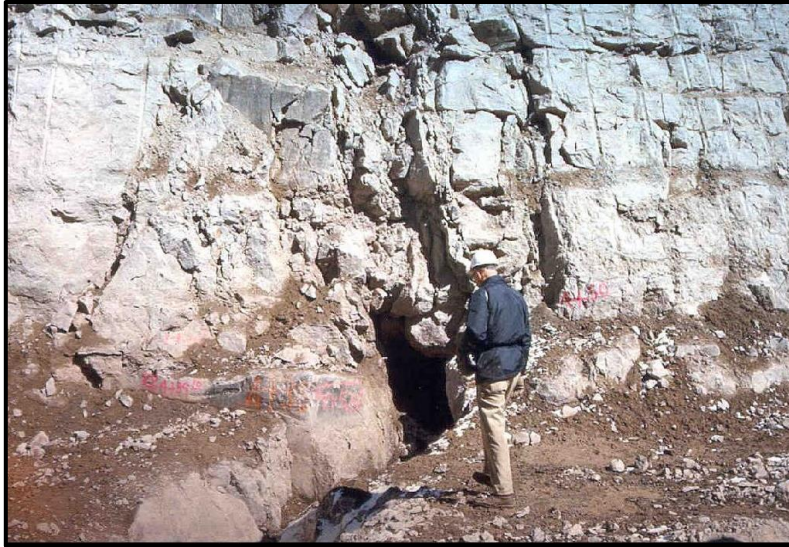
Figure 29: A view of a Large fissure in the right abutment key trench [34].

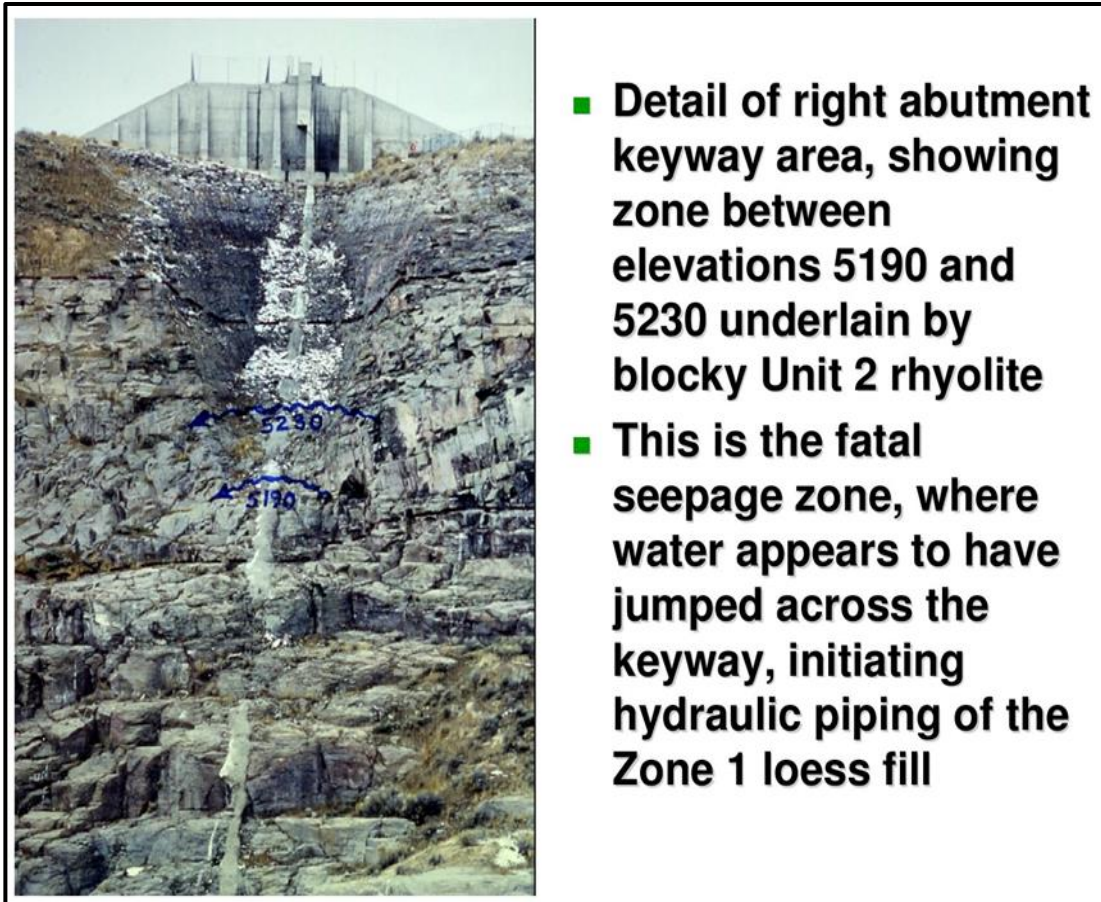
Post failure investigations, after the key trench on the right abutment was uncovered, showed exactly the fatal seepage zone location between el. 5190 and el. 5230 where seepage water jumped across the key trench overpassing the grout cap and initiating piping failure in the Zone 1 losses fill (refer back to Figure 25). This key trench is photographed and presented in Figure 30 on which the seepage zone is marked indicating the blocky unit 2 rhyolite beneath it.

Figure 30: Photograph of the key trench showing the seepage zone [40].
