Dam Safety: Technical Problems of Ageing Concrete Dams

**Nasrat Adamo¹, Nadhir Al-Ansari², Varoujan Sissakian³, Jan Laue⁴
and Sven Knutsson⁵**

Keywords: Dam Aging, Cracking, Expansion, Spalling, Scaling, Abrasion, Cavitation.

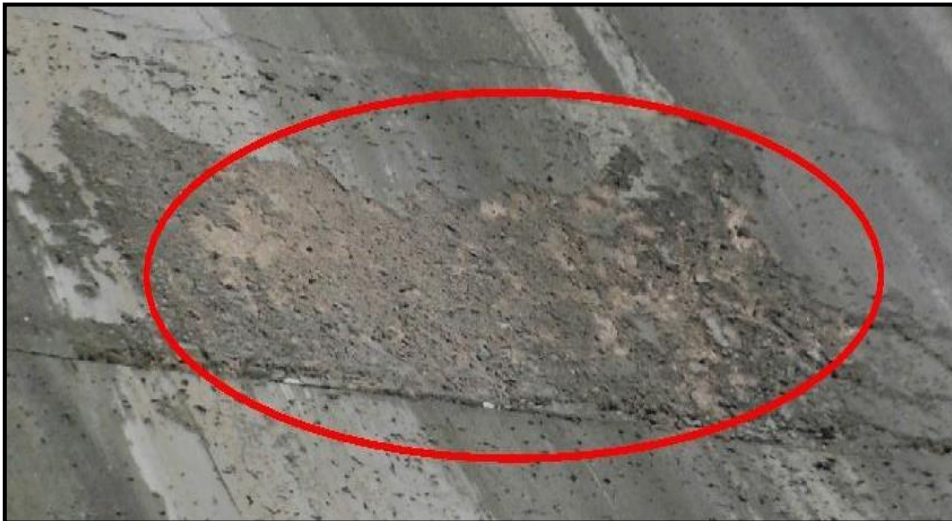
Figure 4: Disintegrating surface concrete observed on dam face.

- a. Removal and replacement of 6 inches of concrete on the spillway face and stilling basin floor.
- b. Repair of concrete on the upper spillway gate operator's decks and complete replacement of the spillway adits (access entryways).

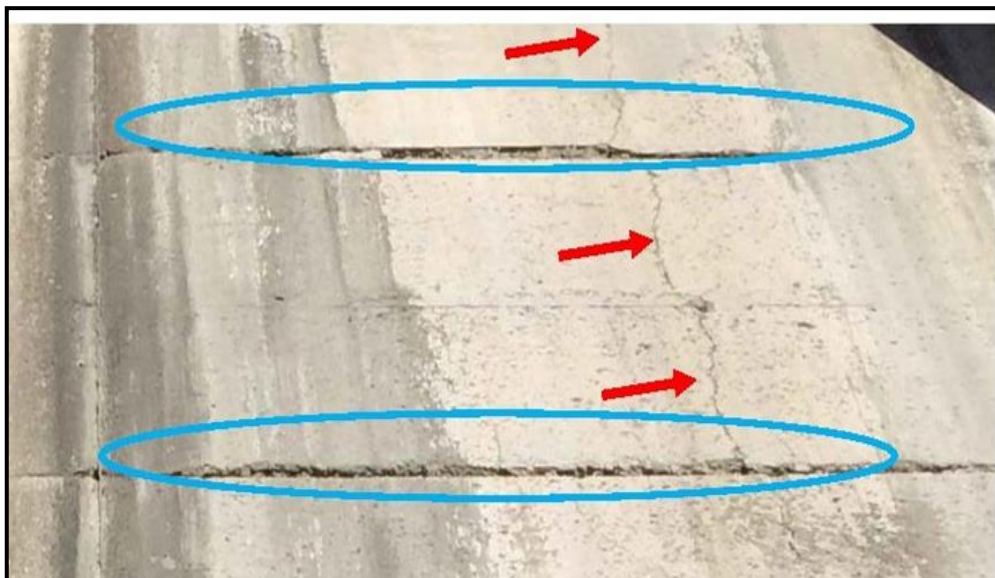
Figure 5: Deterioration of concrete joints observed on the spillway face.

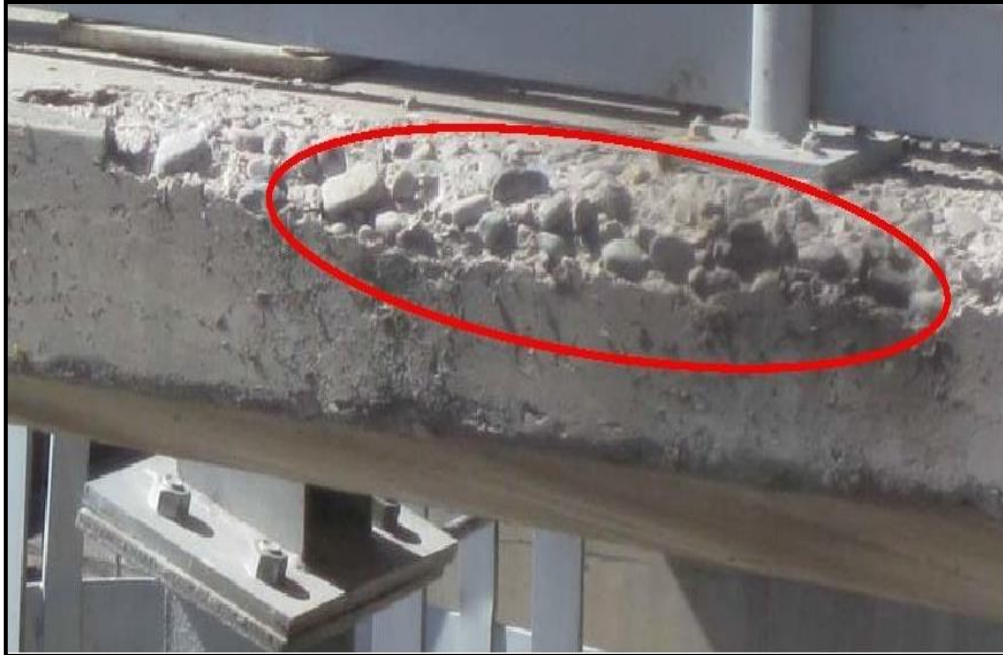
Figure 6: Structural deterioration of concrete on spillway gate operator deck. Extensive exposed aggregate is apparent.

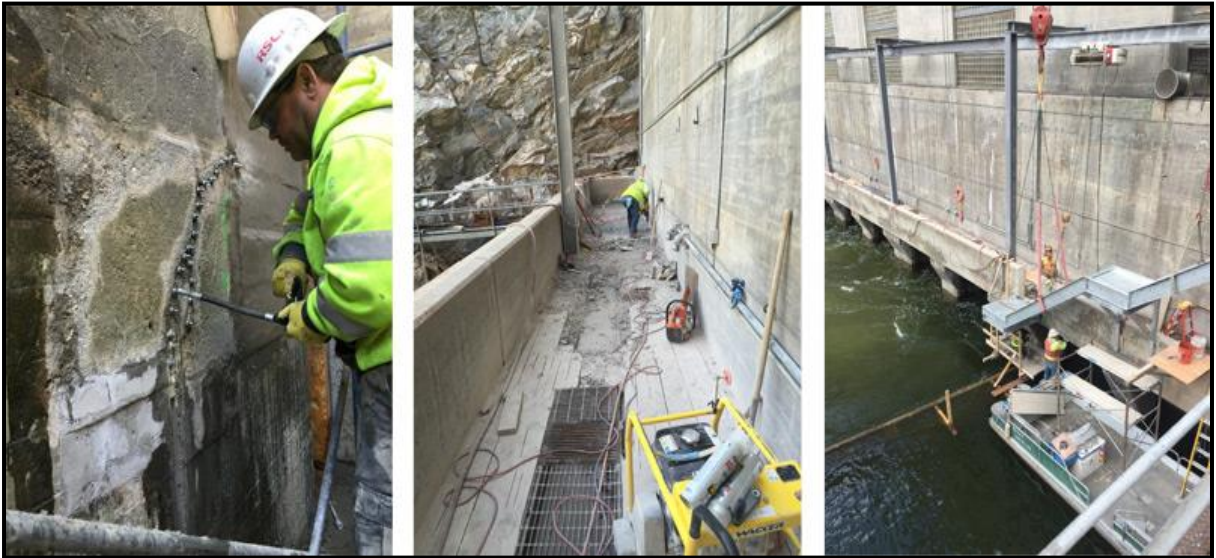
Some concrete repair and stop log replacement project was recently completed at Seminole Dam. The river outlet works and stilling basin at Seminole Power Plant was identified to have deficiencies in the concrete located around the outlet works and the tailrace deck. The stop logs were constructed as part of the original Seminole Dam and Power Plant in 1939 and over 81 years of wear and tear had taken their toll. They no longer provided an adequate seal to allow periodic maintenance of the power plant draft tubes and river outlet gates. The tailrace deck also had deteriorated concrete and the stairway leading to the tailrace deck did not meet accepted standards.

Figure 9: Left: Injecting epoxy to repair crack. Center: Concrete removal on tailrace deck. Right: Installing new stairway.

The tailrace deck was resurfaced by saw cutting the surface, using jack hammers to remove deteriorated concrete, and then adding a new layer of fresh concrete. Photographs of the performance of some of the described works are shown in Figures 9 and 10 [8].

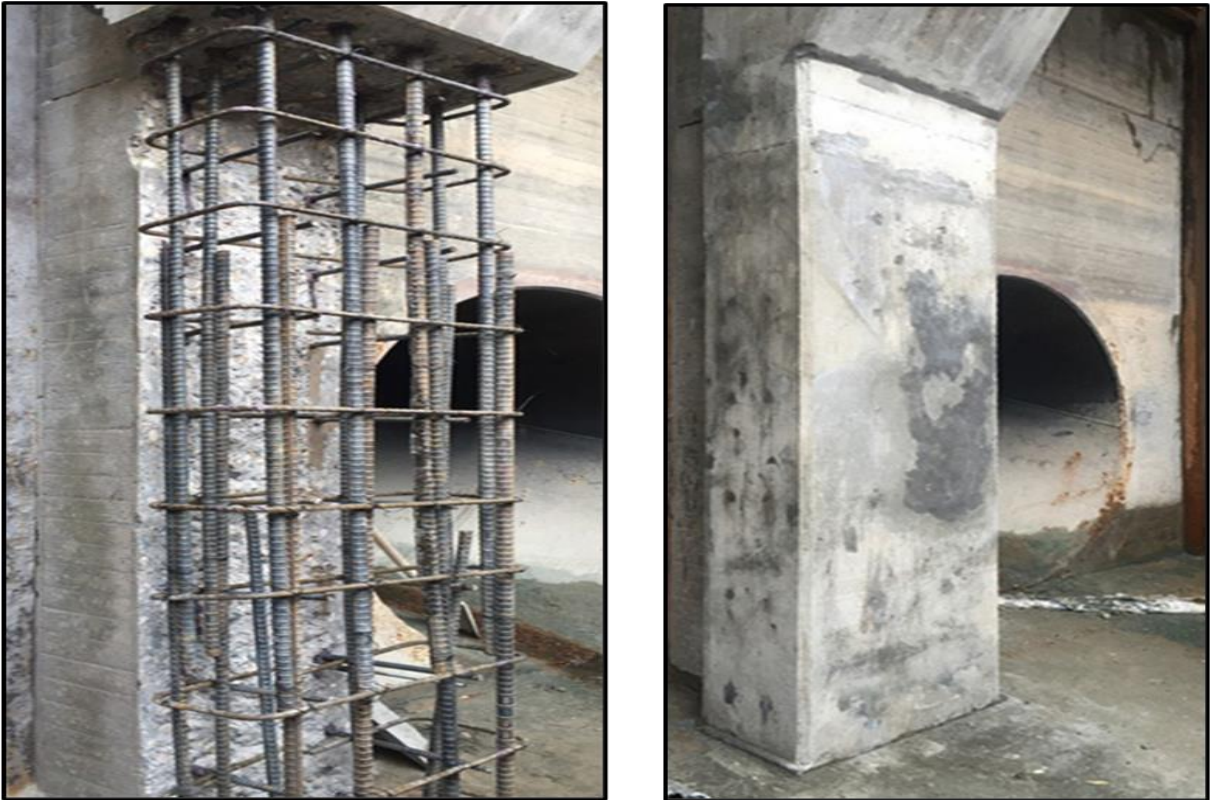
Figure 10: Repairs in river outlet works center pier showing reinforcing bars and the finished shape.

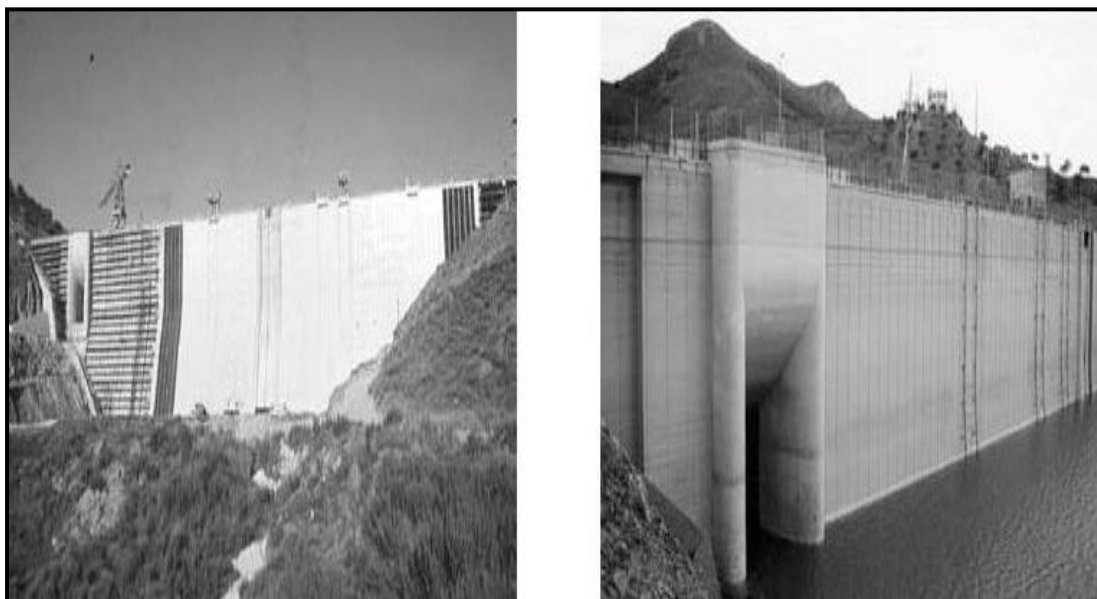
Figure 11: Pracana Dam affected by Alkali Aggregate Reaction during and after rehabilitation by water proofing.

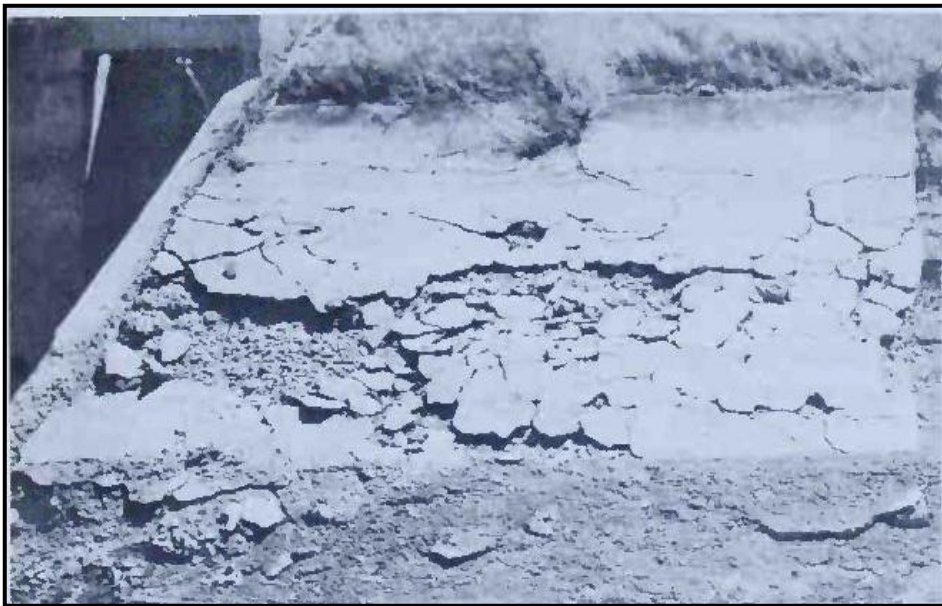
Figure 12: Disintegration of concrete caused by sulfate attack.

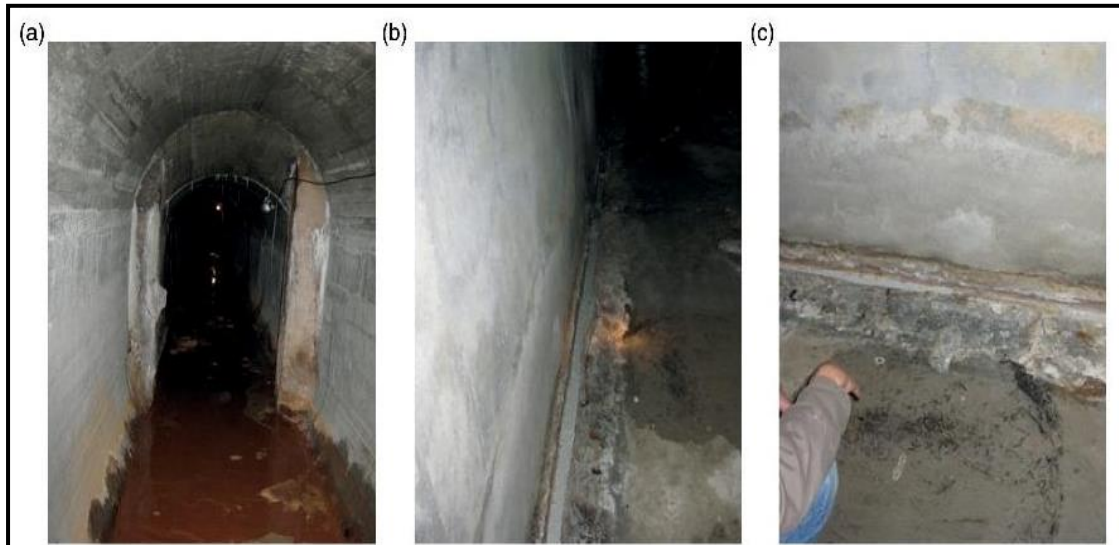
However, these degradation products are not fully extended in the concrete matrix and are located in a few pores. But, Thaumassite Sulfate Attack (TSA) was evident in gallery 81m indicating signs of a severe concrete degradation in the chutes through which the filtered water flows in the gallery and, to a lesser extent, in the walls, refer to Figure 15. Thaumassite is a silicate mineral with chemical formula $\text{Ca}_3\text{Si}(\text{OH})_6(\text{CO}_3)(\text{SO}_4)\cdot 12\text{H}_2\text{O}$.

Figure 15: a) Brownish waters in the floor of gallery 81m. b) and c) Photos of the wall and chute where water is flowing in gallery 81 m.

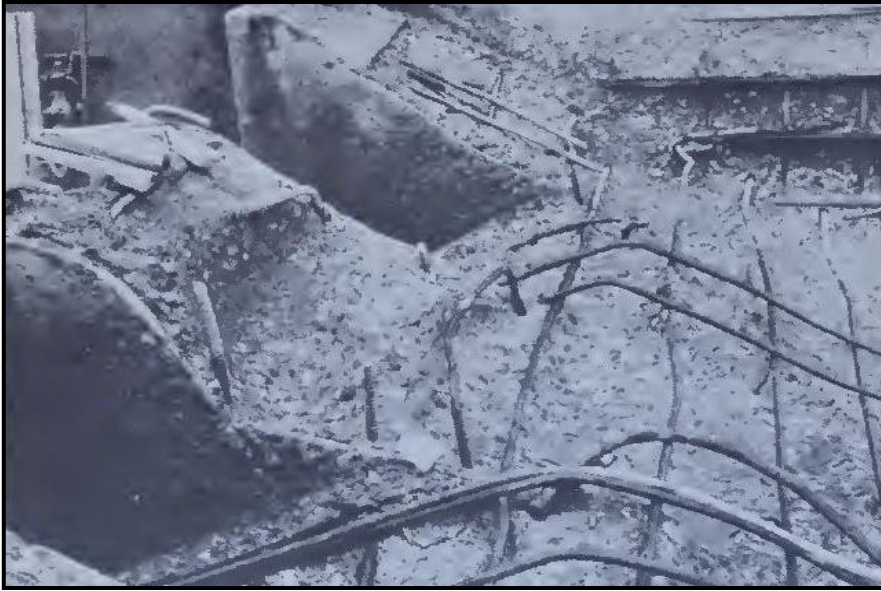
Figure 16: Abrasion erosion on concrete in the dentates, walls, and floors of the Yellotall Afterbay Dam Sluiceway stilling basin. The “ball mill” action of cobbles, gravels, and sand in turbulent water abraded the concrete, thus destroying the integrity of the structure.

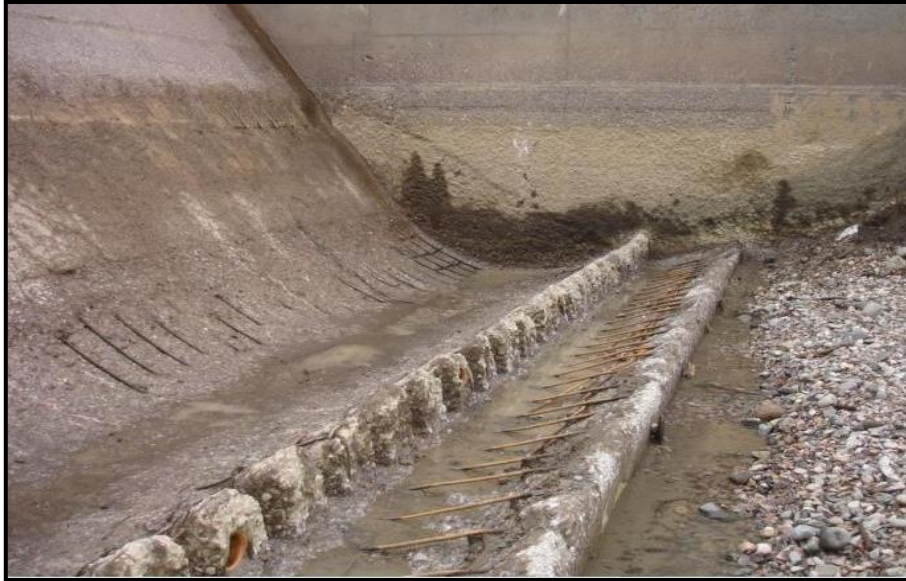
Figure 17: Abrasion erosion damage to the flip bucket and energy dissipators. The cause of the damage was not determined prior to starting repairs.

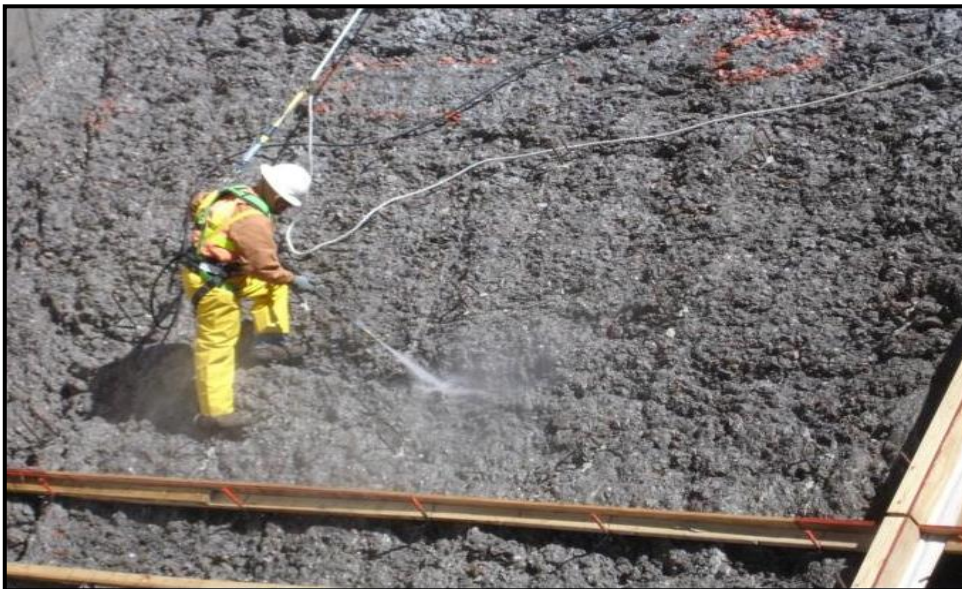
Figure 18: After beginning of concrete removal, the extent of damage became clear. Concrete was easily removed due to extensive deterioration.

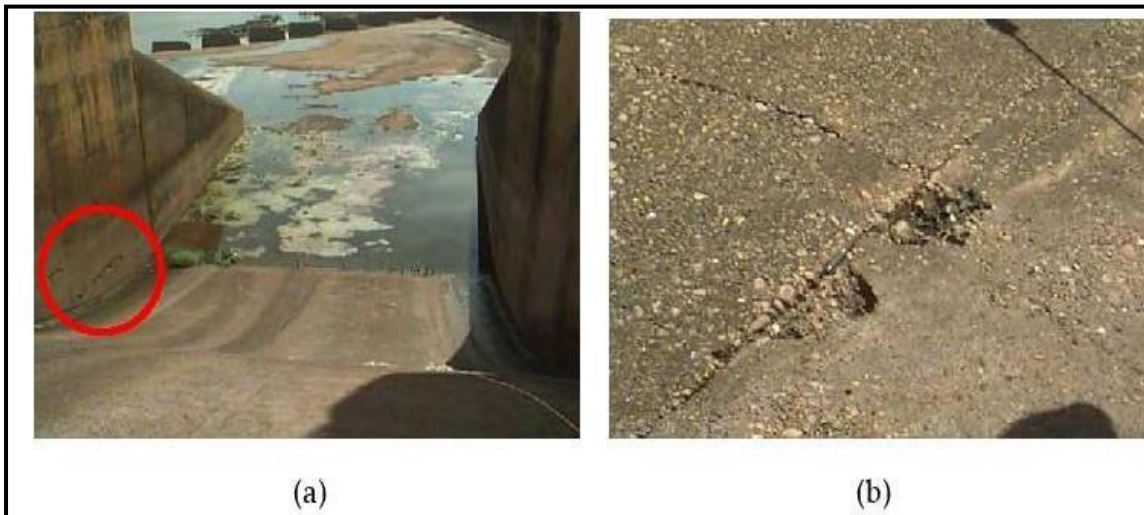
One case study of similar damage is illustrated in Figure (19a) of another spillway chute damaged by abrasion. The damage was clearly visible on the surface of the spillway slab, side walls, pillars of the gates and the energy dissipation blocks. These parts were found damaged at several points which had been caused by abrasive processes. The location of the damaged part on the wall is indicated by the red circle as highlighted in Figure (19a). Similar defects on the spillway slab are shown in Figure (19b).

**Figure19: (a) Dam Spillway deterioration by abrasion.
(b) Defect in the concrete structure caused by abrasive process.**

Many alternative materials for repairing these defects could be suggested including, mortar with silica fume with optimum content of about 10% of cement mass replacing the fine aggregate, epoxy mortar, polymer mortar, concrete with steel fiber or high strength concrete with characteristics similar to concrete used in dam construction in a mix of 1:1.61:2.99:0.376 (cement:sand:gravel:water) with cement content of 426 kg/m^3 [22]. In another case study cited by the same reference, the repair of spillway chute of hydroelectric plant located in southern Brazil was done by adding polymeric materials to the concrete used to repair hydraulic surface degrades and damaged parts of the abrasive processes. The materials used was mixture of agglutinated low-density polyethylene (LDPE), crushed polyethylene terephthalate (PET) and rubber from useless tires. An overview of the dam spillway is shown in Figure (20a) Details of displacements in the surface caused by hydraulic abrasive processes are shown in Figure (20b).

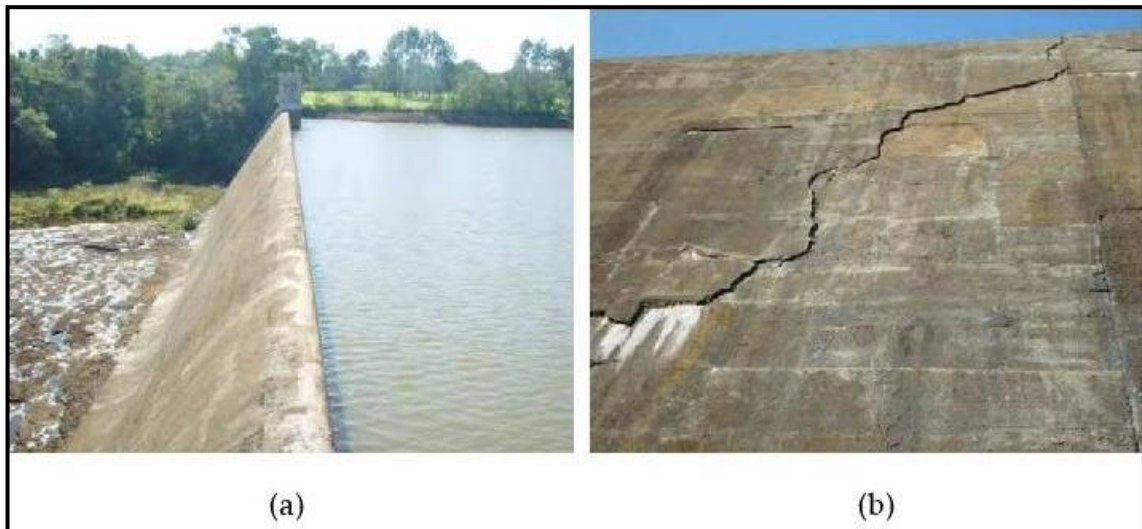
**Figure 20: (a) Overview of the spillway of the dam.
(b) Detail of the displacement of the surface caused by hydraulic abrasive processes.**

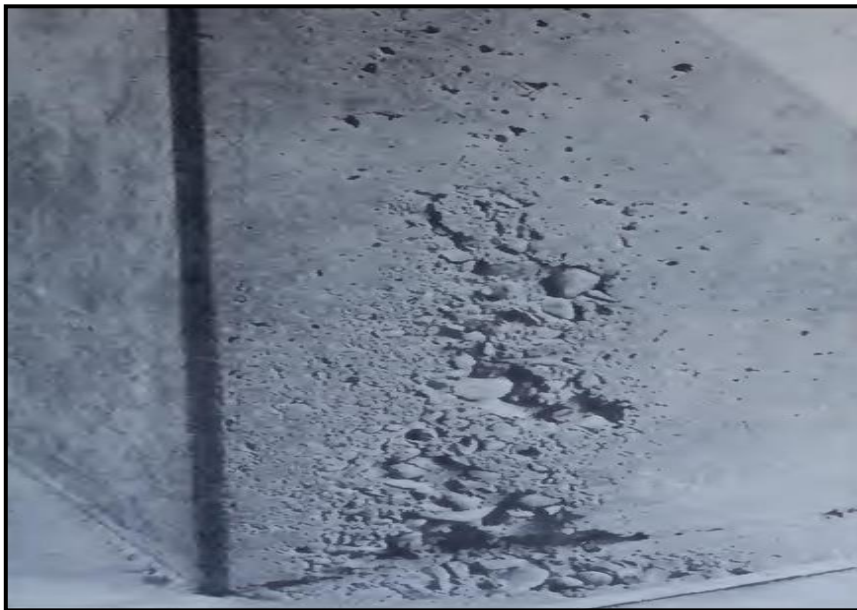
Figure 21: Cavitation erosion of concrete on a dentate in the Yellowtail Afterbay Dam spillway stilling basin. Fast-moving water during a flood flow, caused a pressure phenomenon at the concrete surface which triggered cavitation damage shown here.

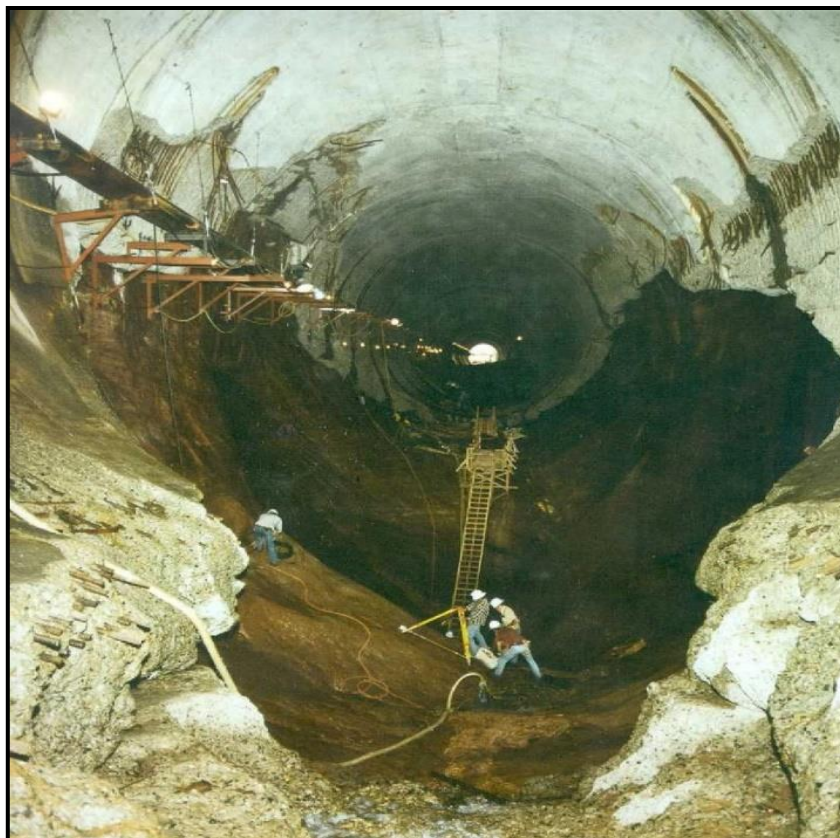
In 1981, an inspection revealed that deposits from cracks in the lining had initiated cavitation damage at several locations in the left spillway. Little damage had occurred in the right hand side spillway which was probably due to the shorter operating time. Following this inspection, surveys and studies were performed to document the damage and to identify the scope of work required for repair and to prevent future occurrence. It was recommended the damage be repaired and aerators be installed near station 6+86.0. These modifications were planned to begin in 1984, but high flows in the Colorado River occurring in the spring of 1983 had to be passed through the spillway.

**Figure 24: Glen Canyon Left Spillway Tunnel, September 1983.
The "big hole" in the spillway invert was 11 meters deep.**

The decision taken for repair was to construct aerators to inject air in the inclined portions of the spillways to stop future cavitation damage. After thorough study and modelling and design work, the aerators consisted of a ramp, a groove or slot, a downstream offset, and a transition back to the original tunnel diameter as shown on the earlier Figure 23 upper right corner. The ramp is 1295mm long and 180mm high at the centerline of the invert. The ramp feathers out to zero height at the springline. The groove is 1200 x 1200mm. The downstream edge of the slot is offset 305mm from the original tunnel diameter. The length of the transition to the original tunnel diameter is 6.1m. The end of the ramp is at station 6+86.5 which is 96.2m below the maximum reservoir elevation. The tunnels were ready for service after finishing construction on 10 October 1984.

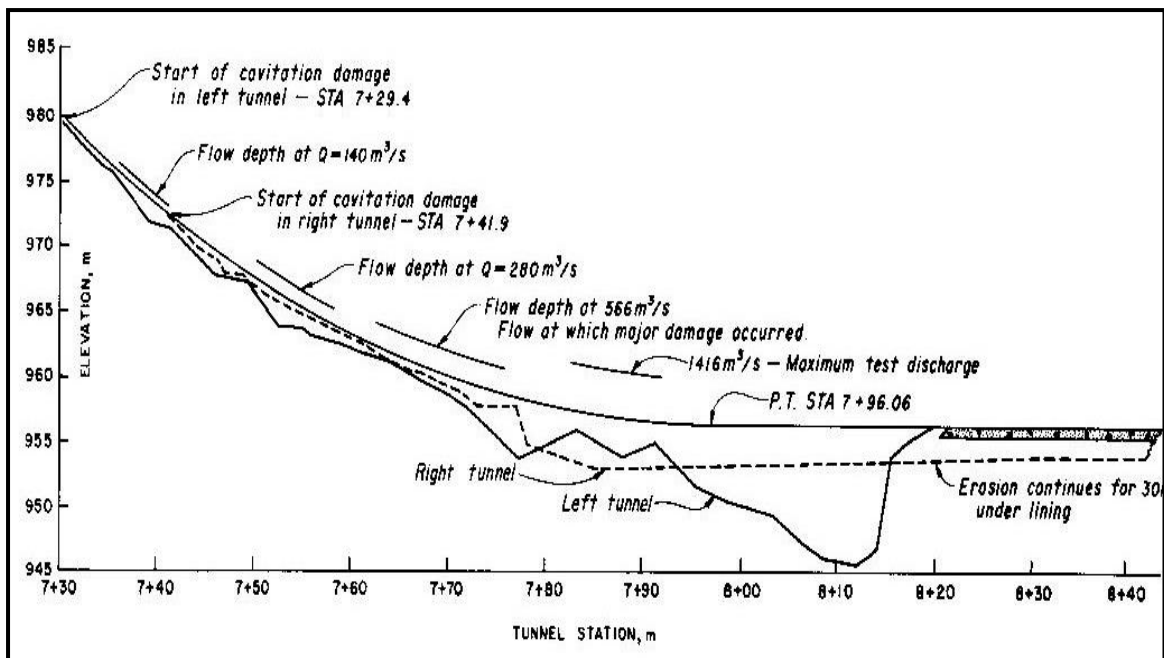
In the elbow portion of the tunnels, the depth of the damage as noted in Figure 25 was on the same order as the depth of the flow.

Figure 25: Glen Canyon Dam, tunnel Spillways- damage profiles.

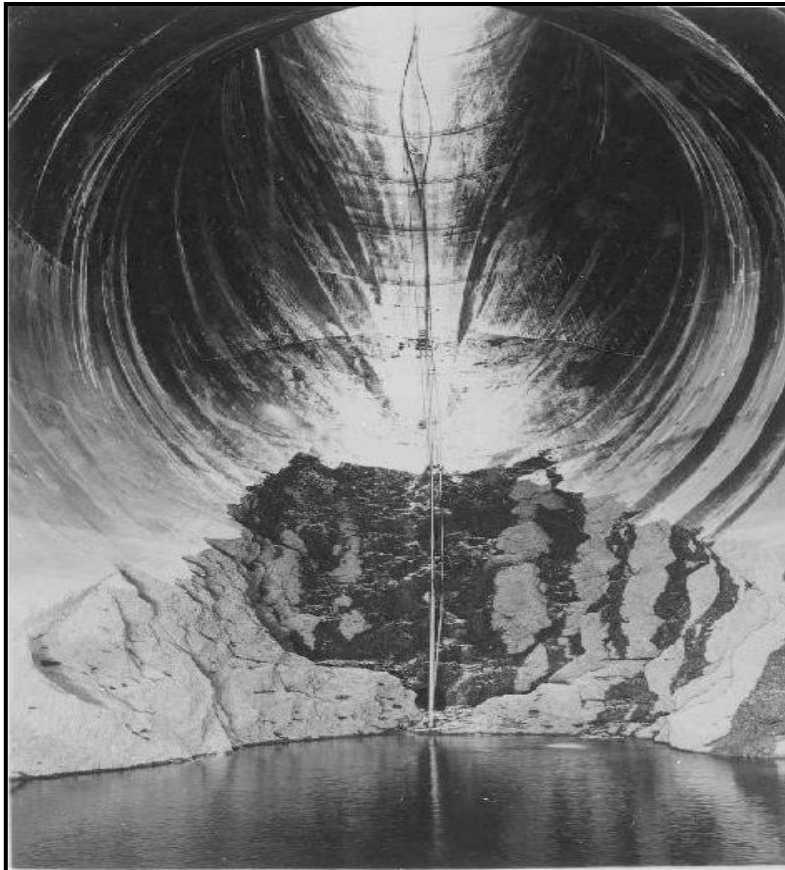
Relatively modest flows, never exceeding 368 cubic meter per second were passed through both spillways for four months. Even with these modest flows, velocities at the elbows reached 175fps (53.3m/s) and cavitation damage ensued on both spillways. The cavitation was most severe on the Arizona spillway elbow, where a hole 112ft long, 35ft wide, and up to 36ft deep was eroded into the high strength reinforced concrete on this spillway; this is illustrated in Figure 28 [26].

Figure 28: Cavitation damage observed in December 1941 in the elbow of the Arizona spillway after modest discharges passed through the spillway between August and October 1941.

It was judged that the most probable reason of this damage was being an abrupt misalignment in the tunnel invert that deflected the high velocity flow causing sub-atmospheric pressures and the formation of vapor pockets. Subsequent implosion of these vapor pockets further downstream caused cavitation damage which destroyed the integrity of the concrete lining and eventually led to the massive erosional damage.

The original volume of the cavity was 1069.6 cubic yards (818m³). Repair work was started almost immediately, but because it was believed that ordinary concrete was not suitable it was decided to utilize the (Prepack and Intrusion) process of concrete repair developed by Durite of Chicago. After repair, the tunnel was polished smooth to help prevent any future erosion [27].
