## **Dam Safety: Technical Problems of Aging Embankment Dams**

### **Abstract**

**Keywords:** Embankment Dams, Faults Karst, Compressible Clay, Soluble Rock, Soft Rock, Differential Settlement, Grout Curtains, Diaphragms, Internal Erosion, Piping, Dispersive Clays, Gap Grading, Filters, Drainage Blanket, Uplift.

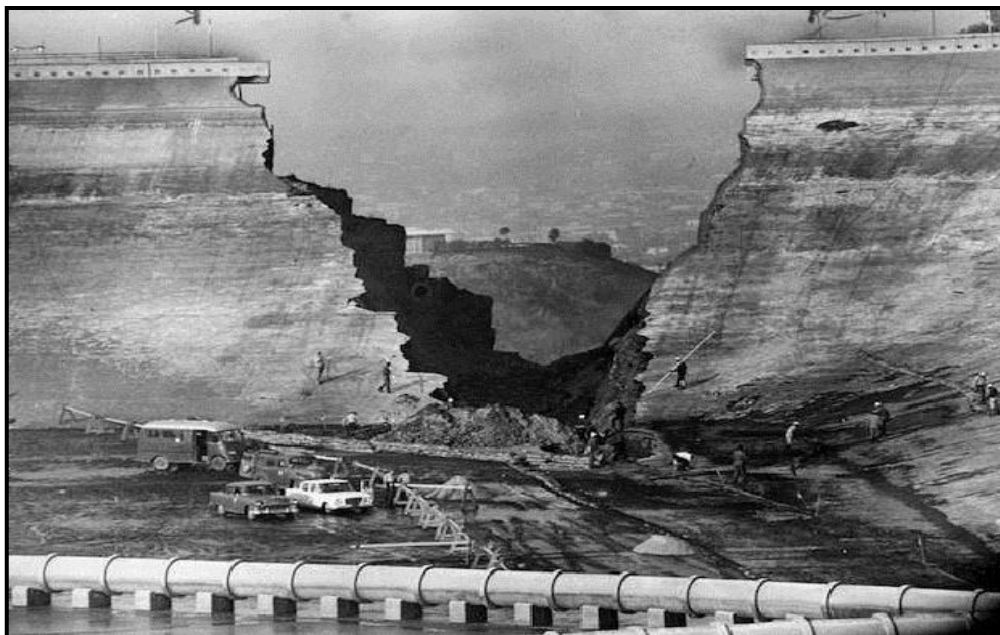
As the reservoir completely drained it was revealed that the asphalt lining had cracked allowing water to penetrate and erode the soil beneath it. In the aftermath of this failure there was much speculation of the primary cause(s) of the crack during the investigation and law suits that followed the failure which are outlined in the following.

**Figure 2: Baldwin Hills Reservoir Dam showing breach section in the aftermath of failure.**

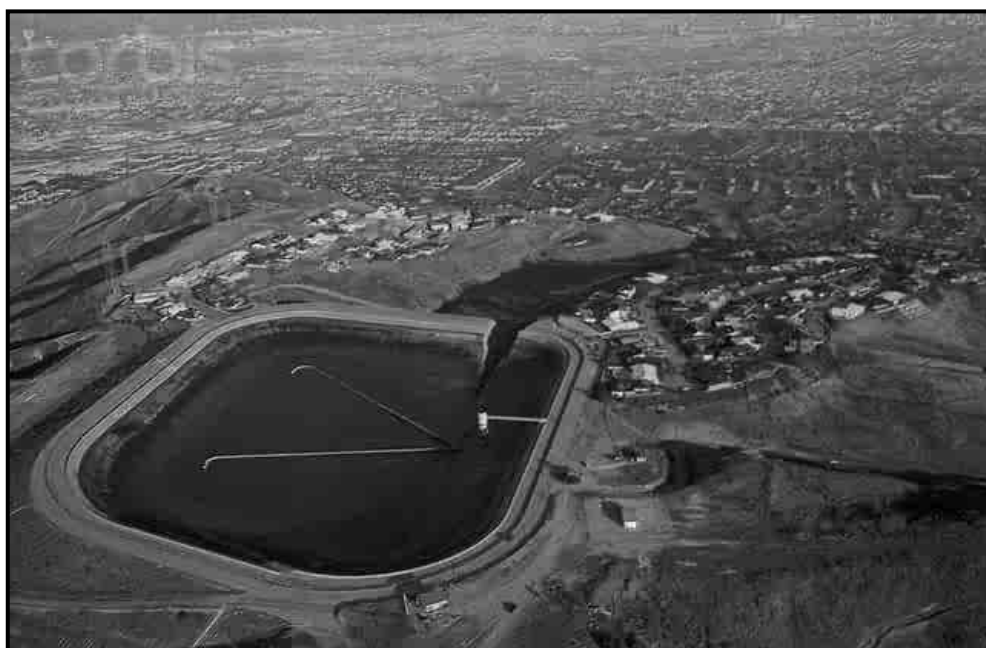
**Figure 3: Aerial view of Baldwin Hill Dam Reservoir showing breaching section.**

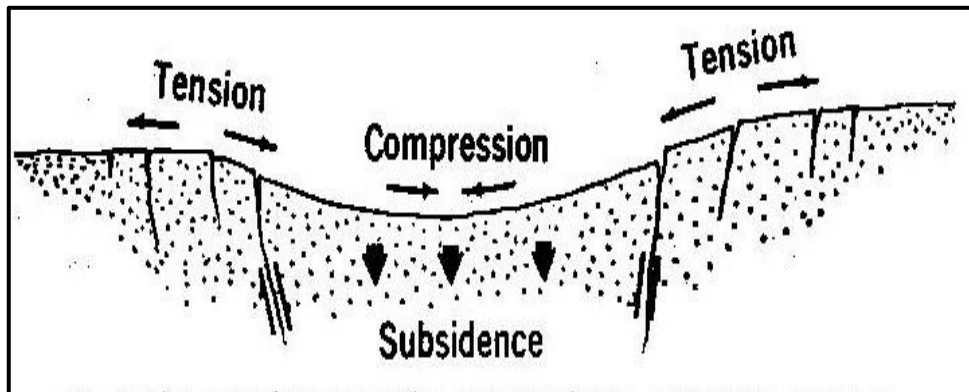
In its investigation, the State Engineering Board of Inquiry determined that the rupture of the reservoir lining which ultimately caused the collapse was result of slow earth movement concentrated at one of the fault lines. This movement was claimed to be caused by the tectonic movement manifested by the general subsidence in the Inglewood fault system area as visualized in Figure 4 [4].

**Figure 4: Diagrammatic representation of fault activation attributed to subsidence [4].**

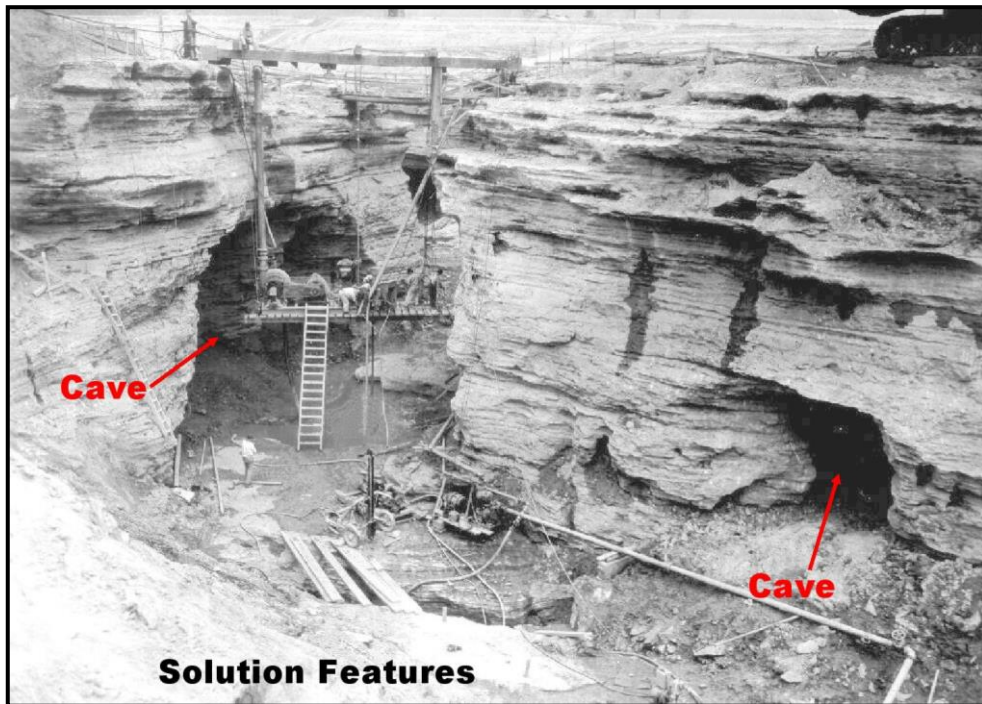
Large cavities and pronounced solution features were encountered during the excavation of the cutoff trench under Monolith 37 and the concrete embankment interface as illustrated by the photograph in Figure 8 [7].

**Figure 8: Cavities and Solution Features encountered in Cutoff Trench Excavation [7].**

Seepage was first encountered during foundation construction and visible karst features were identified. The seepage problems were traced to the karst geology of the region which allows for the dissolution of limestone, and it is recognized to be in large part due to solution of the carbonate rocks lying beneath the embankment section. It is thought now that the foundation treatment techniques used were inadequate for this condition. Most of the alluvium was left in place and except for the cut-off trench, no treatment for the embankment foundation was performed, moreover, the cutoff trench design and construction were not properly done [7].

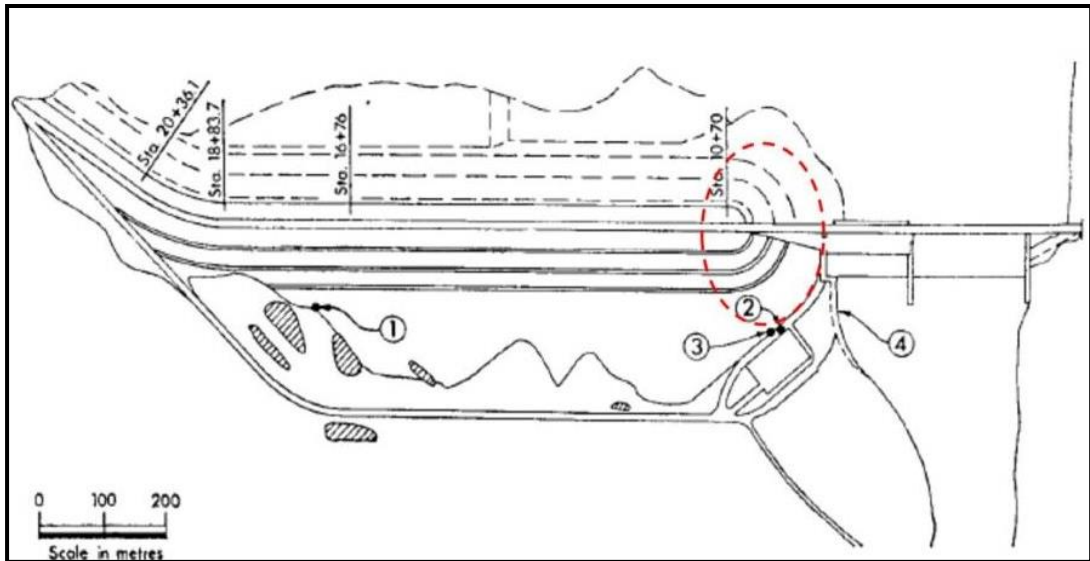
After 17 years of service, excess seepage problems within Wolf Creek Dam foundation began to appear. Beginning of 1968, signs of this seepage were discovered when two sinkholes appeared at the downstream toe of the dam and muddy water was observed in the dam's outflow channel. Solution channels caused by this process allow piping to occur which added to the rate of erosion in the foundation Figures 9 and 10. As concerns over this seepage increased one campaign of investigation was started which found solution channels in the limestone, and local piping.

**Figure 9: Sinkhole location: (1) sinkhole of 8/22/67. (2) Sinkhole of 3/13/1968. (3) Sinkhole of 4/22/1968. (4) Muddy water (Tailrace). (///) Wet areas, red dash outlines the “area around monolith 37”.**

Emergency grouting over 1968-72 stopped the immediate piping, and it is generally accepted that this had saved the dam, but as recognized afterwards more was needed at the time. Following this, severe foundation seepage problem led to the necessity of a permanent solution at Wolf Creek Dam after the completion of the emergency grouting program completion in 1972. A board of consultants was convened whose adopted recommendations were to install pile type concrete walls diaphragm

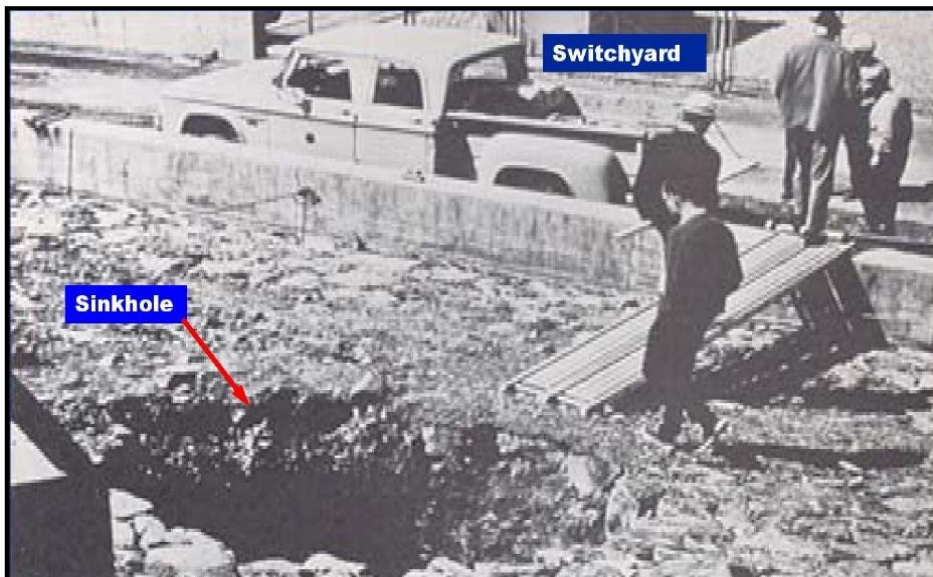
**Figure 10: Sinkhole of 3/13/1968 at the Edge of Switchyard [7].**

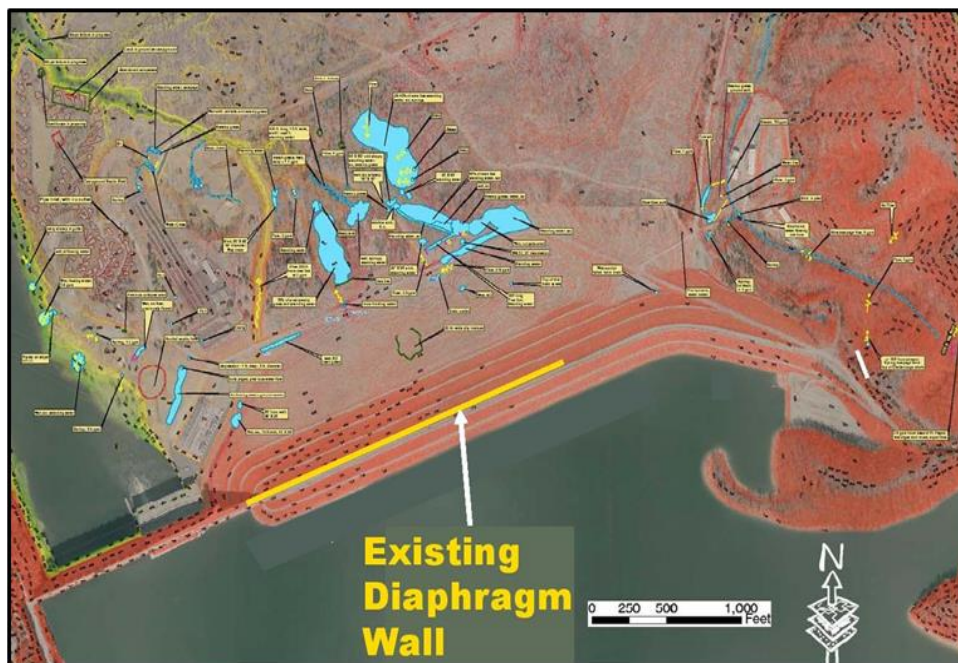
Monitoring of the concrete barrier revealed that the diaphragm wall had slowed but not stopped the seepage and erosion problems. The USACE admitted then that water seepage had found new paths under and around the wall, and even possibly through defects in the wall itself as erosion of solution features continued. The extent of the diaphragm completed in Phases I and Phase II is illustrated in Figure 11.

**Figure 11: The first diaphragm wall of Wolf Creek Dam diaphragm wall as indicated in 2004 ([7] and [38]).**

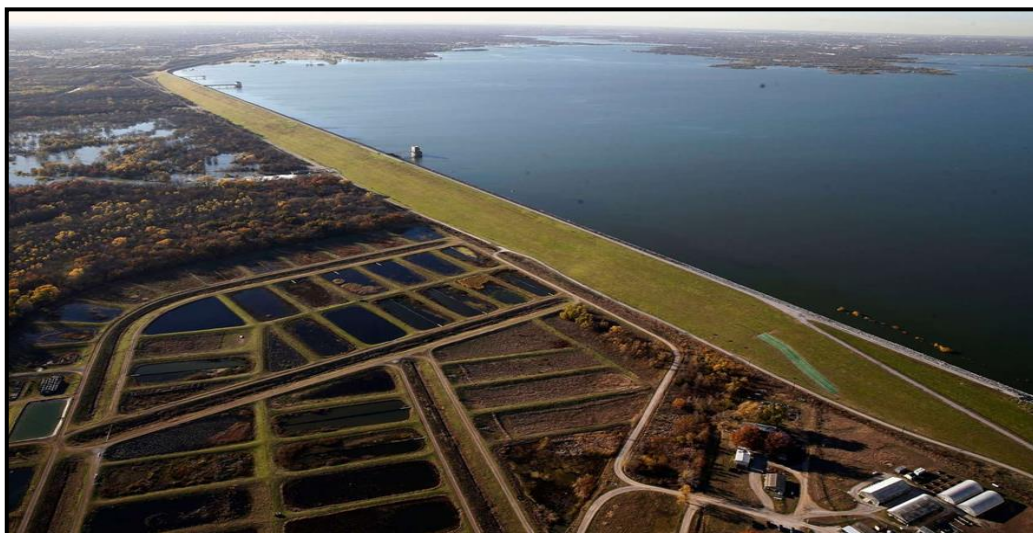
**Figure 14: An aerial view of Lewisville Dam showing location of boggy area created by seepage.**

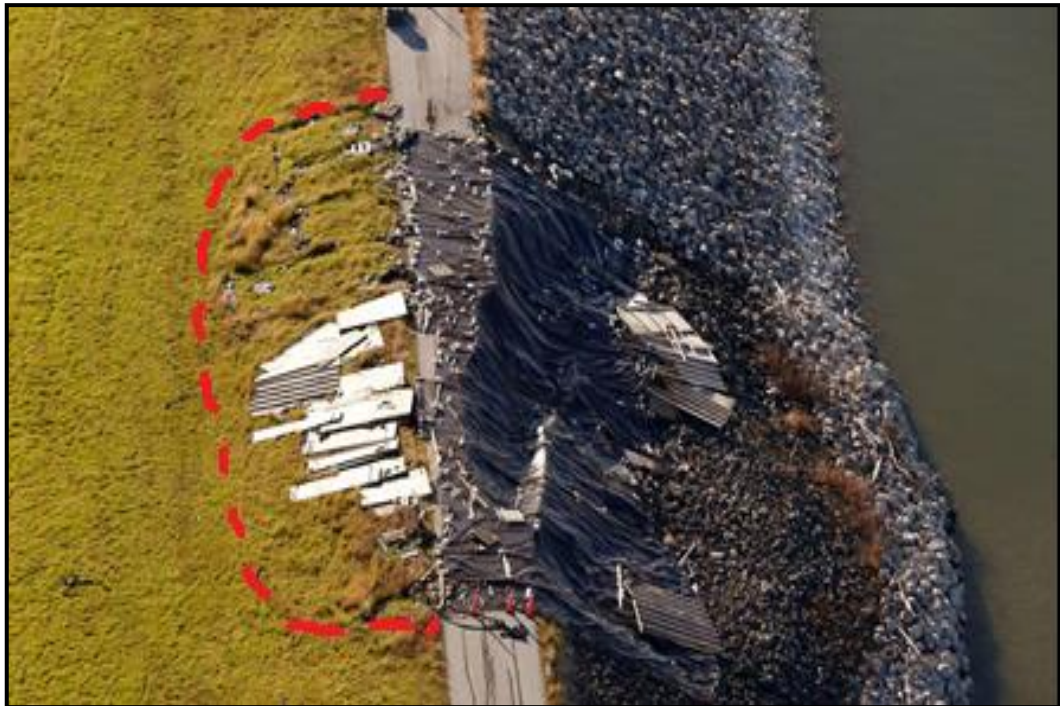
The embankment stability was more questionable since the May, 2015 flood because cracks have spread along the 6 meters wide crest of the dam. The Corps believed that "desiccation cracking" at the crest of the dam caused the earthen slope to collapse and slide. The heavy rains in mid-May and early June of 2015 filled the 1 to 3 inch wide cracks, saturating the soil underneath and vastly increasing its weight while reducing its shearing strength had all caused instability and sliding. This dramatic shrinking and swelling of the embankment materials during the rapid drought-to-deluge cycle may also account for another deformity that were spotted on the upstream face of the dam after the May rains which was a large, bowl-like depression in the slope across from Seepage Area No.1.

**Figure 18: Slide area covered with plastic tarps, sandbags, and wooden planks for fear of heavy rain causing more damage [20].**

The envisaged solution was to surround the slide area at the upstream side by a cofferdam, pump dry the enclosed area to enable heavy-duty construction work below the reservoir's waterline. The contract for this repair work was awarded as a \$6.4 million contract to repair the slide in late 2015; it was scheduled to begin on 4<sup>th</sup> Jan, and should be completed by May 2016 [21].

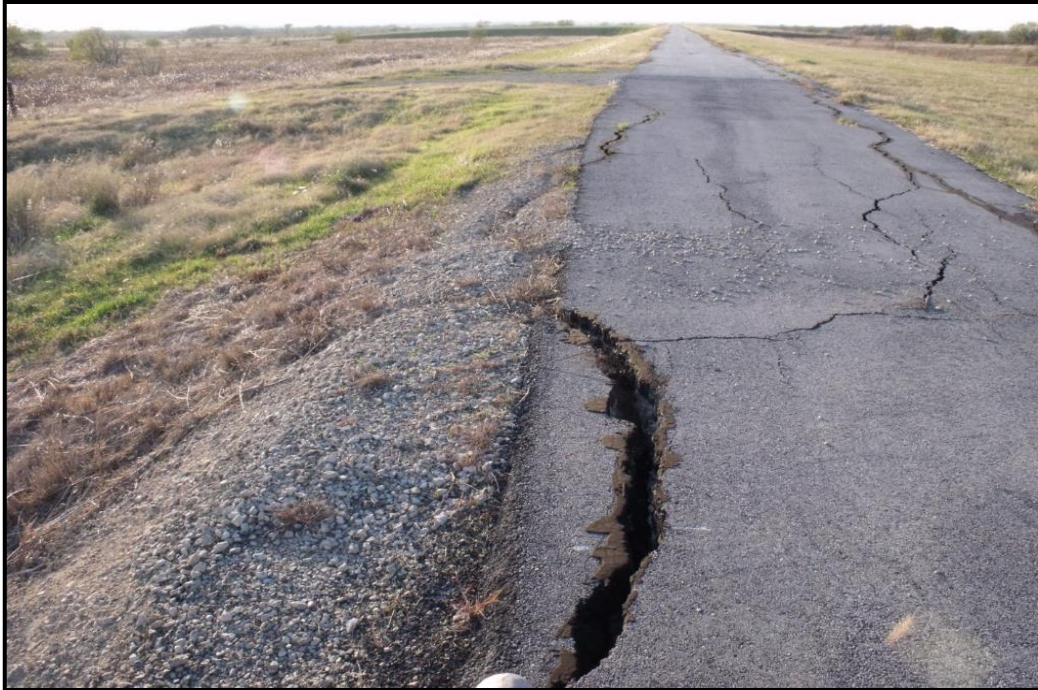
**Figure 19: Typical cracking on Lewisville Lake Dam with clear signs of aging.**

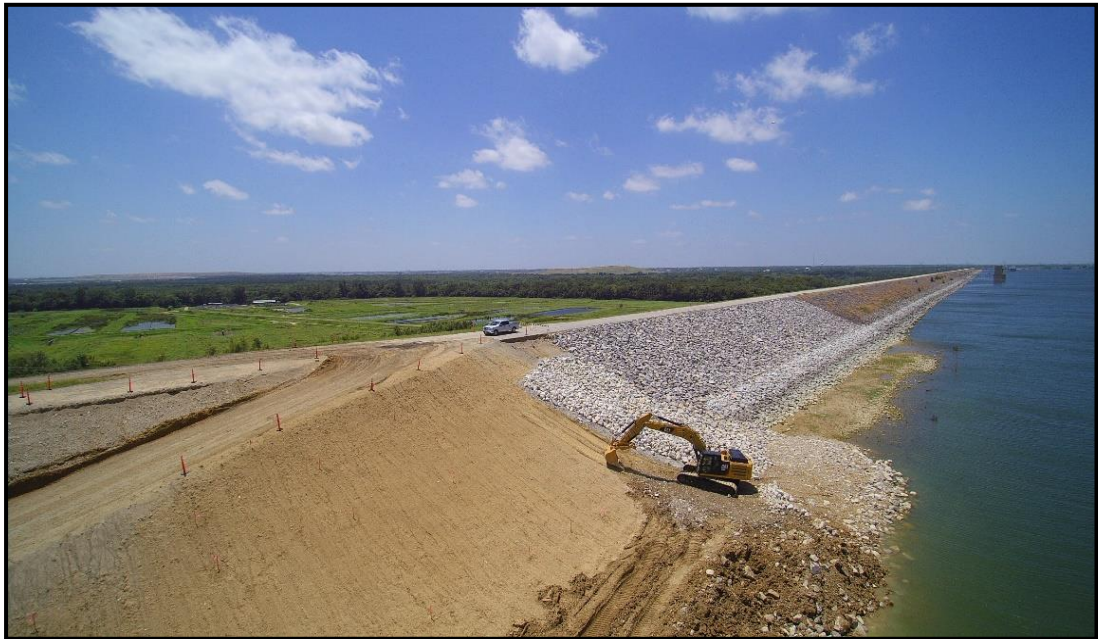
The works went ahead as scheduled, but close to construction completion another small slide of about 850 cubic meters occurred which was replaced also. Since the soil used in the dam contained high amount of clay, which expands and contracts with moisture, the Corps replaced the failed material of the sliding slopes with lime-stabilized soil taken from borrow area downstream of the dam. The progress of work in this case of repair is shown in Figure [20]. But as it was coming to the final stage of adding the slope protection riprap to the newly constructed slope [22].

**Figure 20: Repair work progressing on the slope of Lewisville Dam slide during 2016 [22].**

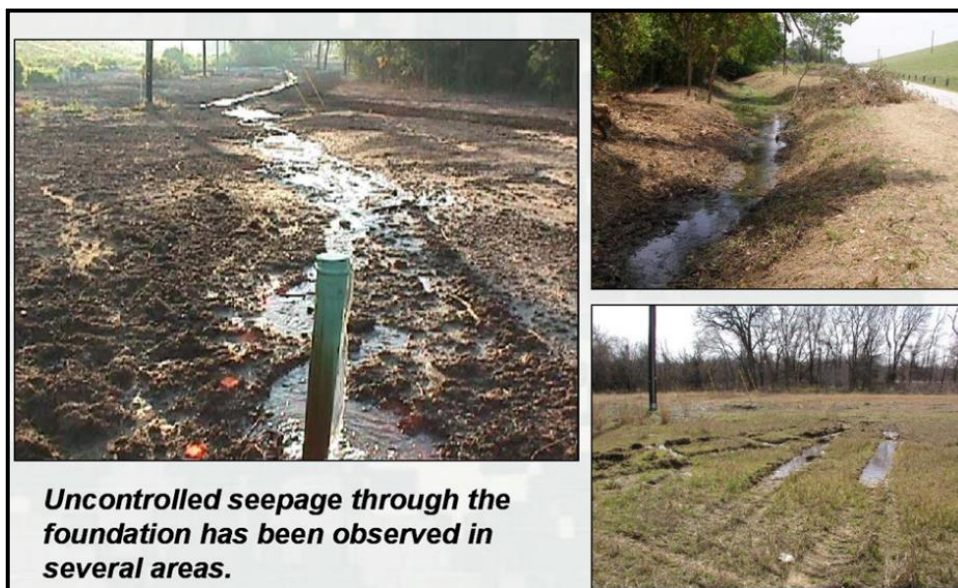
- i. Uncontrolled seepage through foundation was creating unsafe conditions which could develop into piping and lead to erosion of the embankment. This seepage had created boggy areas downstream of the dam and even formed some noticeable water streams as shown in Figure 21. Potential corrective measures ranged between adding filters, toe drains, berms and cutoffs, or combination of all of these measures as suggested in Figure 22.

Figure 21: Uncontrolled seepage water from under the dam found in various area downstream.

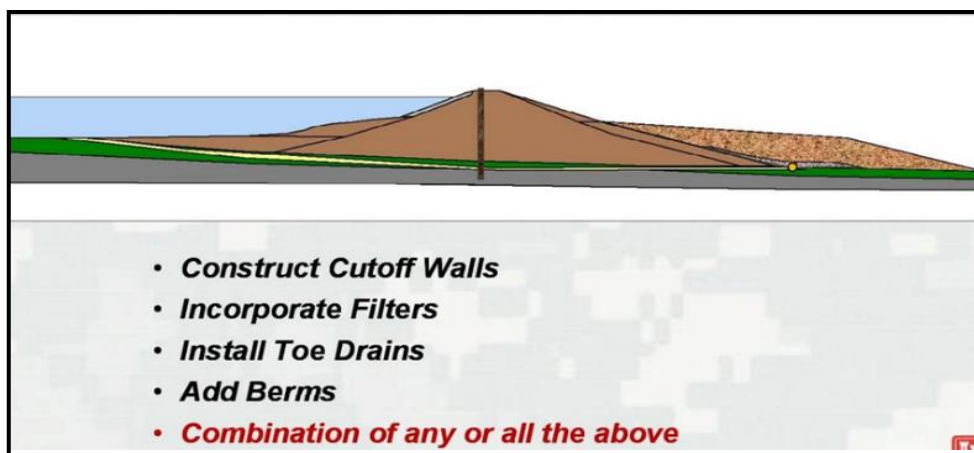
Figure 22: Potential corrective measures for seepage problems.

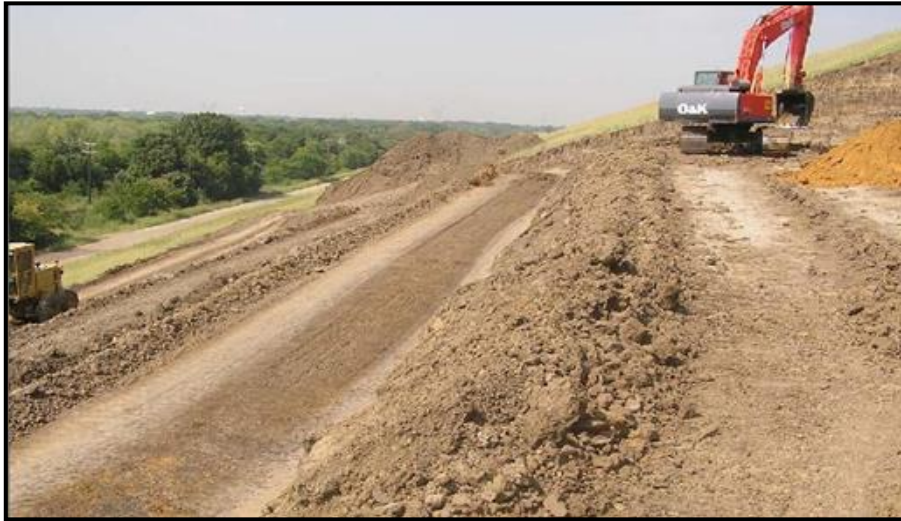
- ii. Embankment Stability was an issue of concern under conditions of higher pool levels due to very high floods. The situation can be aggravated in view of the type of soil materials in the foundation and the embankment itself. The loose and brittle nature of the soil is illustrated in Figure 23.

**Figure 23: Fine materials used in the construction of the embankment.**

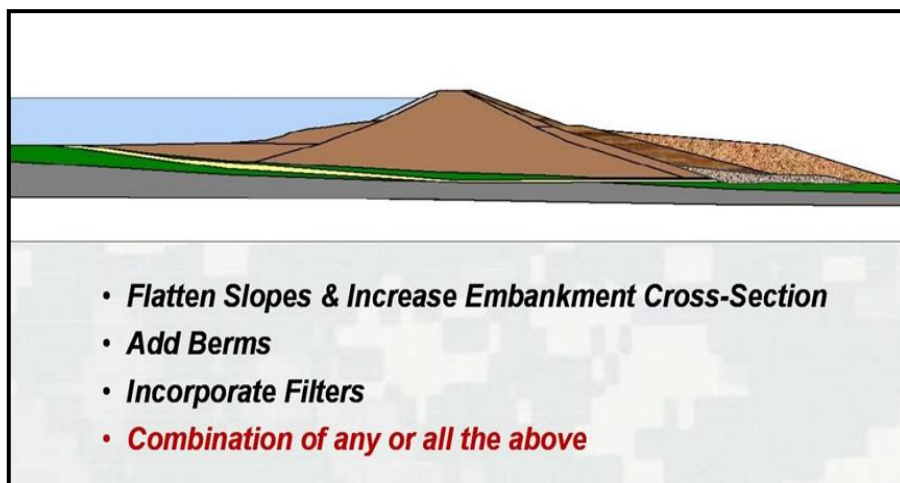
**Figure 24 : Possible corrective measures to improve embankment stability.**

Stabilization of the embankment was necessary under the failure scenarios considered. The corrective measures could vary between many alternatives; such as, flattening of the slopes and increasing embankment cross section, adding berms, and incorporating filters, or combination of any or all these solutions, Figure 24.

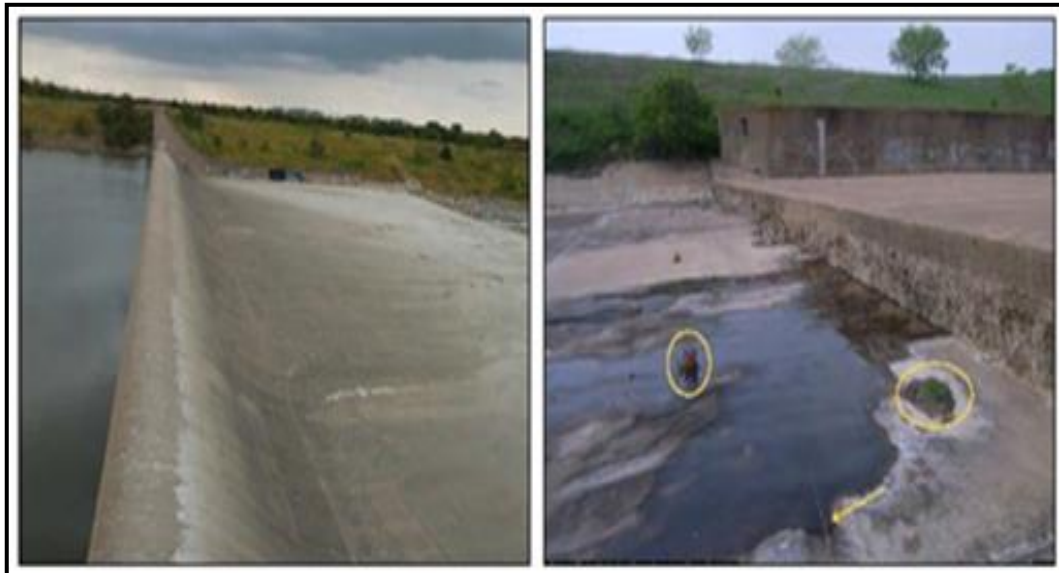
The downstream spillway apron can also suffer from high uplift pressure and therefore measures to reduce the possibility of sliding and initiation of progressive structural failure must be taken by overlaying the existing slab by a new concrete slab together with installing drainage system between the new and old slabs, or removing the whole apron and install a drainage system underneath a new one Figure 25, shows two views of the spillway during operation (on the left) and another view (on the right) of it while not working and showing cracks in the apron [24].

**Figure 25:** to the left, view of the Spillway when overflowing; to right view of the weir when not working showing cracks in the downstream apron.

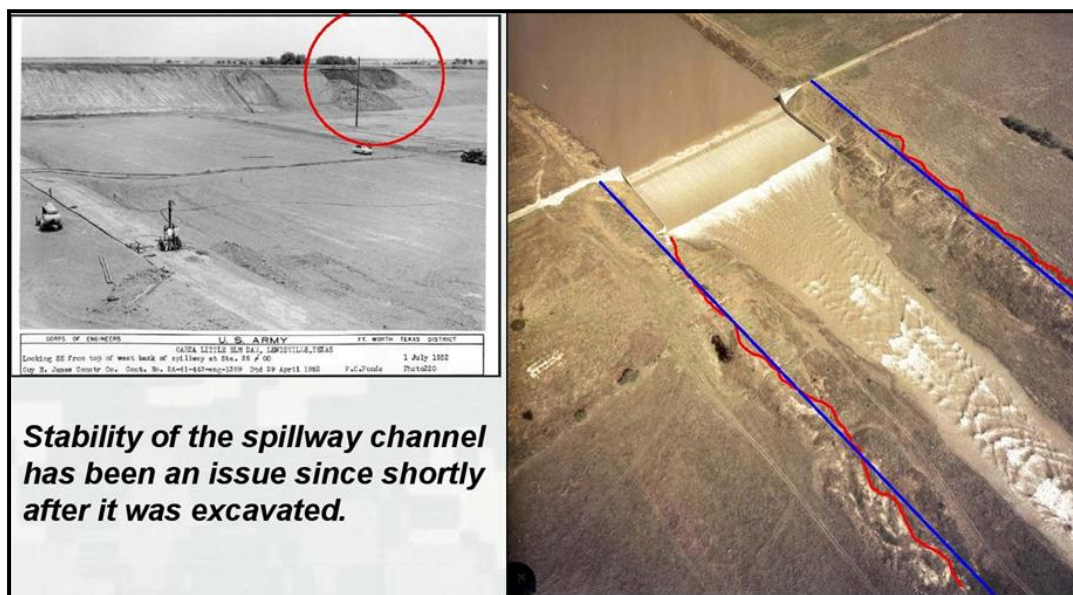
- iv. Spillway Outlet Channel Instability; Problems of stability were encountered during construction and operation of this earthen outlet channel where many slide collapses had occurred in its the side slopes. These failures were continuous problematic issues during the service life of the dam, and they needed; therefore, permanent solution to enhance their stability. The extent of the damaged reach may be visualized by referring to Figure 26.

**Figure 26: Stability problems of the spillway outlet channel.**
