Field Observations of Water and Ice Problems in Railway Tunnels from a Maintenance Perspective

Anna Andrén¹, Lars-Olof Dahlström² and Erling Nordlund³

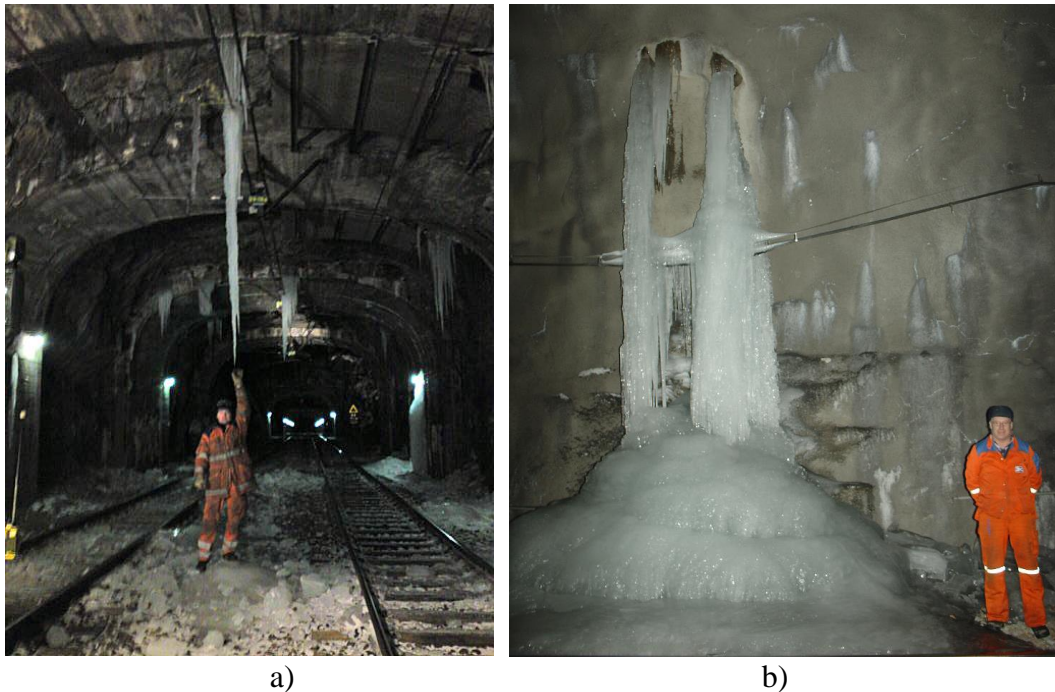
**Figure 1: a) Icicle in the Rönninge tunnel, 2010 (Photo: Infranord).
b) Ice pillar in the Glödborget tunnel (Andrén, 2008).**

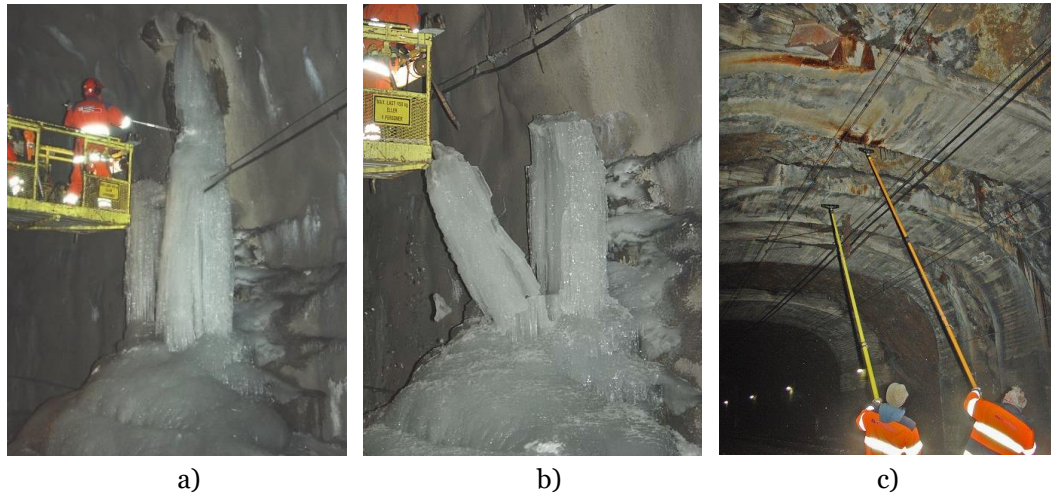
**Figure 2: a) and b) Removal of an ice pillar in the Glödsberget tunnel, 2005 (Andrén, 2008).
c) Removal of icicles from the tunnel roof above the overhead contact line using long insulating plastic rods in the Rönninge tunnel, 2005 (Andrén, 2008).**

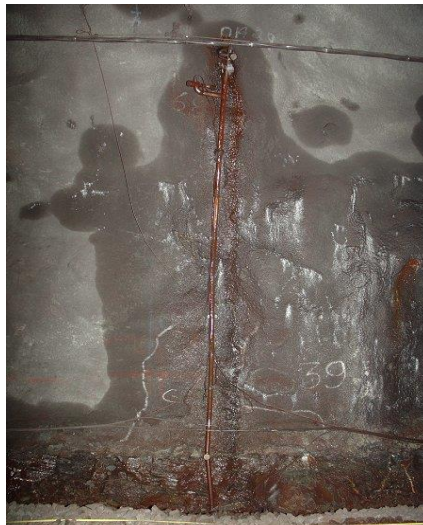
Before 1990, the Malmbanan went through an older tunnel that came into operation as early as 1902. A new tunnel was built because there had been major problems with ice formations in the older tunnel. However, problems with leakage and ice also arose in the new tunnel. The Swedish Rail Administration tried to reduce the problems by grouting the rock mass with polyurethane-based grout in 1992. During 1992-1993, attempts were also made to drain the surrounding rock mass by installing electrically heated drainage pipes in certain parts of the tunnel walls (Figure 7). The problems with ice continued and, in 1996, selected sections were also frost insulated with polyethylene mats covered with shotcrete. Furthermore, concrete elements with insulating rock wool were installed. Despite these measures, many problems remain and the tunnel requires many hours of maintenance during the winter months to address the problems with icicles and ice formation.

Figure 7: Drainage pipe at chainage km 1512+610, Nuolja 2004-10-07 (Andrén, 2008).

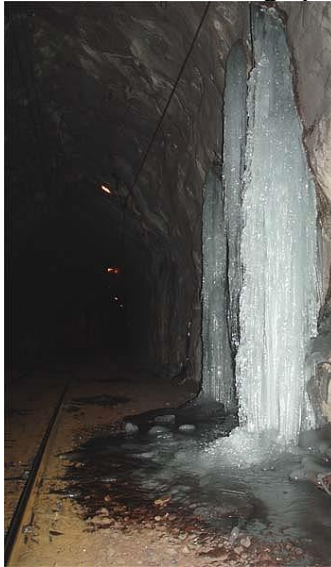
Many icicles and ice layers were observed during the second inspections and large ice pillars had formed at the location of the leakage points on the walls (Figure 10).

Figure 10: Ice pillar, Nuolja chainage km 1512+284 right, 2004-12-07 (Andrén, 2008).

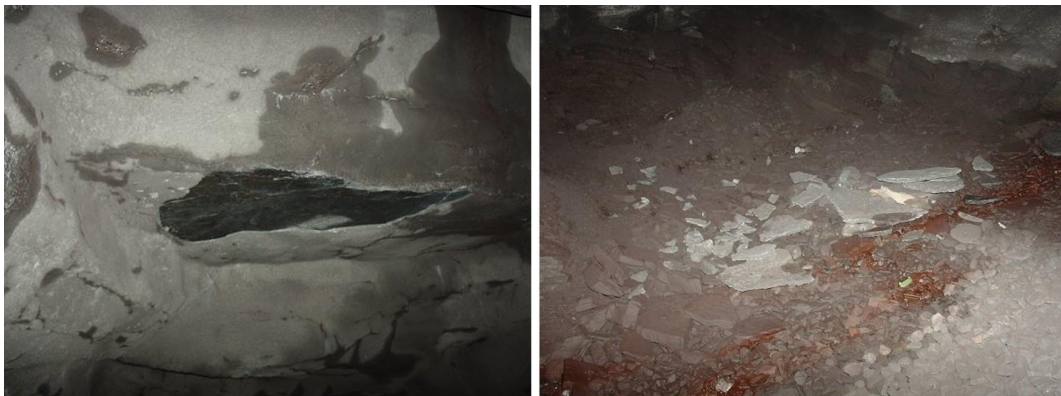
In the first inspection, it was observed that the shotcrete in the roof to the left of the track at chainage km 1512+210 had separated from the rock and fallen down on the ballast surface. The rock was exposed, and water leaked from the exposed rock surface (Figure 11).

Figure 11: Fall out of shotcrete in roof, Nuolja chainage km 1512+210 roof on the left side, 2004-10-06 (Andrén, 2008).

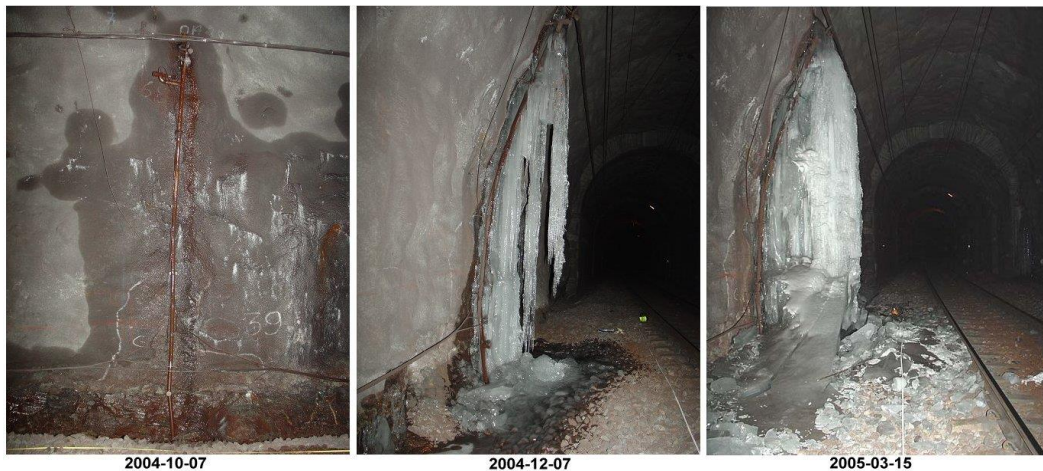
Figure 12 shows ice around one of the drainage pipes in the rock mass. These drainage pipes were initially heated by electricity and the idea was that the pipes would lead the leakage water down to drainage pipes on the tunnel floor. That worked relatively well until the heating system failed. The drainage pipes in the

rock mass still carry a large amount of water into the tunnel but, instead of flowing in a heated drainage pipe, the water flows along the outside of the pipes and gradually freezes as it meets the cold tunnel air, which creates growing ice pillars.

Figure 12: Drainage pipe, Nuolja chainage km 1512+610 left, at different inspections (Andrén, 2008).

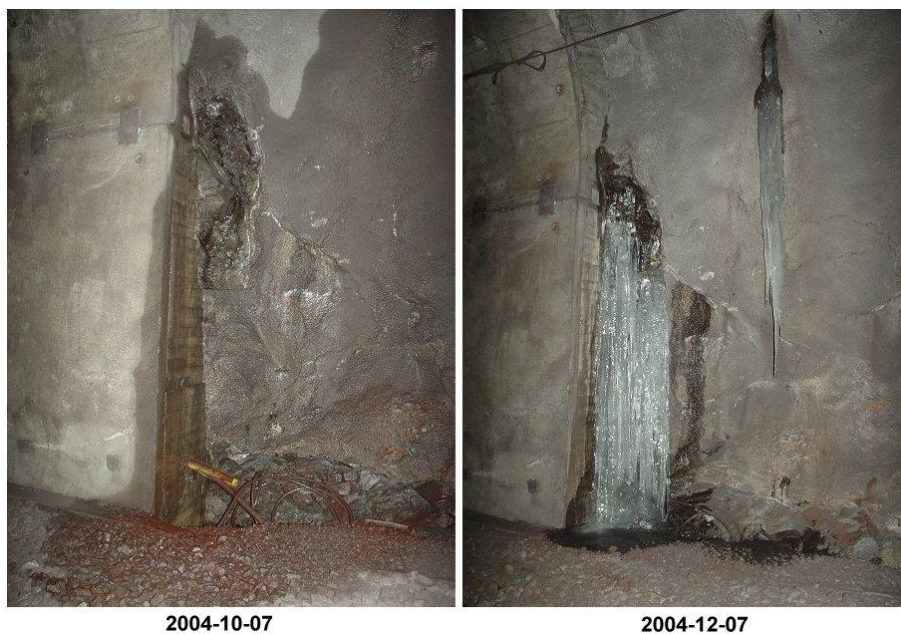
Another problem was leakage where the rock and the concrete arches are connected. At chainage km 1512+626, there was a leak that during the winter inspections had formed a large ice pillar (Figure 13). At the time of the inspection in December, the leak was still active.

Figure 13: Water leakage where the rock and the concrete arches are connected. Nuolja chainage km 1512+626 (Andrén, 2008).

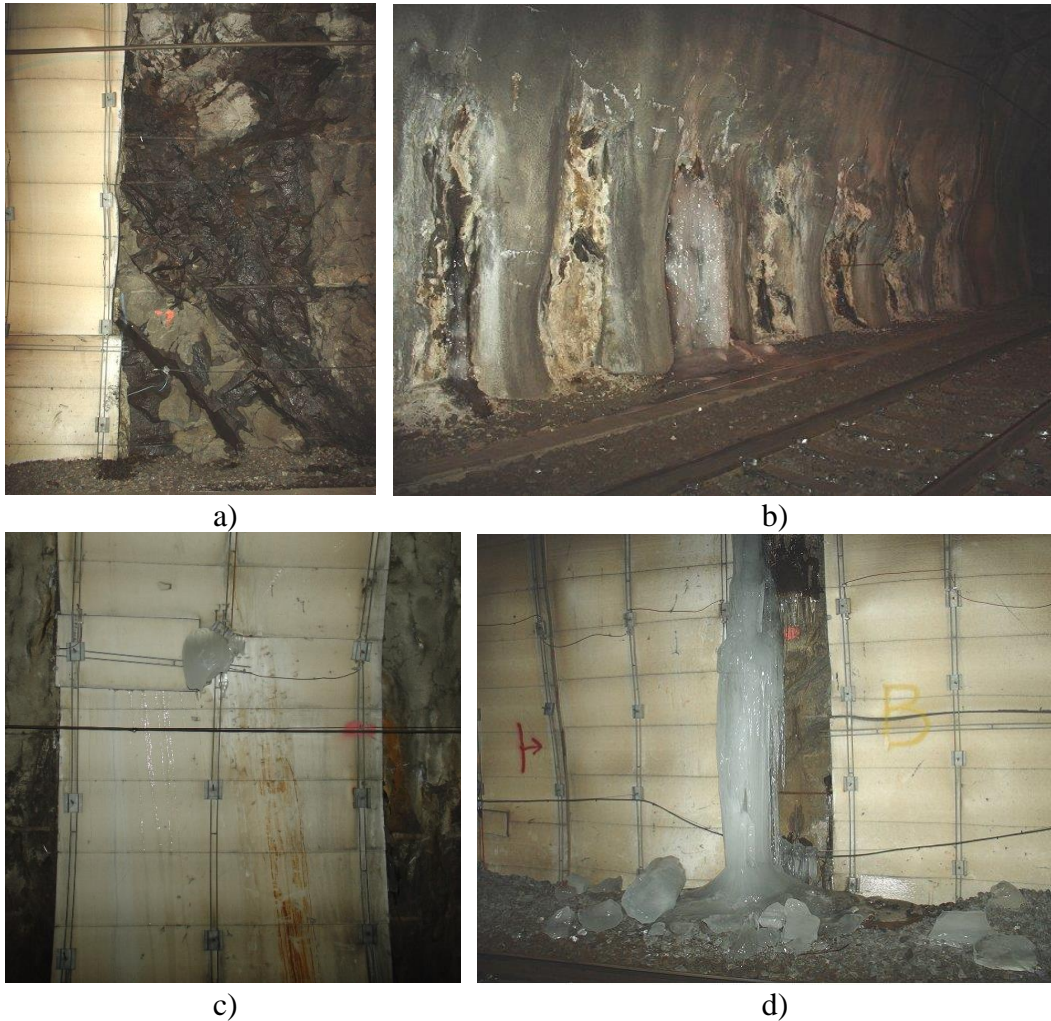
In the Laduberg tunnel, only the roof is sprayed with shotcrete and the rock walls are only reinforced with rock bolts where required. The drain mats are not covered with shotcrete. Many leaks in the tunnel are connected to the drains. In Figure 16a, the water leakage follows the fracture plane in the rock, which makes it difficult to seal the drain against the rock and get the water to stay inside the edge of the drain. Figure 16b shows water leakage and ice formation in an area that is reinforced with shotcrete arches. In Figure 16c, the leakage appears in the joint between two drain mats. An icicle has formed in the centre and a large area was wet. In Figure 16d, a large ice pillar has formed next to a drain, due to a gap between two separate drains. The ice pillar could have been avoided by extending the drain width and connecting the two drains.

Figure 16:a) Leakage that spreads in the fracture plane next to the drain, Laduberg chainage km 1104+675 left, 2004-11-04 (Andrén, 2008).
 b) Water leakage and ice formations at shotcrete arches in Laduberg chainage km 1105+185 left, 2005-01-27 (Andrén, 2008).
 c) Water leakage through drains resulting in ice formations, Laduberg chainage km 1104+911 right, 2005-01-27 (Andrén, 2008).
 d) Ice pillar between two drains, Laduberg chainage km 1104+932 right, 2005-01-27 (Andrén, 2008).

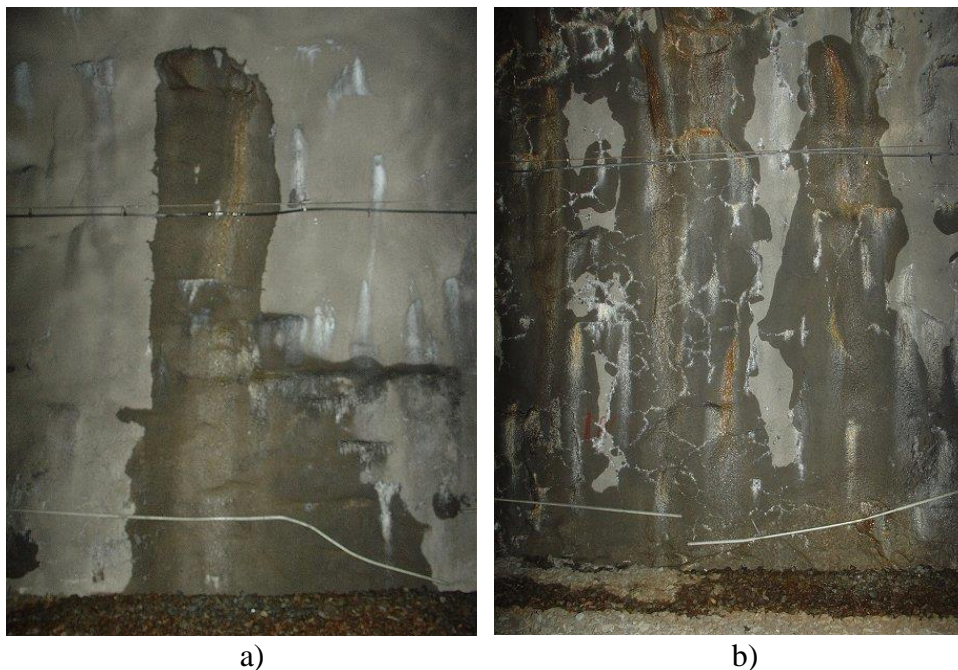
A problem observed in several places was broken handrails (Figure 19a and b). These problems often occurred near the locations of leakage points. The damage to the handrail was probably caused by the formation of large ice pillars during the winter, which broke the brackets holding the handrail to the wall and the handrail itself. Another problem observed was cracked shotcrete along the walls and roof (Figure 19b). Many cracks were calcareous, but moisture and drips penetrated through several cracks.

**Figure 19: a) Broken handrail near a leak, Glödberget chainage km 816+665 left, 2004-11-02 (Andrén, 2008).
b) Cracked shotcrete and broken handrail, Glödberget chainage km 817+104 left, 2004-11-02 (Andrén, 2008).**

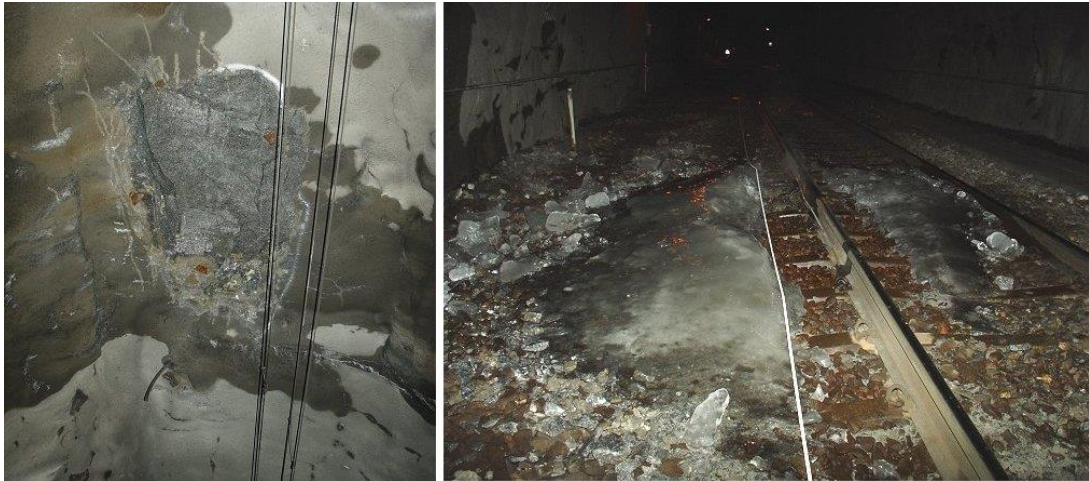
In the roof at chainage km 816+597, shotcrete had been scaled and the rock surface was exposed. There were many water leakage points in the section and a large ice layer had formed over the track (Figure 20). The ice layer had been removed from the rails to prevent derailment.

Figure 20: Exposed rock surface after scrapping of shotcrete and ice layer at the track, Glödborget tunnel chainage km 816+597, 2005-01-20 (Andrén, 2008).

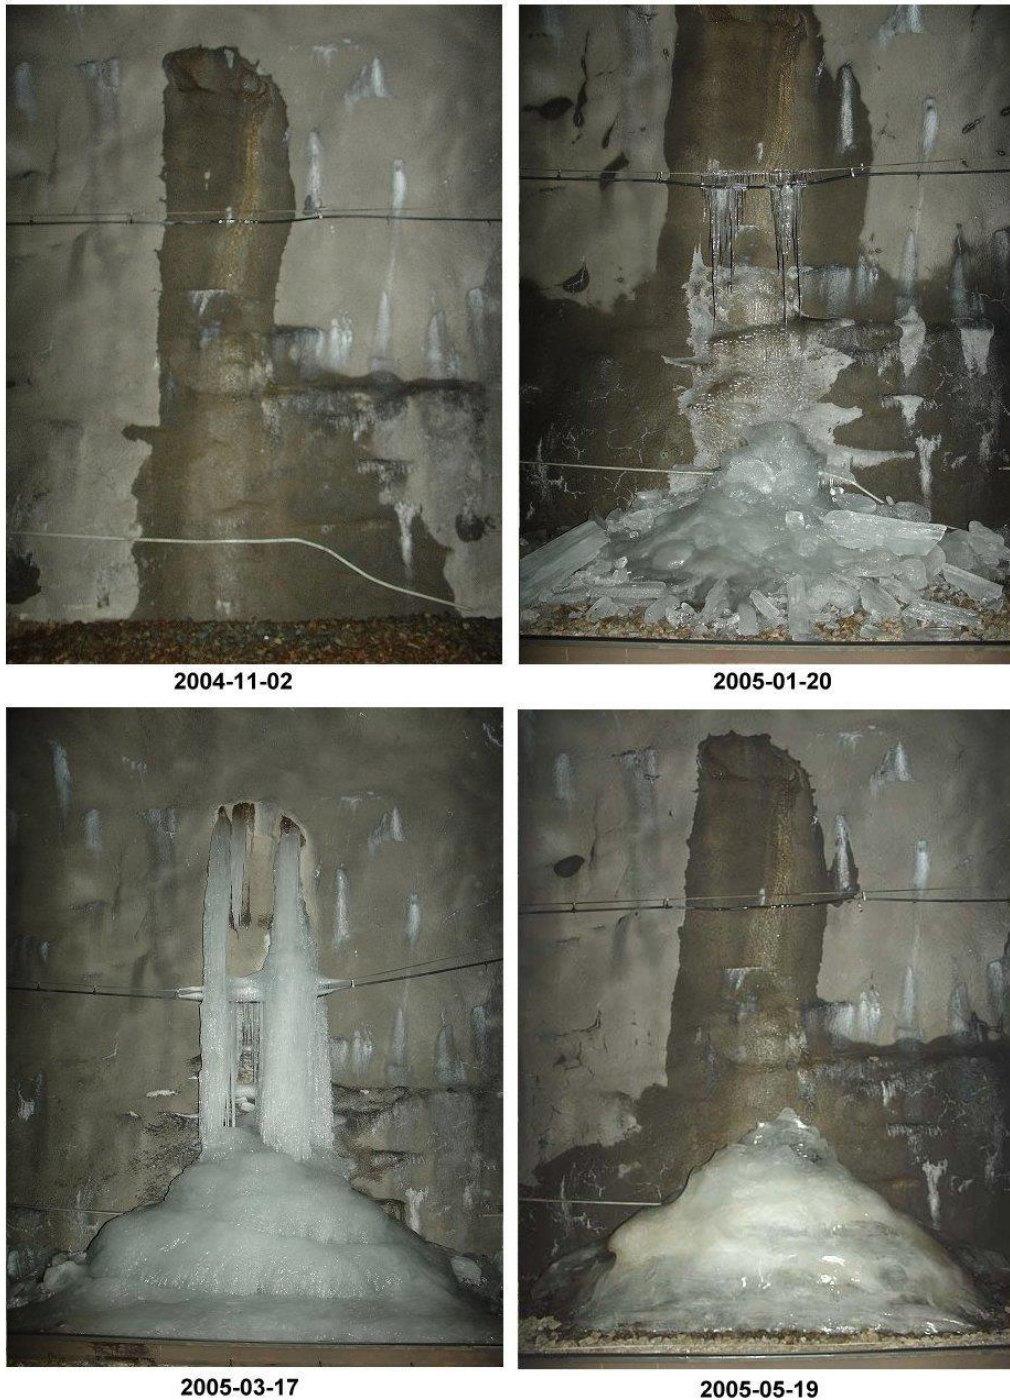
Chainage km 816+665 is a known problem spot for the maintenance workers (Figure 21). The section did not look like a problem spot, the shotcrete was not cracked, and the moisture was not spread over a particularly large area. But the handrail was broken, so this might be a problem spot. In the second inspection, the extent of the problem was clear, because an ice pillar had formed, ice layers were approaching the track and icicles were hanging on the cable. Despite the temperature in the tunnel, the leak continued, which meant that the ice pillar was still growing. There was significantly more moisture on the wall during the second inspection compared to the first. In the third inspection, water still leaked out of the leakage point and a very large ice pillar had formed that applied load to the cable in the left shoulder. The shotcrete on the wall was now dry, except around the leak itself. In the fourth inspection, the shotcrete was moist again and the ice pillar was slowly melting away.

Figure 21: Differences between the four inspections in the Glödsberget tunnel, chainage km 816+665 left (Andrén, 2008).

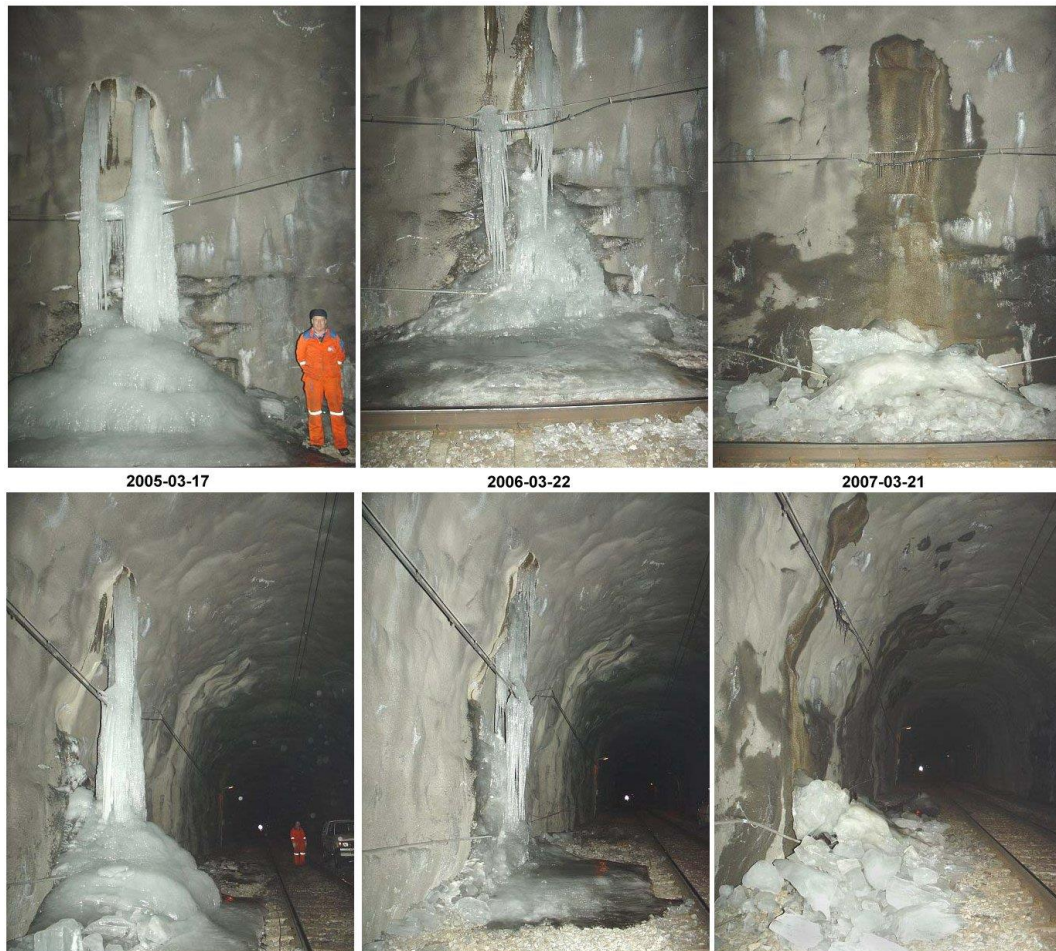
2006 and 2007. These inspections showed an annual variation in the moisture and quantity of ice in tunnels. Figure 22 shows the difference in the size of the ice formation in a certain section during the three annual inspections.

Figure 22: Comparison at chainage km 816+665 in the Glödborget tunnel in March 2005, 2006 and 2007 (Andrén, 2008).

The photos in Figure 22 also show the difference in moisture conditions on the tunnel wall. During the 2007 inspection, the shotcrete was much moister than in the two previous years, which can partly be explained by the fact that the temperature had fluctuated around 0°C for about a week before the inspection (Figure 23). This may have caused warmer outside air to penetrate the tunnel, thawing the rock mass nearest the tunnel wall and causing the leak to become active again.

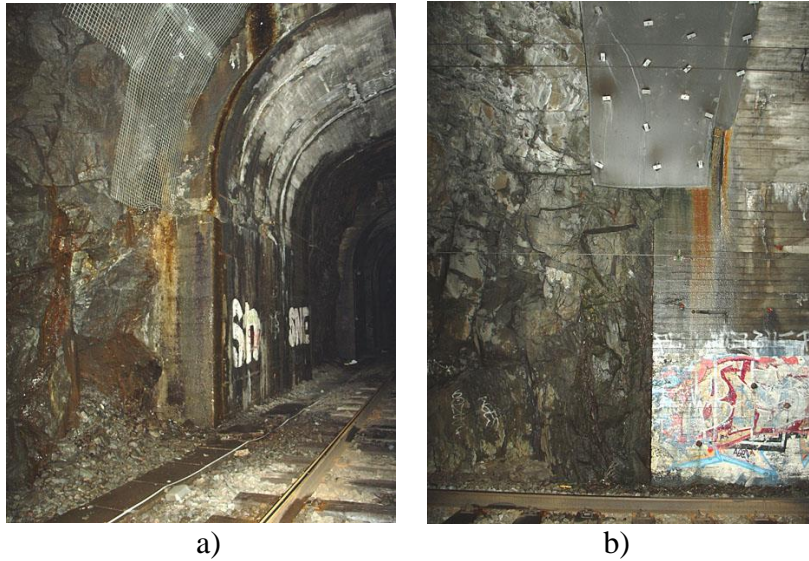
The tunnels were reinforced with cast-in-place concrete arches as early as 1915 (Figure 25a). After a large rockslide in Rönninge in 1925, additional reinforcements were carried out between 1925 and 1927 using additional concrete arches. The rock surface in the rest of the tunnel is not reinforced except for some selective bolting, as well as some smaller surface support with rock safety mesh. There are sporadic drain mats installed along the tunnel. These are mainly located where the rock and the concrete arches are connected. They consist of uncovered PE mats that are fastened with bolts and some drain mats are covered with nets (Figure 25b).

**Figure 25: a) Cast-in-place concrete arches, Rönninge South chainage km 29+714 left, 2004-12-16 (Andrén, 2008).
b) Uncovered PE mats Rönninge North chainage km 29+448 right, 2004-12-16 (Andrén, 2008).**

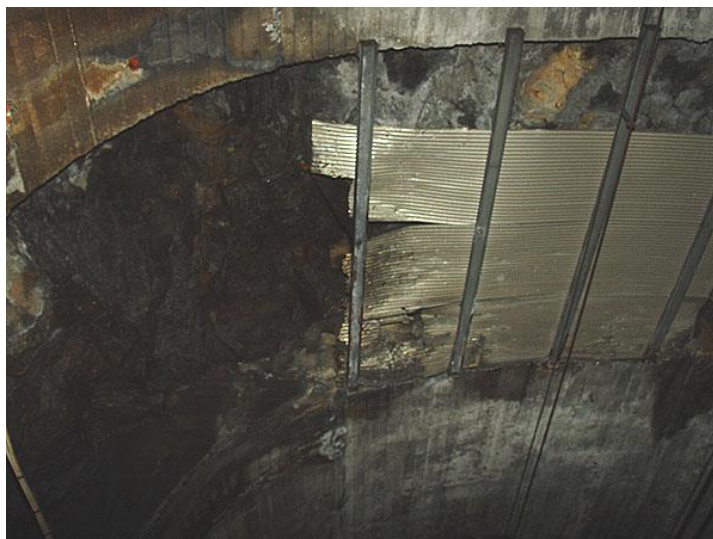
Attempts have been made to lead the water away from the roof with metal plates lying on the beams between the concrete arches (Figure 26).

Figure 26: Sheet metal lying on beams between the concrete arches, Rönninge South chainage km 29+730, 2004-12-16 (Andrén, 2008).

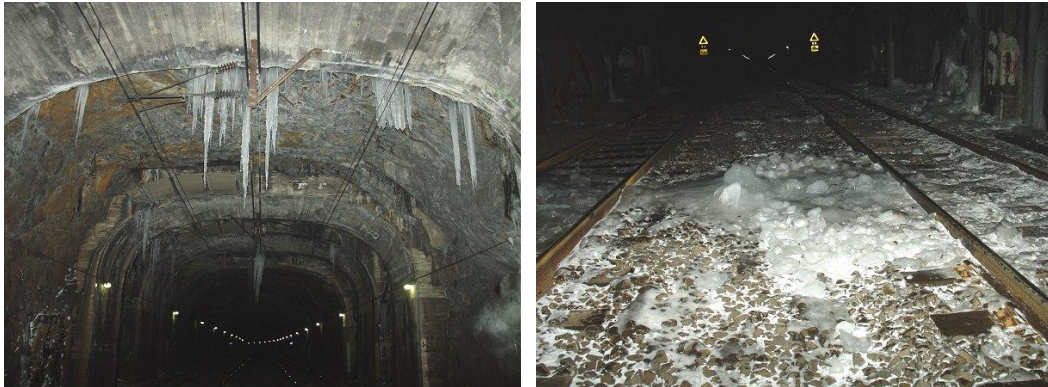
entrance of the south tunnel, where there were leakage points along the entire roof and walls. Many icicles had formed here, as well as a large layer of ice on the track area (Figure 28). The concentration of ice formations matched closely the areas that had the most drip observations in the first inspection, compare Figure 29a and b.

Figure 28: Icicles at an active leakage point and ice layers on the tracks, Rönninge South chainage km 29+720 the first picture photographed to the south, the second to the north, 2005-02-25 (Andrén, 2008).

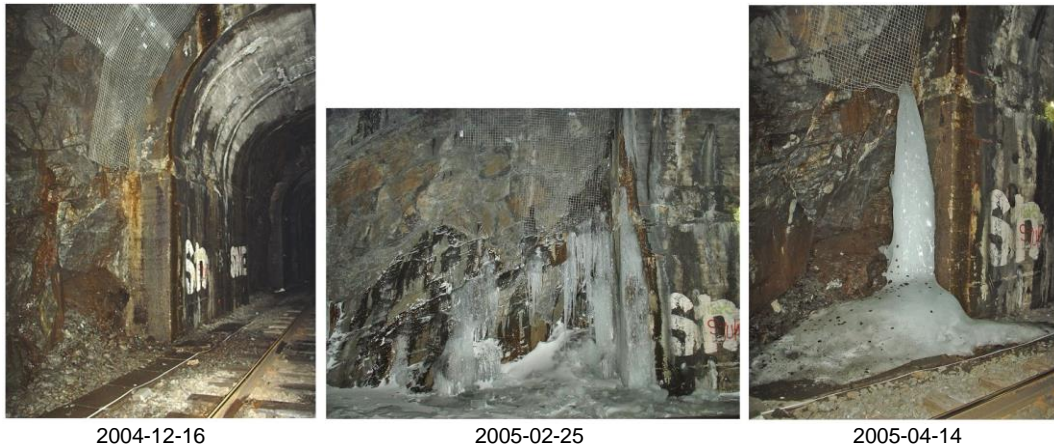
Many leaks occurred where the rock and the concrete arches are connected and several of the leakages came from the joint planes along the entire tunnel. In the second inspection, several icicles/pillars had formed at the location of a leakage from a joint in the rock mass around chainage km 29+710. In the third inspection, many of the ice formations in the tunnel had melted, but there was still a large ice pillar adjacent to the concrete arc in this section. The extent of the ice pillar indicates that the leak had been active for a long time (Figure 30).

Figure 30: Difference between the three inspections, Rönninge South chainage km 29+710 left (Andrén, 2008).

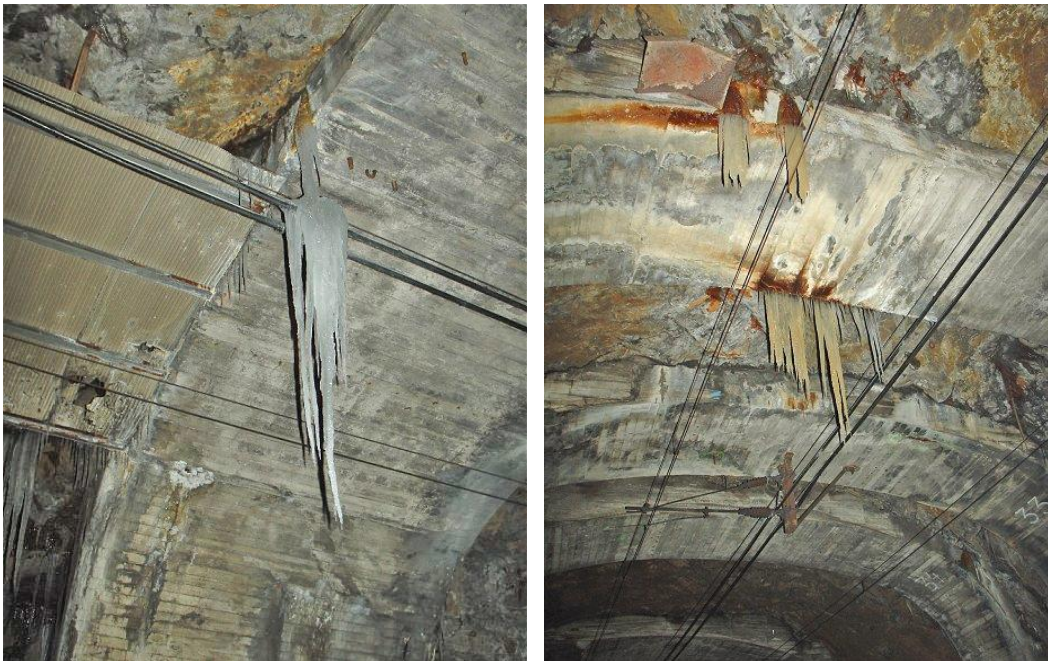
In the Rönninge tunnels, the majority of the ice observations were icicles in the roof (Figure 31). According to maintenance workers, Rönninge is one of the tunnels in the Stockholm regions that requires the most maintenance. During periods of negative temperatures, ice must be removed every night.

Figure 31: Rönninge South chainage km 29+734 and km 29+813 photographed to the south, 2005-02-25 (Andrén, 2008).

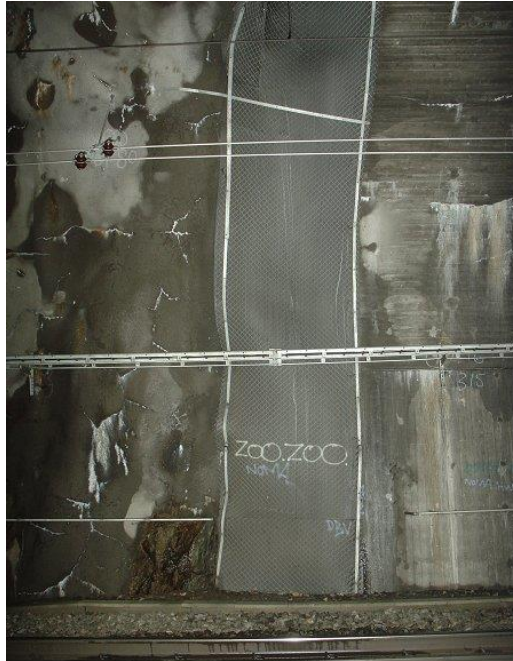
The railway tunnels were built without continuous pre-grouting. Only major crush zones were grouted. The frost insulation used consists of drains constructed from approximately 1 m wide insulation mats covered with mesh or fibre-reinforced shotcrete. In addition, uncovered drains have been set up with strips along the edges (Figure 32).

Figure 32: Uncovered drain, Kvedesta North chainage km 39+241 right, 2004-12-17 (Andrén, 2008).

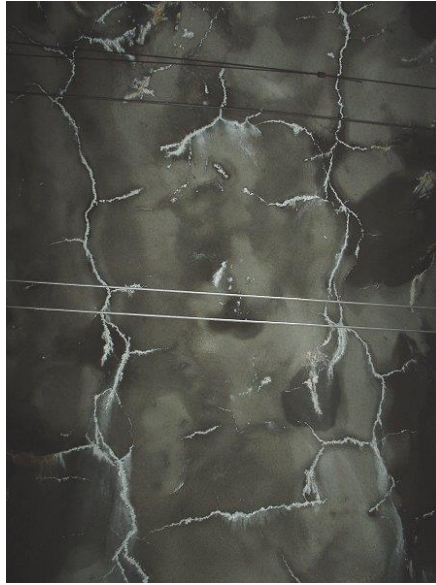
In several places in the Kvedesta tunnels, the shotcrete was cracked and there were moist areas in the shotcrete around the covered drains, which indicates that water was seeping out around the side of the drains (Figure 35).

Figure 35: Cracks around a covered drain, Kvestesta South chainage km 39+372 left, 2004-12-17 (Andrén, 2008).

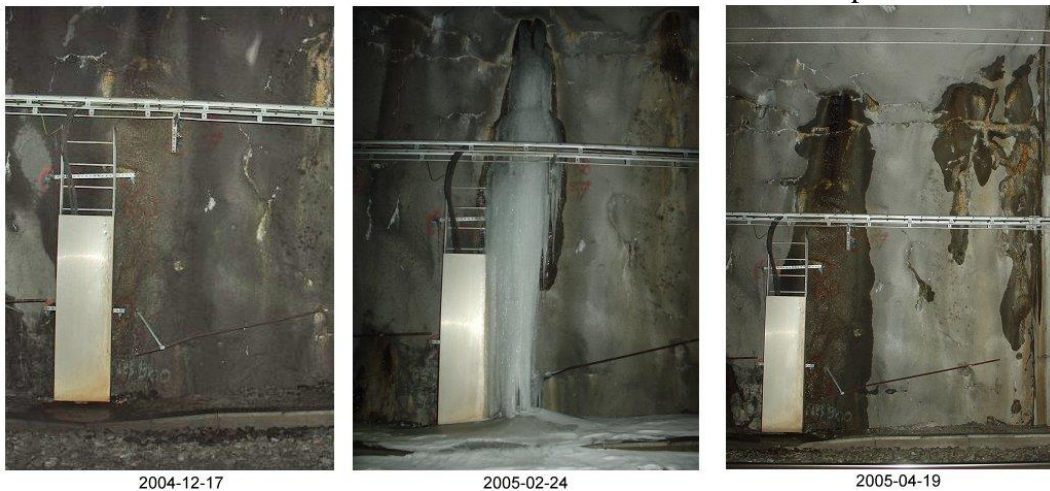
In the Kvestesta tunnels, one recurring problem was on the right side at chainage km 39+367 in the south tunnel (Figure 36). Ice must be removed from the electrical cabinet every cold period. This tunnel section is 10 m from the northern entrance and is, therefore, affected almost directly by the temperature changes outside the tunnel. In the first inspection, the entire wall was moist. In the second inspection, a large ice pillar had formed next to the electrical cabinet and pushed the cabinet out of its original position. In the third inspection, the tunnel was dryer, but the leakage point just above the electrical cabinet was active. Note the difference in the moisture on the wall between the first and last inspection.

Figure 36: Differences between the three inspections, Kvestesta South chainage km 39+367 right (Andrén, 2008).
