# **Geotechnical Properties and Slaking Characteristics of Shales in the Calabar Flank, Southeastern Nigeria**

Samples of Ekenkpon and Nkporo shales from the Calabar Flank in southeastern Nigeria were analysed to determine their swelling and slaking characteristics and effect on pavement construction and stability of slopes. Engineering problems reported in areas underlain by the soils include pavement failure and landslides. Results show that for the Ekenkpon shale, Liquid Limit, Plasticity Index and free swell averaged 45%, 14%, and 23% respectively compared to values for Nkporo shale which were 45%, 14%, and 17% respectively. Montmorillonite, illite and kaolinite are major mineral components of the soils. The undrained cohesion values of 47 to 49kN/m<sup>2</sup> and angle of internal friction between 3 and 4° suggest low shear strength. The slake durability index of Ekenkpon shale was 41% compared to 8% for Nkporo shale. The index properties, mineralogy and the slake durability index imply that all the shales are soil-like, have moderate expansivity and are of low shear strength. They are susceptible to expansion on moisture influx, which would trigger pavement fatigues and fai

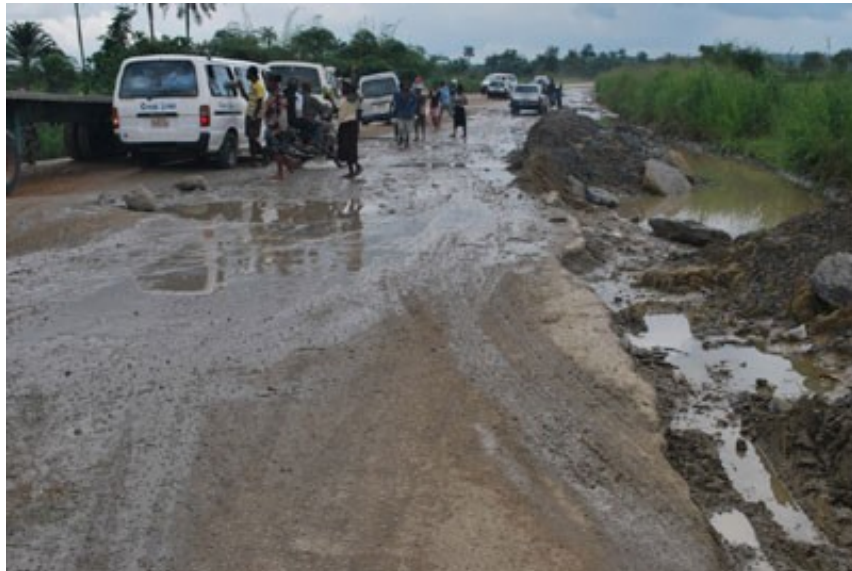
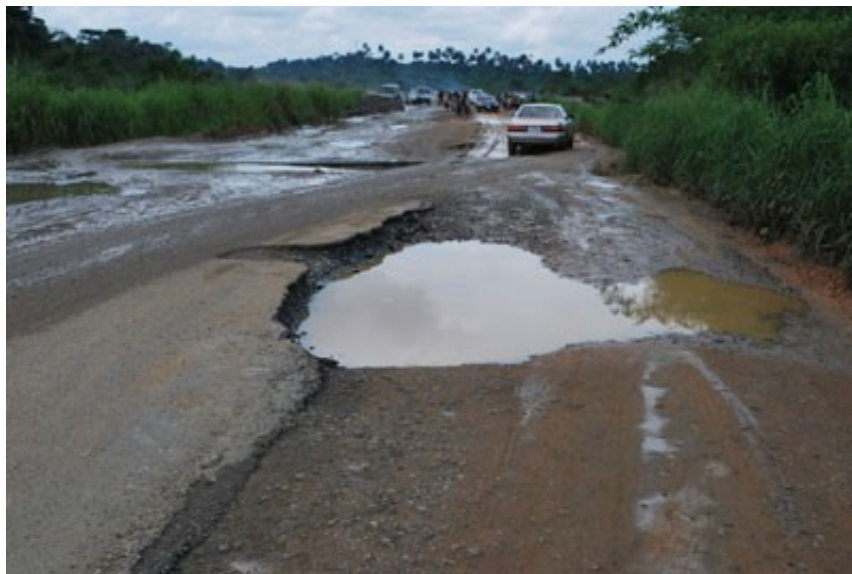
Figure 1: Typical pavement failure alongthe Calabar-Itu Road  
<http://www.akwaibomnewsonline>

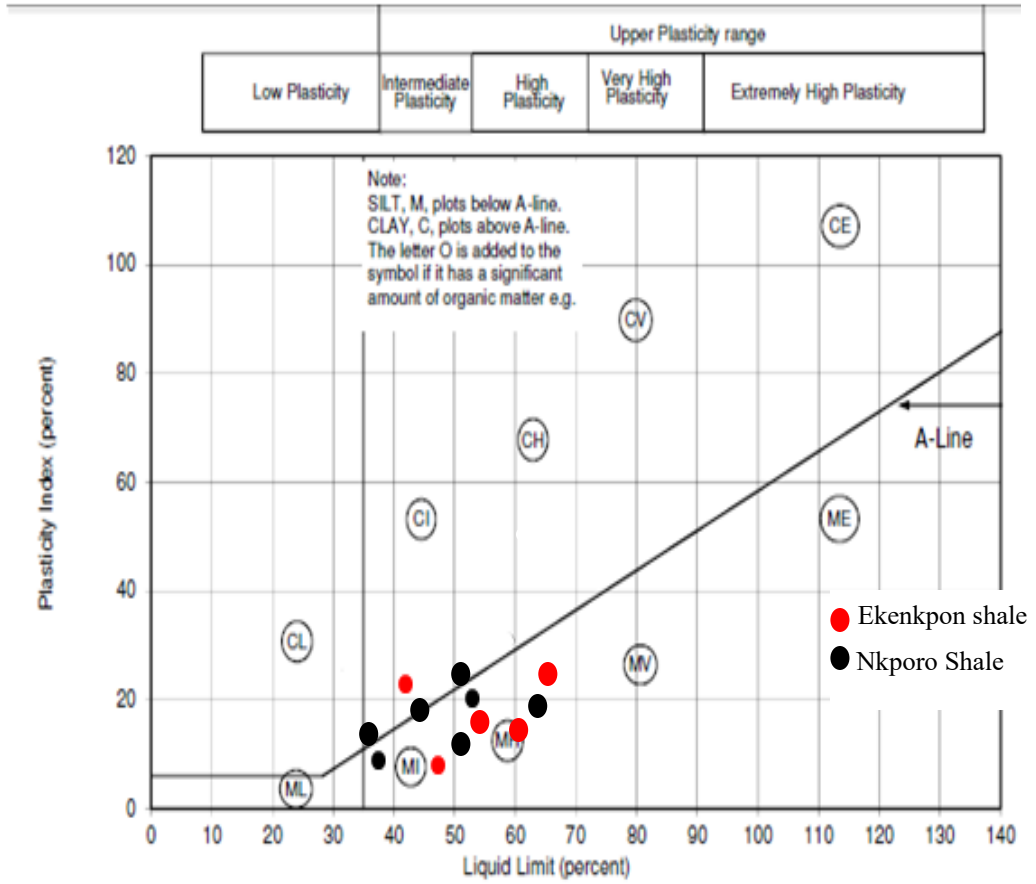
Figure 3: Plasticity classification of the shales

between 6 and 22%) of the shale samples shows the low to medium swelling potentials of the shales according to the relationship established by Ola (1982) between plasticity index and swelling potential of clays. When the liquid limit and plasticity index values were plotted on the plasticity chart, the samples plotted below the A-line (Fig. 3) implying that they are organic clays of intermediate plasticity (OM). The LL and PI values indicate the presence of expansive clay minerals. This is corroborated by the XRD peaks in Figs. 4 and 5 which show the presence of illite and montmorillonite in Ekenkpon shales while kaolinite dominates in the Nkporo shales. The 24 hour free swell test results correlate well with plasticity index results indicating that the degree of expansiveness of the shales range from low in Nkporo Formation (average free swell index of 17%) to moderate in Ekenkpon Formation (average free swell index of 23%). This will trigger a strong decay of these materials, causing them to decay spontaneously when they absorb water. All the shales examined do not meet the Federal Ministry of Works and Housing, FMWH (1997) requirement which specifies that a good sub-base material must have liquid limit and plasticity index of <35 % and <16 % respectively (Table 2). Neither do they satisfy the requirements that the liquid limit and plasticity index of materials must be  $\leq 30$  % and  $\leq 13$  % respectively to be suitable as base course materials. The high liquid limit and plasticity index may lead to structural damage. Results obtained from the quick undrained unconsolidated triaxial test show that shear strength of the shales is contributed by both cohesion and frictional resistance. The undrained cohesion values of 47 to 49 kN/m<sup>2</sup> and angle of internal friction between 3 and 4° suggest poor performance of the shales as engineering materials. The implication of the low value of the cohesion is that the stress needed to destroy the cohesion which binds the individual grains and give the rock its strength is small (Nickmann et al. 2006). The undrained cohesion values fall short of the greater than 103 kN/m<sup>2</sup> values specified for base course materials (FMWH 1997), thus the shales are not suitable as base course materials for road pavements. Generally, the cohesive strength, angle of internal friction and natural moisture content of the shales do not meet the Underwood (1967) minimum values favourable for durability.
