# Temperature Flows in Railway Tunnels: Field Measurements of Frost Penetration

Anna Andrén<sup>1</sup>, Lars-Olof Dahlström<sup>2</sup> and Erling Nordlund<sup>3</sup>

## Abstract

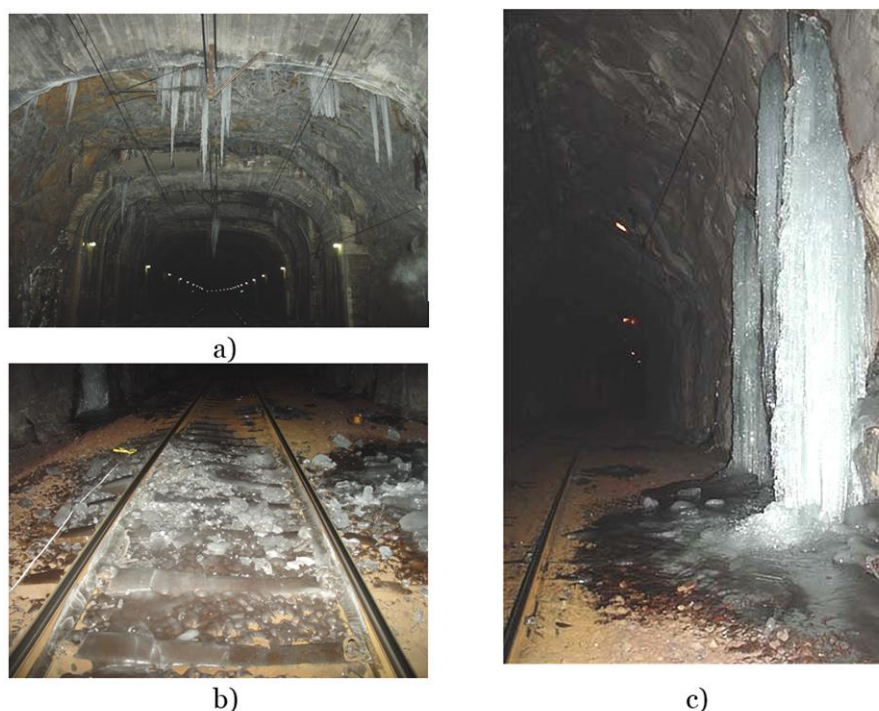
**Figure 1: Typical ice formation problems that may develop in unlined tunnels:**

- a) **Icicles in the tunnel roof**
- b) **Ice layer spread out over the tunnel floor**
- c) **Ice pillars or icicles on the tunnel wall [2].**

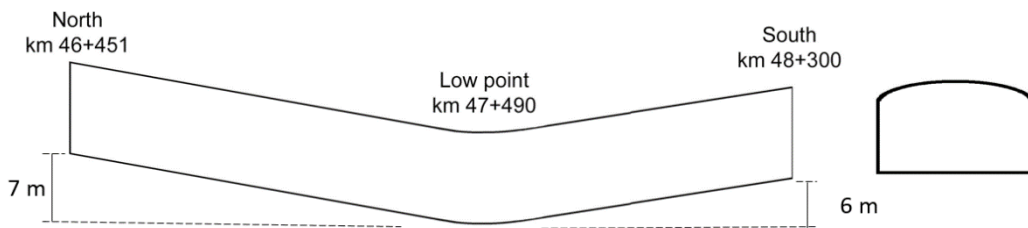
Figure 3: Longitudinal sketch of the Åsa tunnel.

The Åsa tunnel is a double-track tunnel with a length of 1850 m. It is located 50 km south of Gothenburg (Figure 2). The northern entrance is located at chainage km 46+451 and the southern entrance is located at chainage km 48+300. The tunnel declines approximately 10‰ from the northern entrance towards its lowest point at chainage km 47+490 and then inclines 12‰ towards the southern entrance. The elevation difference between the higher north and the lower south entrance is only about 1 meter, but the low point further into the tunnel (1039 m in the tunnel from north) is approximately 7 m lower than the northern entrance and 6 m lower than the southern entrance (Figure 3). The tunnel height is 7.3 m above the top of rail and the width is 14 m. The rock type in the area is intrusive granite and granodiorite with gneissic texture and the tunnel is reinforced with selective bolting and shotcrete with a thickness of 40 mm in the roof in most sections along the tunnel. In some sections, the roof is supported with bolts and shotcrete with a thickness of 70 mm. In some parts of the tunnel where more extensive water leakage occurs, insulated drain mats have been installed to protect installations from dripping water and to prevent freezing.

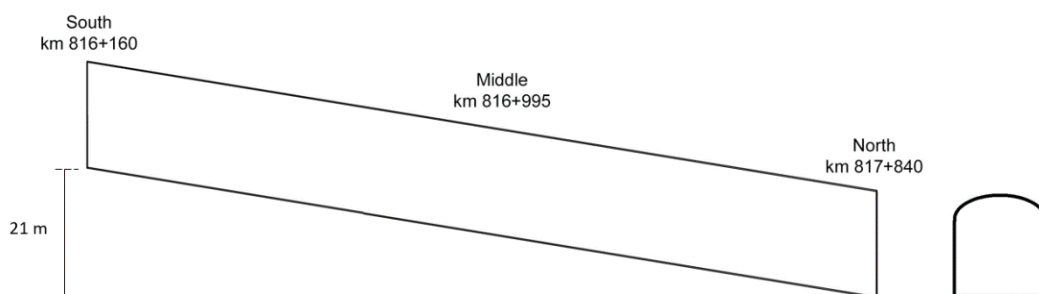
**Figure 5: Longitudinal sketch of the Glödsberget tunnel.**

The Glödborget tunnel is a single-track tunnel, 1680 m long, near Nyåker, 80 km southwest of Umeå (Figure 4). The southern entrance is located at chainage km 816+160 and the northern entrance at chainage km 817+840. The tunnel has, unlike the Åsa tunnel, a constant inclination of 12.5%. The elevation difference between the higher south entrance and the lower north entrance is 21 m (Figure 5). The tunnel consists from the south of a 60 m long concrete tunnel between chainage km 816+160 and chainage km 816+220, before entering into the 1350 m long rock tunnel. The rock tunnel is reinforced with bolts and shotcrete (thickness: roof 60 mm and wall 25 mm in most sections along the tunnel) until chainage km 817+570. In the north, the tunnel ends with a 270 m long concrete tunnel between chainage km 817+570 and chainage km 817+840. The tunnel height is 7 m above the top of rail and the width is 8 m. The rock type in the area is intrusive granite, metagreywacke and granodiorite. The insulated drain mats installed in the Glödborget tunnel are twice as thick as those installed in the Åsa tunnel, due to a more severe climate zone. A total of 70% of the roof and the walls are covered with drain mats with a thickness of 140 mm. The insulated drain mats along the 1680 m

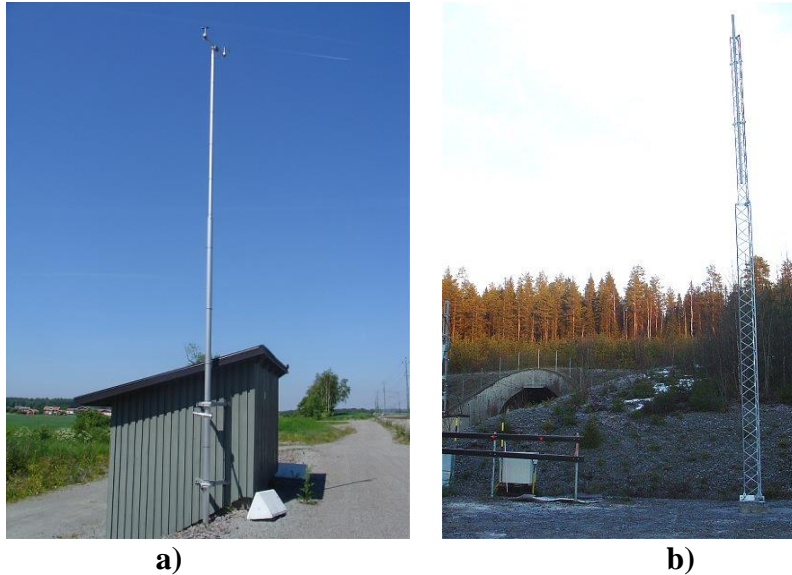
**Figure 8: Mast for meteorological station at:**  
**a) the northern entrance of the Åsa tunnel**  
**b) the southern entrance of the Glödberget tunnel.**

Meteorological stations were installed outside the highest tunnel entrance for both tunnels, to get the outside temperatures, which are compared with temperatures in the tunnels. Wind velocity and wind direction were measured at the top of the mast, which is located 10 m above the ground surface. Air temperature and atmospheric humidity were measured about 1.5 m above the ground level and the equipment has a radiation protection that protects against direct sunlight and rainfall (Figure 8).

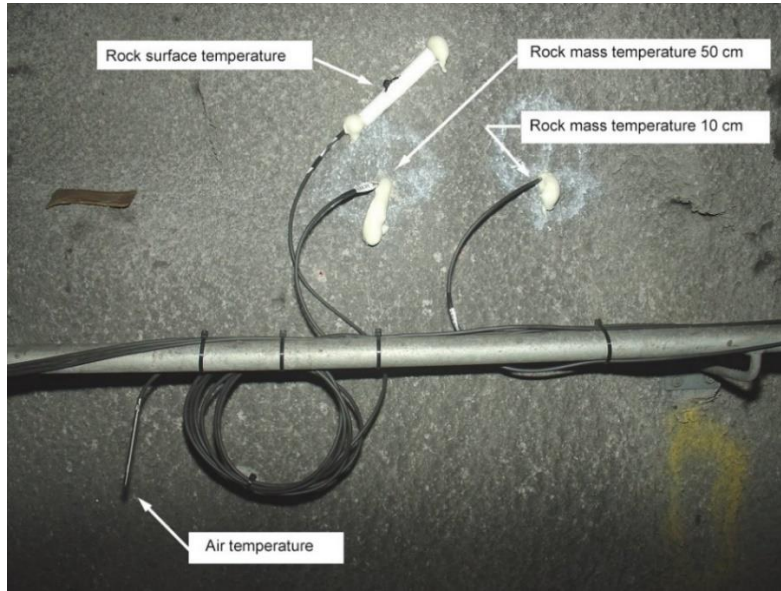
**Figure 9: Temperature sensor at a typical measuring station.**

Measurements of temperatures of the tunnel air and the rock surface have been made to analyze the frost penetration along the tunnel. Furthermore, the measurements in the rock mass perpendicular to the tunnel wall, were performed to monitor how the freezing front propagates depending on the tunnel air temperature. The air temperature sensors in the track tunnels were installed at the handrail, approximately 10-20 cm from the tunnel wall surface and 1.2 m above the surface of the sidewalk. The rock surface temperature sensors were installed in contact with the rock/shotcrete and covered with insulating material as not to be affected by the temperature of the tunnel air. The rock mass temperature sensors were placed in boreholes, which were filled up with insulating material to prevent convection, to allow the gauges to measure true rock mass temperature (Figure 9 and Figure 10).

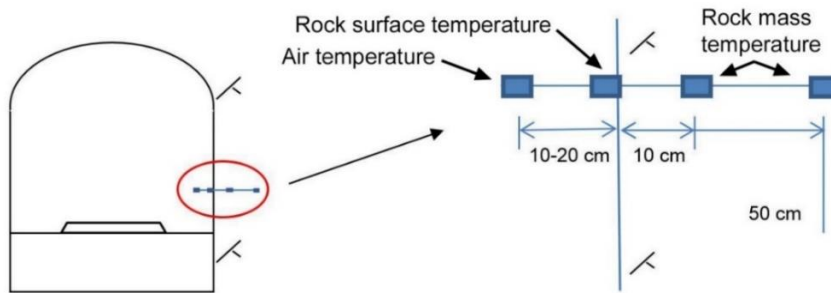
**Figure 10: Location of temperature sensors. In the Glödsberget tunnel, the rock mass temperatures were measured at the depths of 10 and 50 cm, and in the Åsa tunnel only at a depth of 10 cm.**

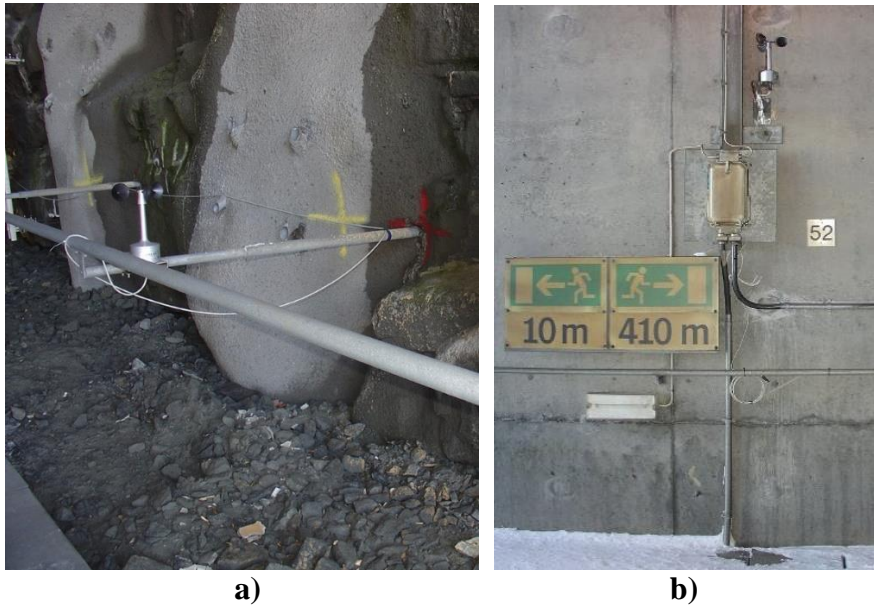
**Figure 11: a) Wind gauge in the Åsa tunnel, installed at the handrail; b) Wind gauge in the Glödborget tunnel, installed on a steel rack.**

To improve knowledge about air movements in track tunnels, gauges for air velocity and air pressure were installed. There were four measuring cabinets installed at both tunnels. One for each measuring station inside the track tunnel (south, north and middle) and one in the engineering house, outside the highest tunnel entrance for both tunnels. In both track tunnels, pressure gauges were installed in both the northern and southern cabinets. Air velocity was measured in three sections along the tunnels. In the Åsa tunnel, the wind gauges were installed at the handrail about 1.2 m above the surface of the sidewalk and approximately 1-1.5 m from the tunnel wall (Figure 11a). In the Glödberget tunnel, the wind gauge was installed on a steel rack about 2.5 m above the surface of the sidewalk and approximately 30 cm from the tunnel wall (Figure 11b).

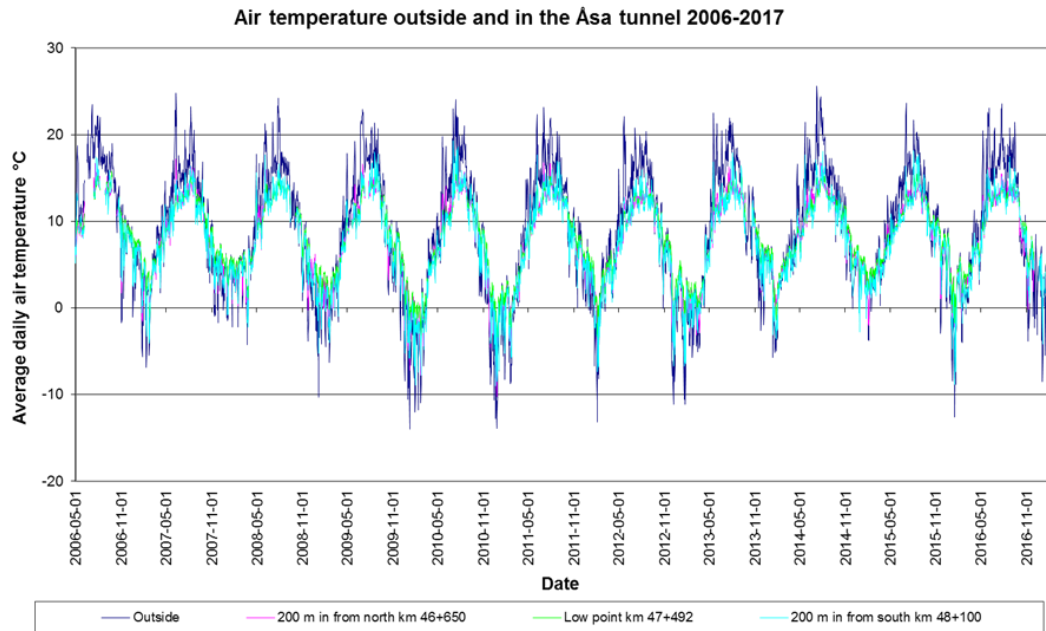
**Figure 12: Average daily air temperatures outside and in the Åsa tunnel 2006-2017.**

Temperatures have been measured in the two tunnels for more than 10 years. In Figure 12 and Figure 13, the average daily air temperatures, outside and along the tunnels, are shown. The individual measuring series are difficult to distinguish in the charts, but they give an overview of how temperatures have varied over the years. Figure 12 shows the air temperature measurements outside and inside the Åsa tunnel from 2006-05-01 to 2017-02-01, and in Figure 13, the measurements from the Glödborget tunnel from 2007-03-01 to 2017-06-01 are shown. According to the temperature range in the figures below, it is clear that the Glödborget tunnel and the Åsa tunnel are located in two different climate zones.

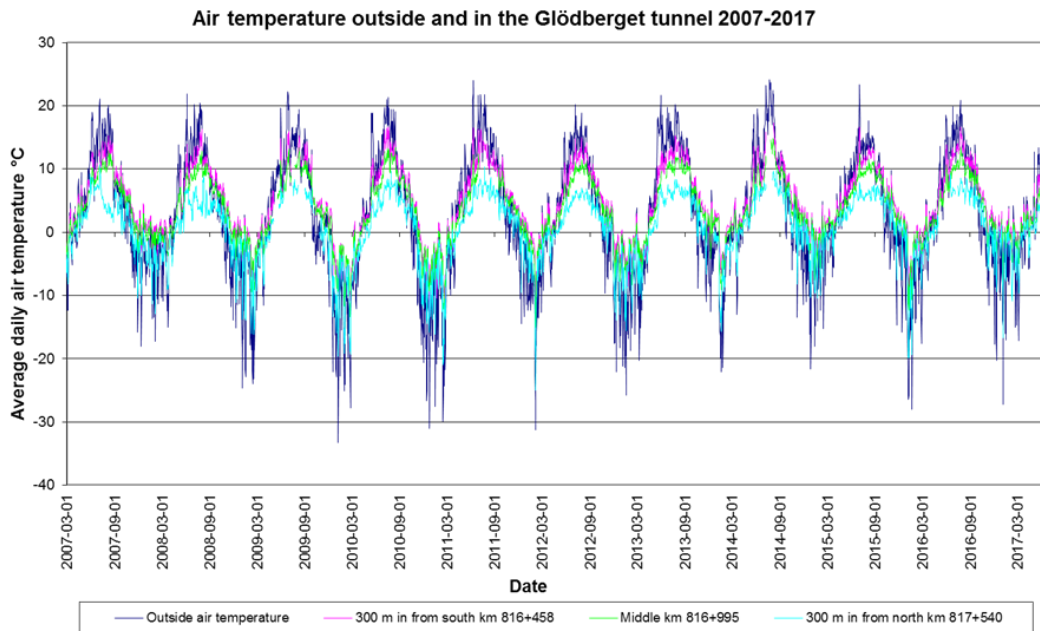
**Figure 13: Average daily air temperatures outside and in the Glödsberget tunnel 2006-2017.**

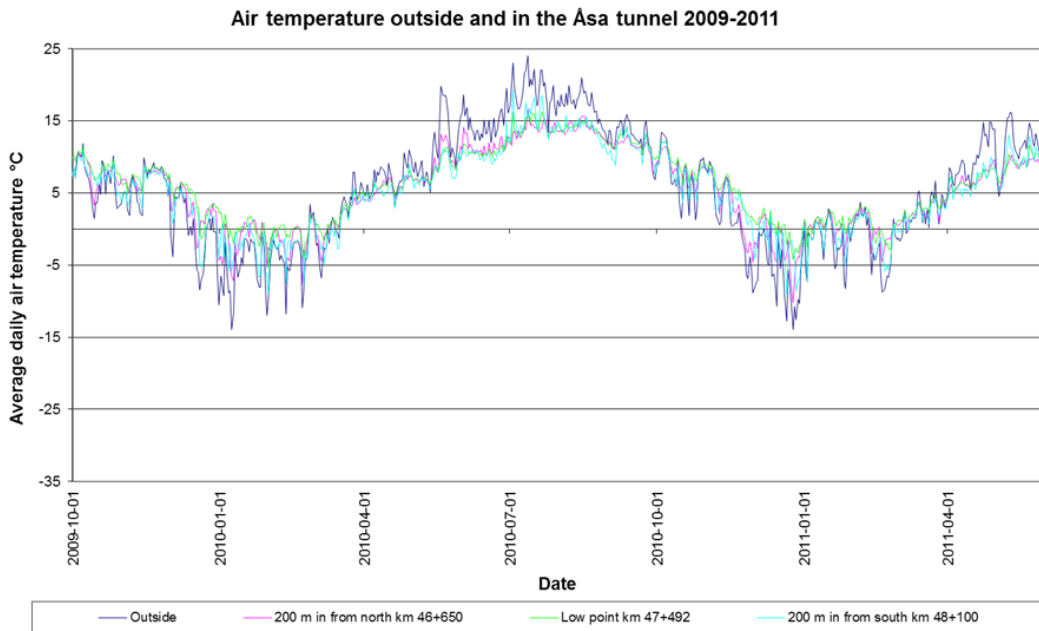
**Figure 14: Average daily air temperatures outside and in the Åsa tunnel 2009-2011.**

Figure 14 and Figure 15 show the average daily air temperature from October 2009 to July 2011, for the Åsa and Glödberget tunnel, respectively. The Åsa tunnel has a complicated temperature situation, due to its low point. Sometimes the higher, northern entrance (the pink curve in Figure 14) is warmer than the lower, southern entrance (the cyan curve in Figure 14), and sometimes it is the other way around. Because of the low point, it seems that the air motion can change direction and move towards either of the entrances. For the Glödberget tunnel, the temperature in the higher, southern part of the tunnel (the pink curve in Figure 15) is usually higher than that at the lower, northern part (the cyan curve in Figure 15). That is because the Glödberget tunnel has a constant inclination and the heated tunnel air, moves due to the chimney effect towards the higher, southern entrance.

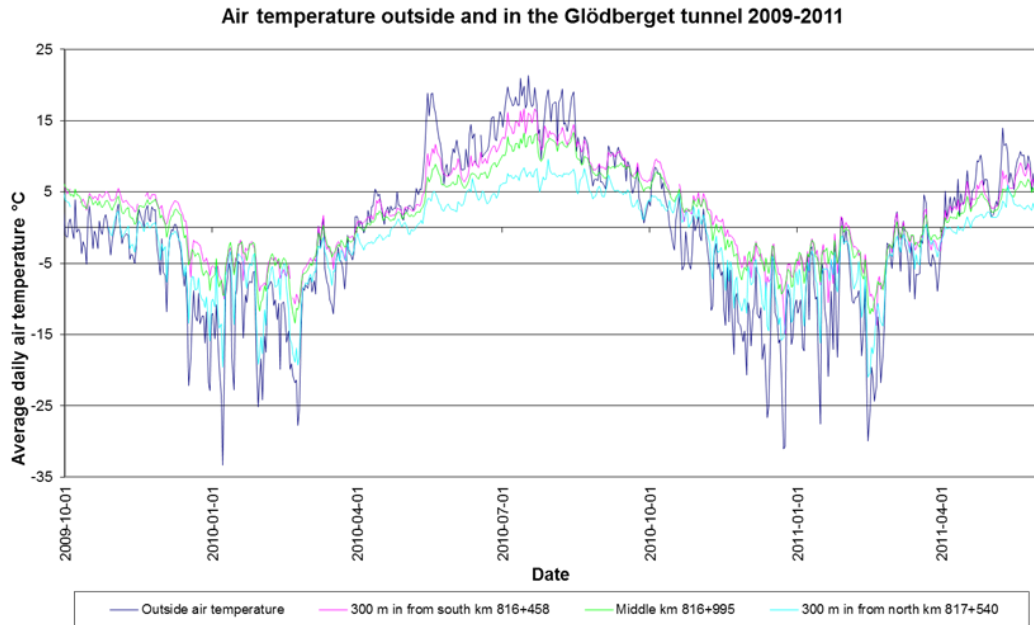
**Figure 15: Average daily air temperatures outside and in the Glödsberget tunnel 2009-2011.**

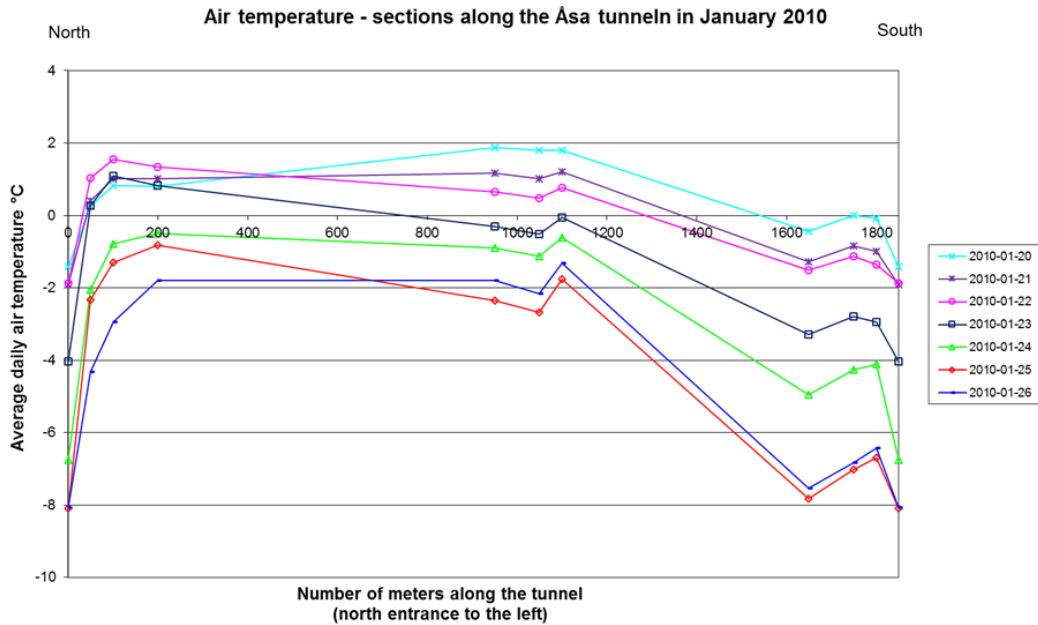
**Figure 16: Air temperature in the Åsa tunnel for seven consecutive days in January 2010.**

Figure 16 shows the air temperature at the measuring stations in the Åsa tunnel for seven consecutive days in January 2010. To the left is the northern entrance with a higher elevation than the southern entrance at the right side of the chart. The temperature displayed at both ends of the chart is the temperature measured at the climate station outside the northern entrance.

The frost penetrates further into the tunnel from the lower south entrance and the measurements show that the tunnel air temperature is higher in the northern parts of the tunnel. The cold outside air is heated by the rock mass and moves towards the higher northern parts of the tunnel. At the measuring station, 200 m from the northern entrance, the temperature starts to decrease, probably due to cold outside air entering the tunnel along the tunnel floor. However, it is clear that a major temperature difference from north to south remain, which indicates the chimney effect.

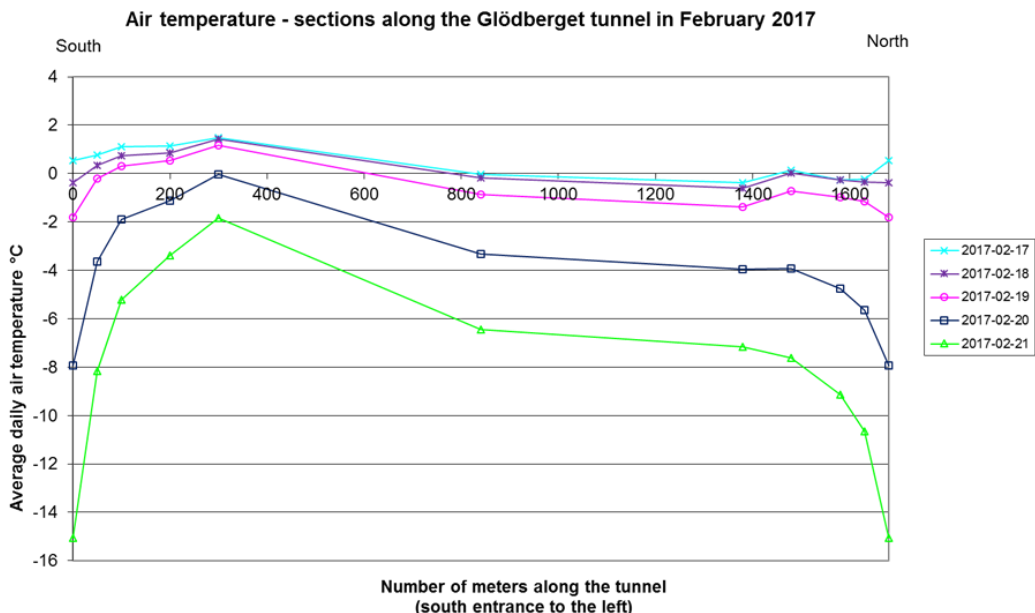
**Figure 17: Air temperature in the Glöddberget tunnel for five consecutive days in February 2017.**

Figure 17 shows the air temperature at the measuring stations along the Glödborget tunnel for five days in February 2017. The higher southern entrance is on the left side of the chart, and the lower northern is on the right side. The temperature displayed at both ends of the chart, is the temperature measured at the climate station outside the southern entrance.

The measurements made so far show that freezing temperatures penetrates further into the tunnels than previous assumptions in the model test [3]. Although the Glödborget tunnel is 1680 m long, frost penetration takes place along the whole tunnel length even at an outside temperature of a few degrees below zero. The frost penetrates further from the lower northern entrance than from the higher southern entrance. The tunnel air, heated by the rock mass, moves by convection towards the southern tunnel entrance, resulting in higher temperatures in this part.

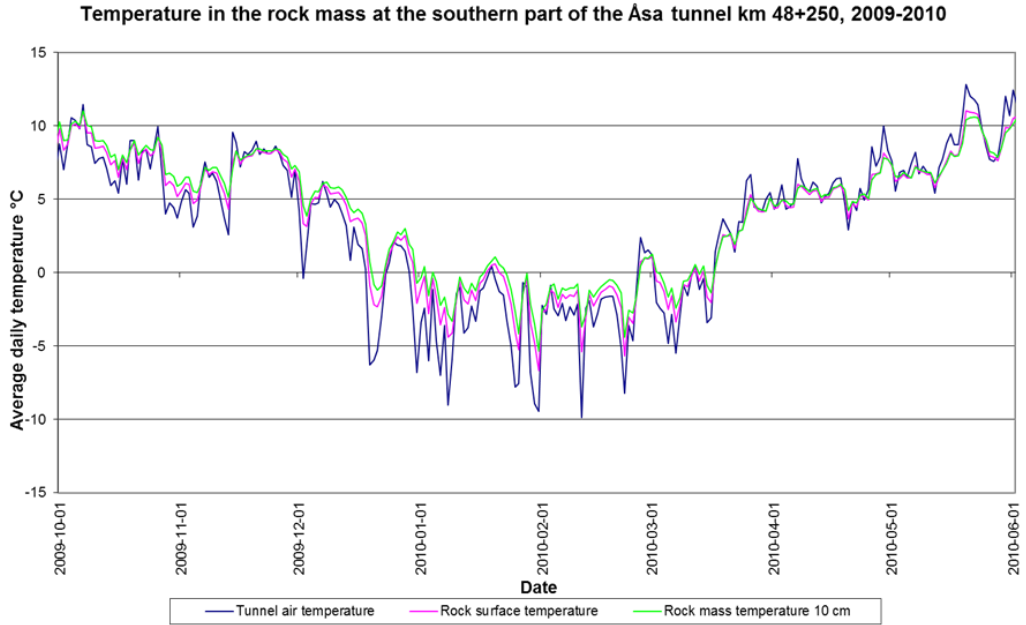
**Figure 18: Rock mass temperature at the southern part of the Åsa tunnel, 2009-2010.**

For the southern measuring station 50 m in from the southern entrance (km 48+250), the rock mass is frozen for a long time, when the tunnel air temperature is below zero degrees for a long continuous time period (see February in Figure 18). For the same time period at the low point, about 800 m into the tunnel from south (km 47+500), the rock surface and the first 10 cm into the rock mass stays more or less unfrozen. This is because the tunnel air temperature is several degrees warmer in this part of the tunnel, due to heat exchange from rock to air (Figure 19).

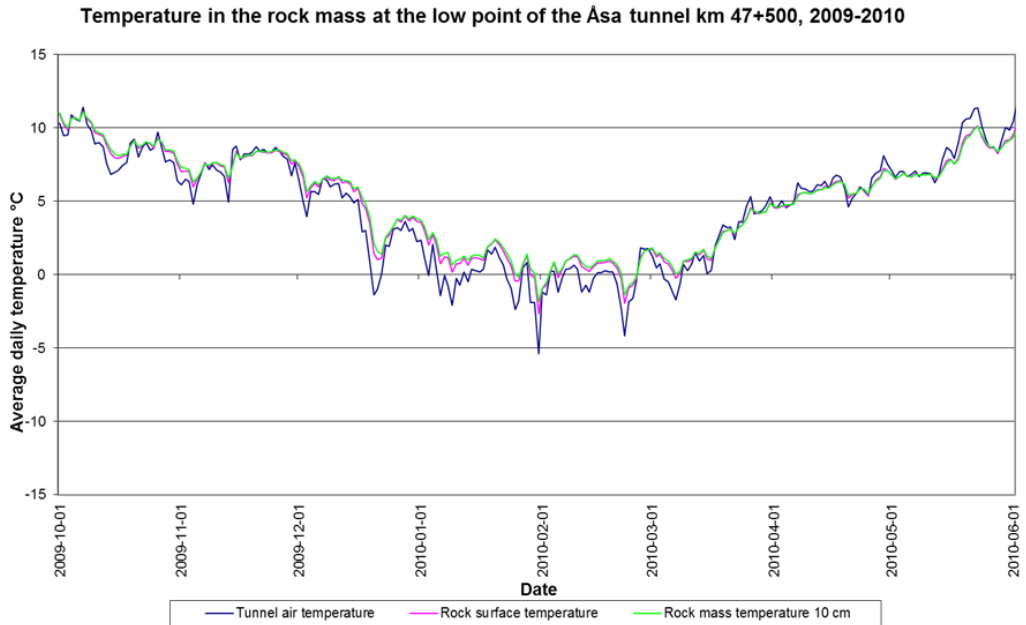
**Figure 19: Rock mass temperature at the low point of the Åsa tunnel, 2009-2010.**

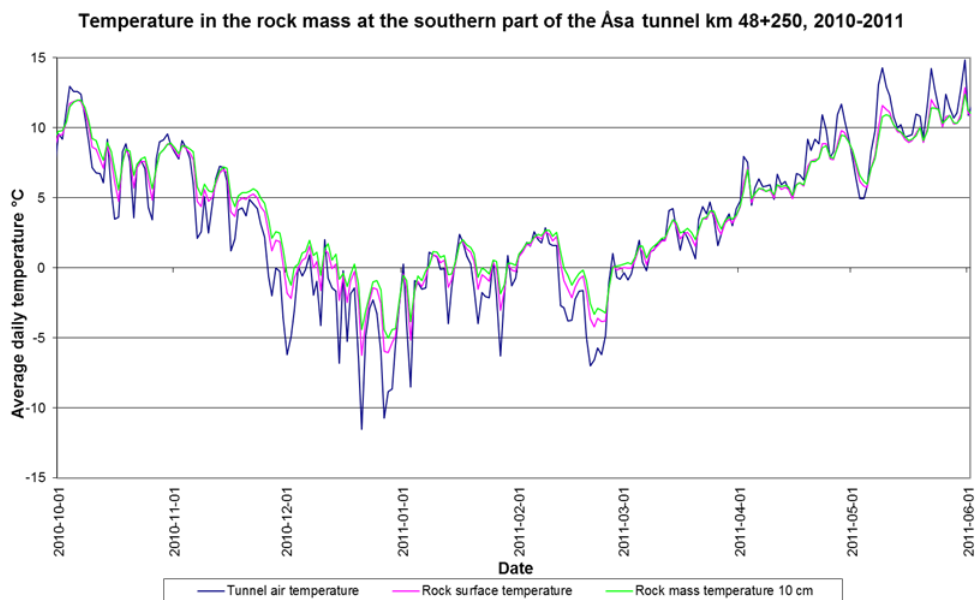
**Figure 20: Rock mass temperature at the southern part of the Åsa tunnel, 2010-2011.**

The same pattern is observed for the winter 2010/2011. The southern part of the tunnel is colder than at the low point and the rock mass is freezing periodically in this part (Figure 20), while the rock mass only gets frozen for shorter periods at the warmer low point (Figure 21).

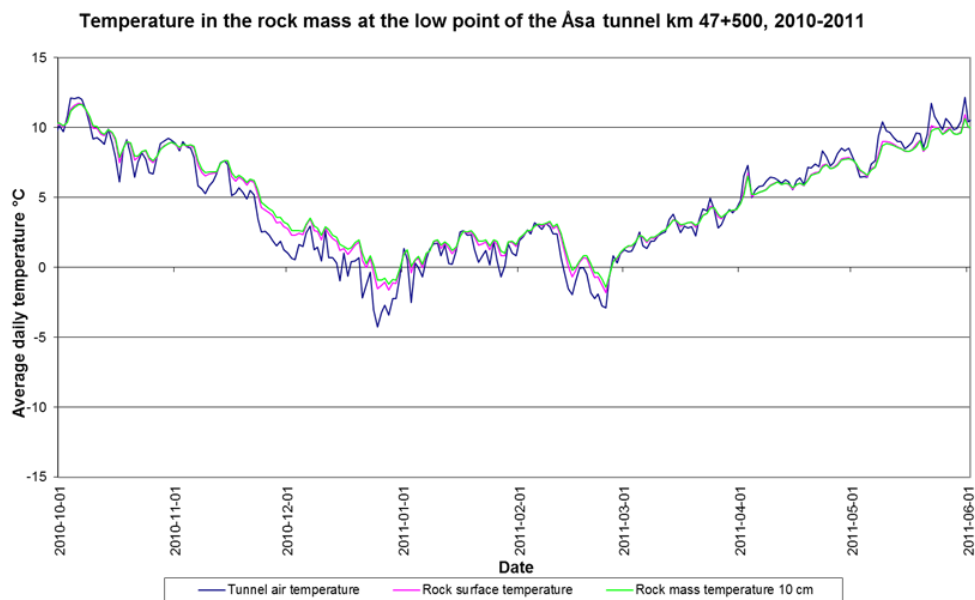
**Figure 21: Rock mass temperature at the low point of the Åsa tunnel, 2010-2011.**

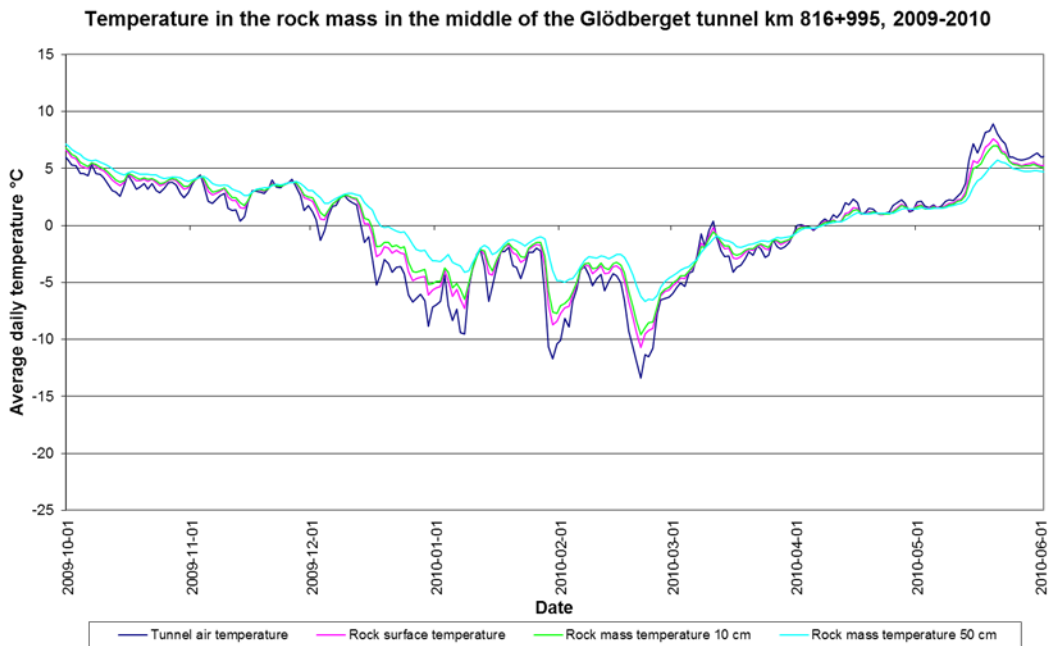
**Figure 22: Rock mass temperature in the middle of the Glödborget tunnel, 2009-2010.**

For the middle measuring station, 840 m from each tunnel entrance (km 816+995), the temperature measurements show that the rock mass freezes quickly, when the temperature in the tunnel air is permanently below zero degrees. This is the case even at small temperature changes of the tunnel air. In Figure 22, the temperature at a depth of 50 cm drops below zero degrees when the tunnel air temperature drops from 0°C to -5°C during four days in the middle of December 2009. Correspondingly, the rock mass thaws quickly when the tunnel air temperature increases. Figure 23 shows that the same freezing process took eight days during the middle of November 2010. The depth of frost penetration in the rock mass depends on many factors. Some of these factors are the temperature of the tunnel air and the duration of the temperature drop, the rock mass properties [7], the freezing rate (decrease in temperature per unit of time, °C/h) [8] in combination with the degree of water content [9]. The temperature drop in November 2010 (Figure 23) occurred at a lower freezing rate than in December 2009 (Figure 22) and it therefore took longer time for the freezing front to reach a depth of 50 cm.

At the measuring station 300 m in from the northern tunnel entrance (km 817+540), the tunnel air temperature is lower than that in the middle part. Here the rock mass at 50 cm depth stays frozen for a longer period of time than in the middle of the tunnel, consequently, it is more likely that leakage spots remain frozen for a longer period of time in this part of the tunnel. Measurements at 50 cm depth show that the temperature is about 5°C lower at the northern part of the tunnel than in the middle during the coldest days (compare cyan curve at the end of February in Figure 24 with Figure 22 and Figure 25 with Figure 23).

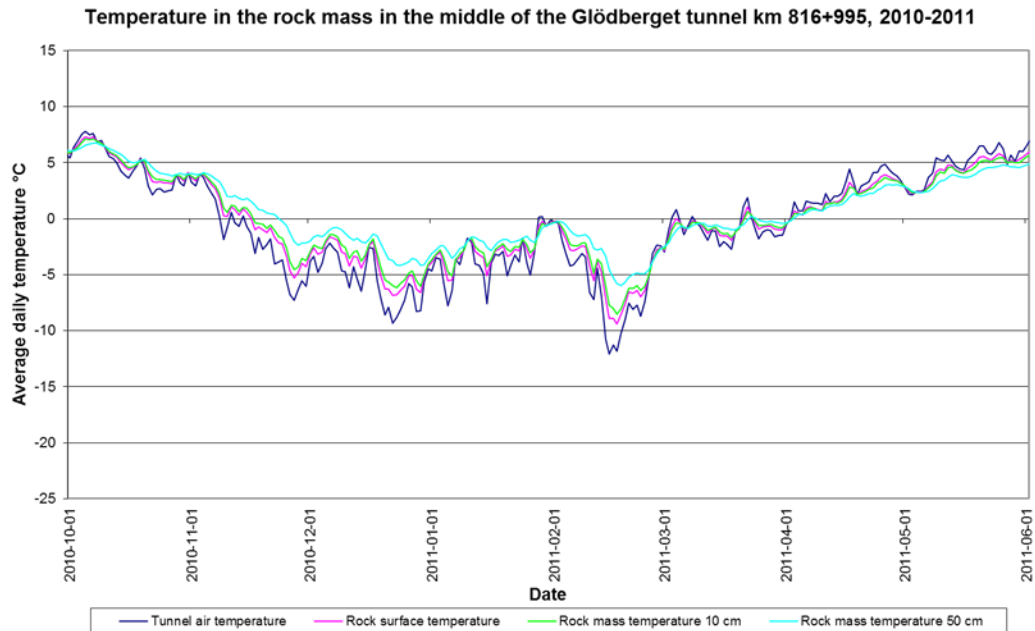
**Figure 23: Rock mass temperature in the middle of the Glödsberget tunnel, 2010-2011.**

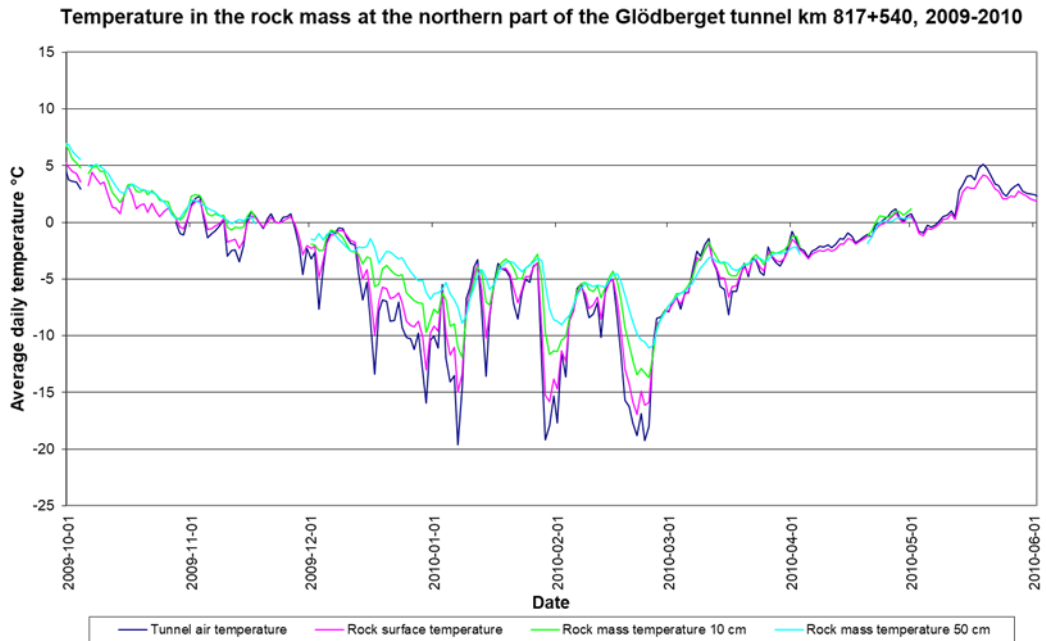
**Figure 24: Rock mass temperature in the north of the Glödberget tunnel, 2009-2010.**

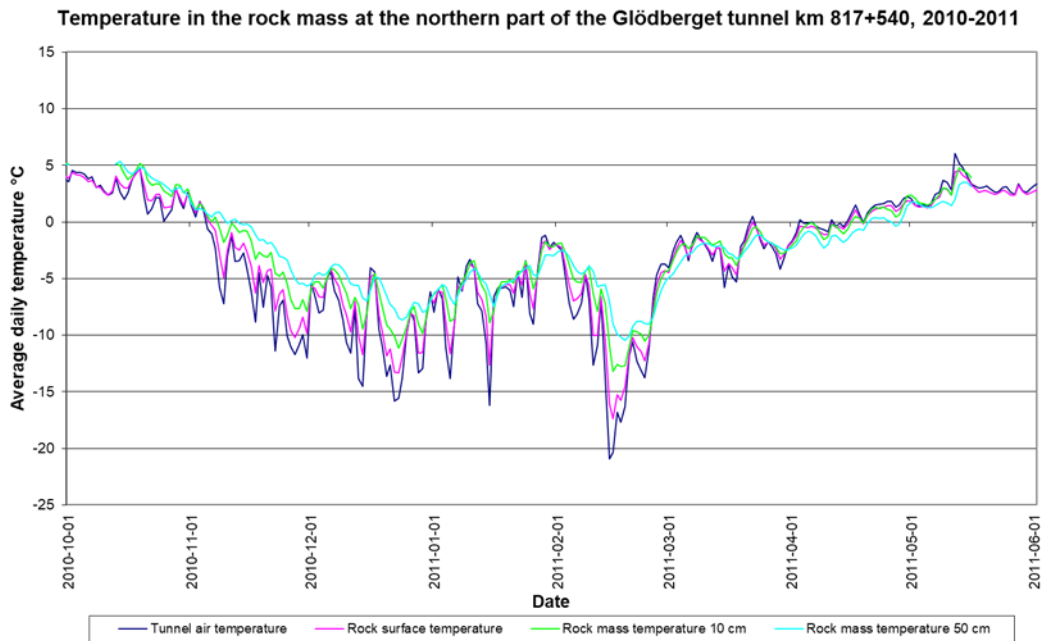
**Figure 25: Rock mass temperature in the north of the Glödberget tunnel, 2010-2011.**

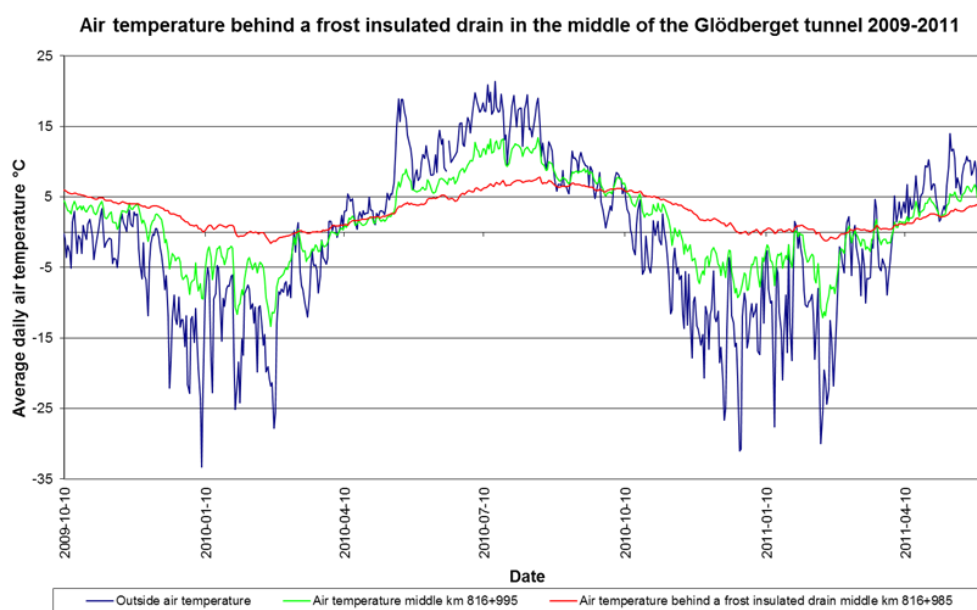
**Figure 26: Temperature behind a frost insulated drain, Glödborget 2009-2011.**

In Figure 26, the temperature behind the drain is compared to the outside air temperature and the tunnel air temperature at the same section as the drain mat. The measurements show that the insulated drain is able to even out the temperature changes occurring in the tunnel air right outside the drain. The winter period 2010/2011 was longer than 2009/2010 but the temperature behind the drain drops slowly below zero degrees at the end of both winter periods. If there are sub-zero degrees behind the drain, the water from the rock mass cannot be drained properly and frost shattering may develop. Water can begin to leak on the side of the drain, with formation of ice pillars and icicles as a result (see Figure 27).

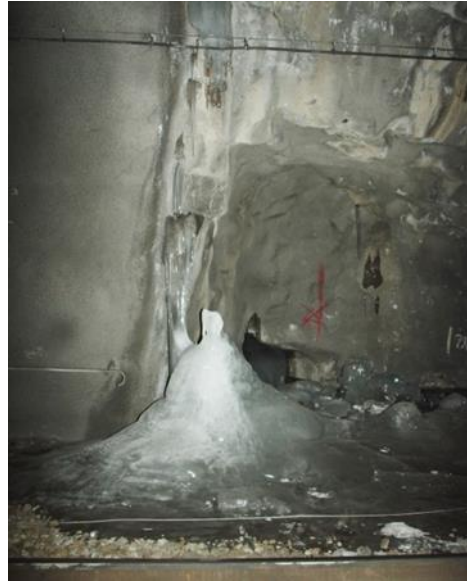
**Figure 27: Ice pillar at the edge of the drain mat in the Glödsberget tunnel.**

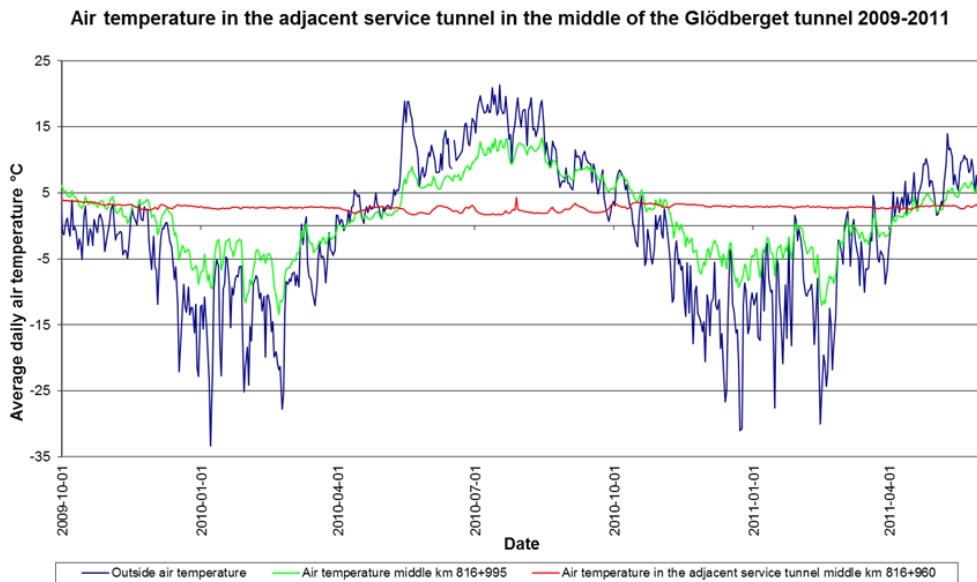
**Figure 28: Temperature in the adjacent service tunnel (red curve), in comparison to outside temperature (blue) and middle section tunnel air temperature (green), Glödsberget 2009-2011.**

The measurements show that the temperature in the service tunnel is almost constant throughout the year, around 2-3°C regardless of the temperature outside the tunnel. In Figure 28, the red curve is the temperature in the adjacent service tunnel and the green curve is the temperature in the track tunnel right next to the service tunnel door.

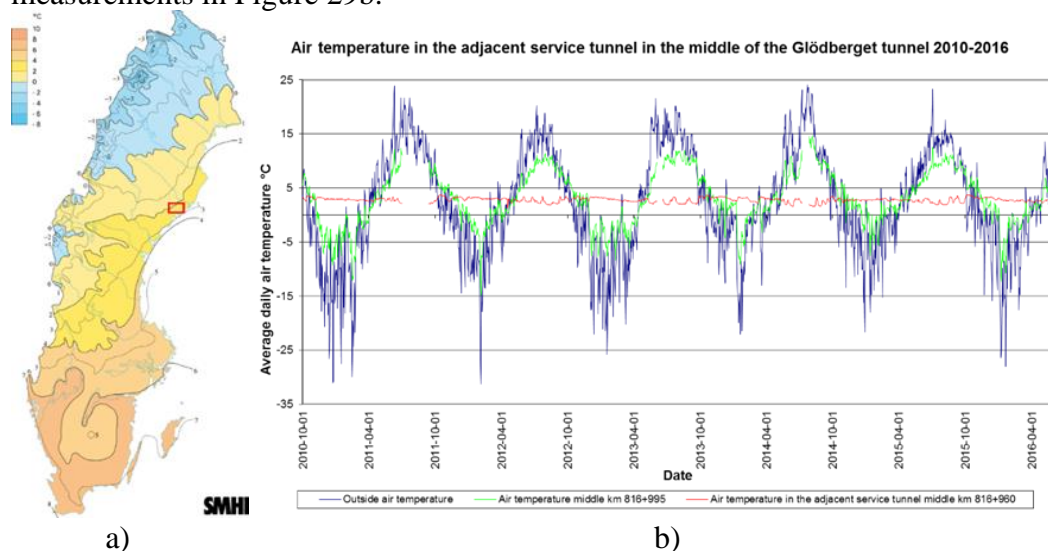
**Figure 29: a) The annual average temperature in Sweden – the location of the Glödborget tunnel is marked with a red rectangle [10].**

**b) Temperature in the adjacent service tunnel (red curve), in comparison to outside temperature (blue) and middle section tunnel air temperature (green), Glödborget 2010-2016.**

This corresponds to the normal temperature of the rock mass and that usually coincides with the annual average temperature applicable to the region where the tunnel is located. The isotherms of the annual average temperatures, according to SMHI, the Swedish Meteorological and Hydrological institute [10], is given in Figure 29a. The figure shows that, in the region where the tunnel is located the annual average temperature is 2-3°C, which complies well with the performed measurements in Figure 29b.

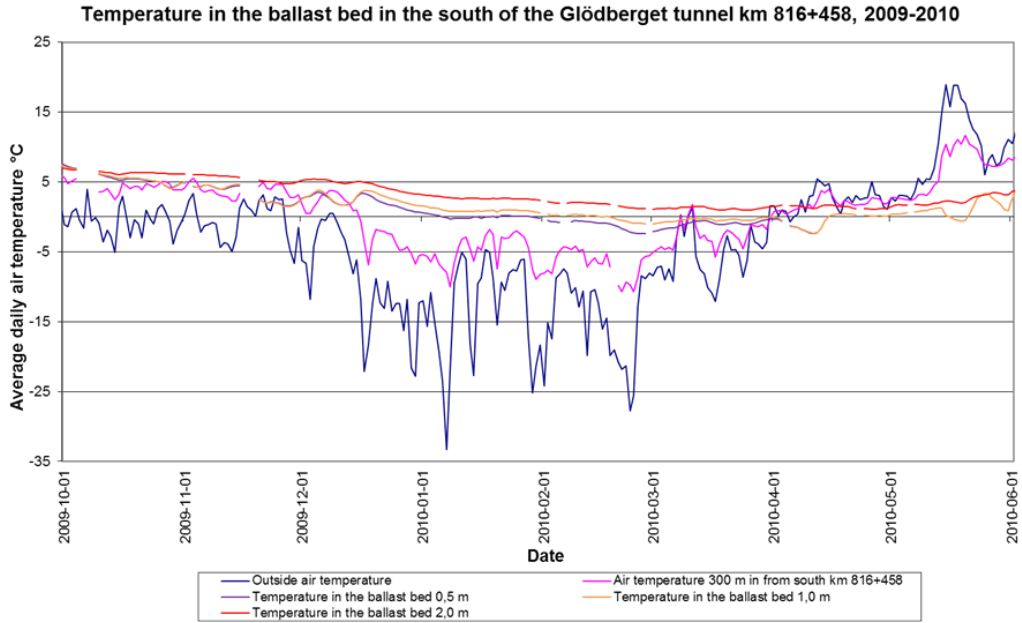
**Figure 30: Temperature in the ballast bed in the south of the Glödsberget tunnel, 2009-2010.**

Figure 30 and Figure 31 show that in the southern part of the Glödborget tunnel (300 m in from the southern tunnel entrance) the temperature at 1 and 2 m depth in the ballast bed is relatively unaffected by the outside and tunnel air temperature. However, as the temperatures drop throughout the winter period, the temperature at 1 m depth drops below zero degrees at the end of the winter, but the frozen zone never reaches 2 m depth. For the sensor located 0.5 m below the ballast surface, it takes relatively long time (about 20 days) for the temperature to drop below zero degrees. The results for the thawing phase at 0.5 m depth, are missing in this part of the tunnel, since the sensor at this particular depth sometimes had a bad connection.

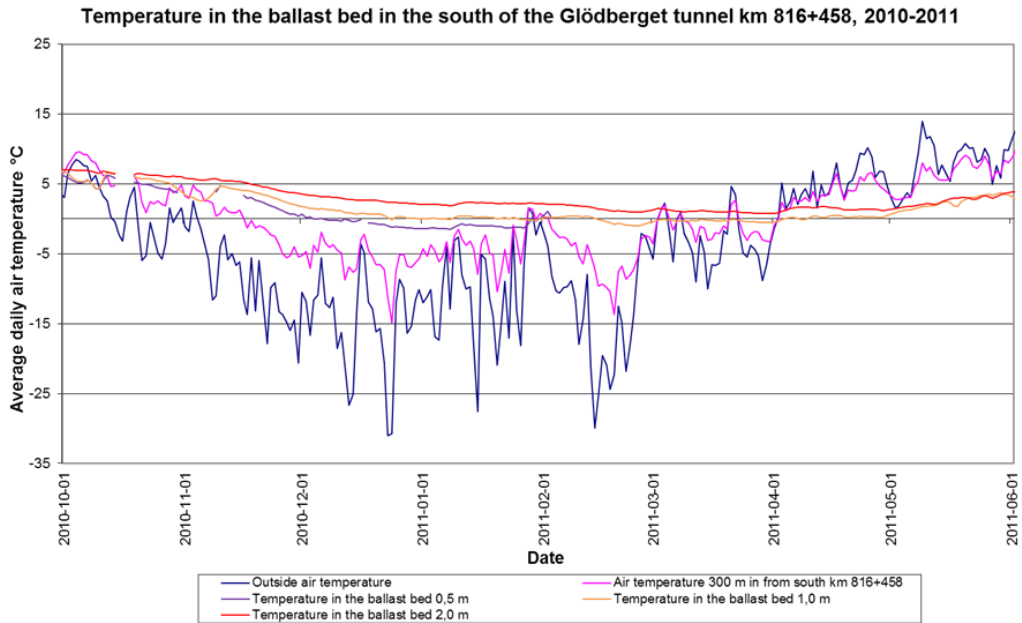
**Figure 31: Temperature in the ballast bed in the south of the Glödsberget tunnel, 2010-2011.**

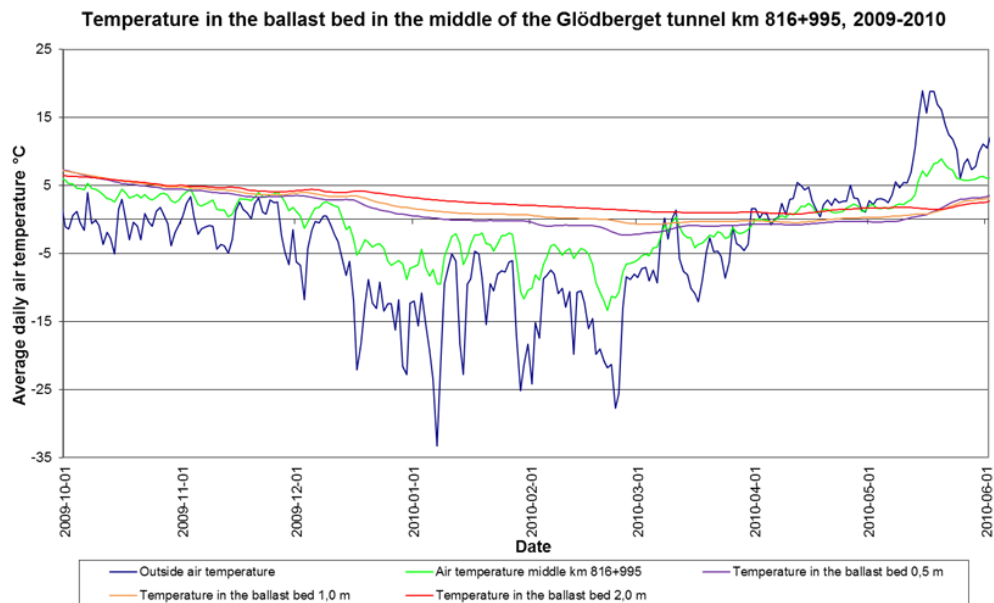
**Figure 32: Temperature in the ballast bed in the middle of the Glödborget tunnel, 2009-2010.**

In the middle of the Glödborget tunnel (km 816+995), Figure 32 and Figure 33, the temperature at 0.5 m depth is relatively unaffected by the outside and tunnel air temperature and all the measured temperatures gradually drop during the winter. The temperature at 1 m depth drops below zero degrees at the end of the winter, and the frozen zone never reaches 2 m depth. For the sensor located 0.5 m below the ballast surface, it takes a long time (about 30-40 days) for the temperature to drop below zero degrees. The results for the thawing phase at 0.5 m depth show that it takes about 20-25 days for the temperature to increase above zero degrees.

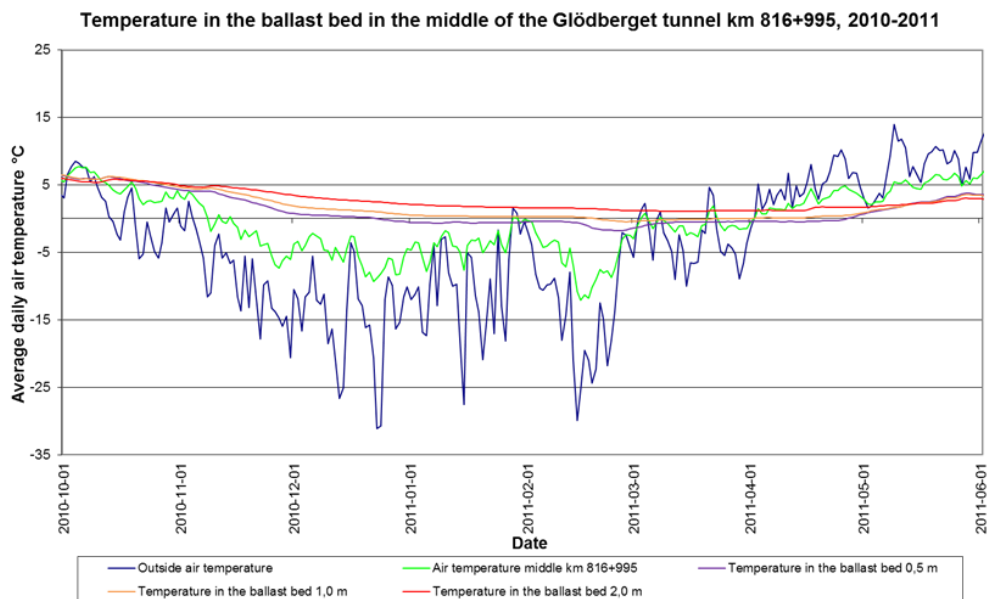
**Figure 33: Temperature in the ballast bed in the middle of the Glödberget tunnel, 2010-2011.**

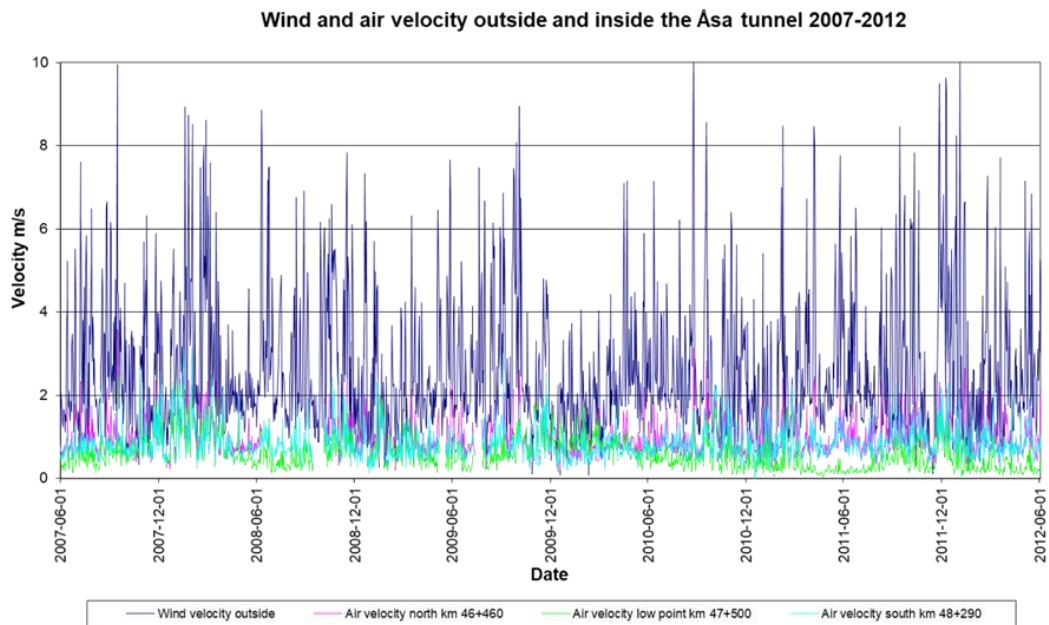
**Figure 34: Wind and air velocity outside and inside the Åsa tunnel during 2007-2012.**

Figure 34 and Figure 35 show the wind and air velocity outside and inside the respective tunnels. The results from the different measuring series show that the curves are following each other to some extent, but the wind velocity outside the tunnel does not significantly affect the air velocity inside the tunnel. The air velocity is usually lower in the middle of the tunnels (green curve) than at the entrances (pink and cyan curve), where the pattern of air movement is more complex. The highest air velocity usually occurs at the measuring stations located at the highest elevation (pink curve), due to the chimney effect.

When comparing the results from the middle measuring stations (green curves in Figure 34 and Figure 35) of the two tunnels, the air velocity is higher in the Åsa tunnel than in the Glödberget tunnel. The higher air flow is caused by the complex air situation arising due to the low point in the Åsa tunnel. The Glödberget tunnel has a constant inclination, resulting in a more constant flow in the middle parts of the tunnel.
