# Temperature Flows in Railway Tunnels: Field Measurements of Frost Penetration

Anna Andrén<sup>1</sup>, Lars-Olof Dahlström<sup>2</sup> and Erling Nordlund<sup>3</sup>

## Abstract

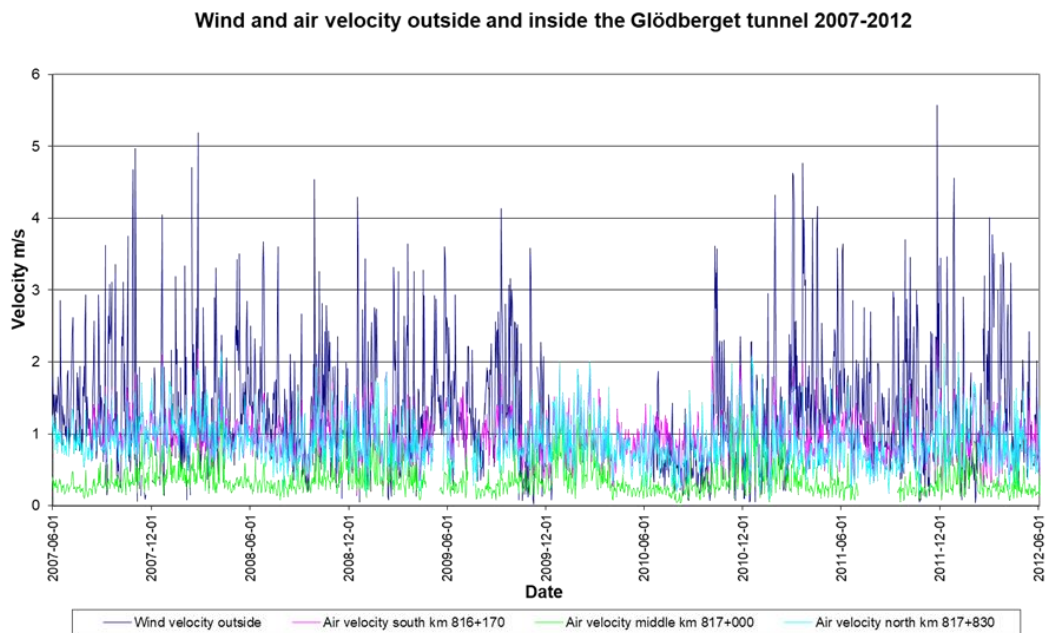
**Figure 35: Wind and air velocity outside and inside the Glödsberget tunnel during 2007-2012.**

Figure 34 and Figure 35 show the wind and air velocity outside and inside the respective tunnels. The results from the different measuring series show that the curves are following each other to some extent, but the wind velocity outside the tunnel does not significantly affect the air velocity inside the tunnel. The air velocity is usually lower in the middle of the tunnels (green curve) than at the entrances (pink and cyan curve), where the pattern of air movement is more complex. The highest air velocity usually occurs at the measuring stations located at the highest elevation (pink curve), due to the chimney effect.

When comparing the results from the middle measuring stations (green curves in Figure 34 and Figure 35) of the two tunnels, the air velocity is higher in the Åsa tunnel than in the Glödberget tunnel. The higher air flow is caused by the complex air situation arising due to the low point in the Åsa tunnel. The Glödberget tunnel has a constant inclination, resulting in a more constant flow in the middle parts of the tunnel.

During the summer periods, the air velocity at the middle measuring station (green curve) is lower than at both the higher (pink curve) and the lower measuring station (cyan curve). During the winter periods, the measurements show an increased air velocity at the middle station, which indicates increased air movements throughout the whole tunnel length during this time. This is because the temperature difference between the outside and tunnel air (heated by the rock mass) is greater during the winter, which causes the heated tunnel air to move by convection through the tunnel and start the chimney effect. This phenomenon is most evident at the Glödsberg tunnel because of the large difference in elevation between the entrances (Figure 35).

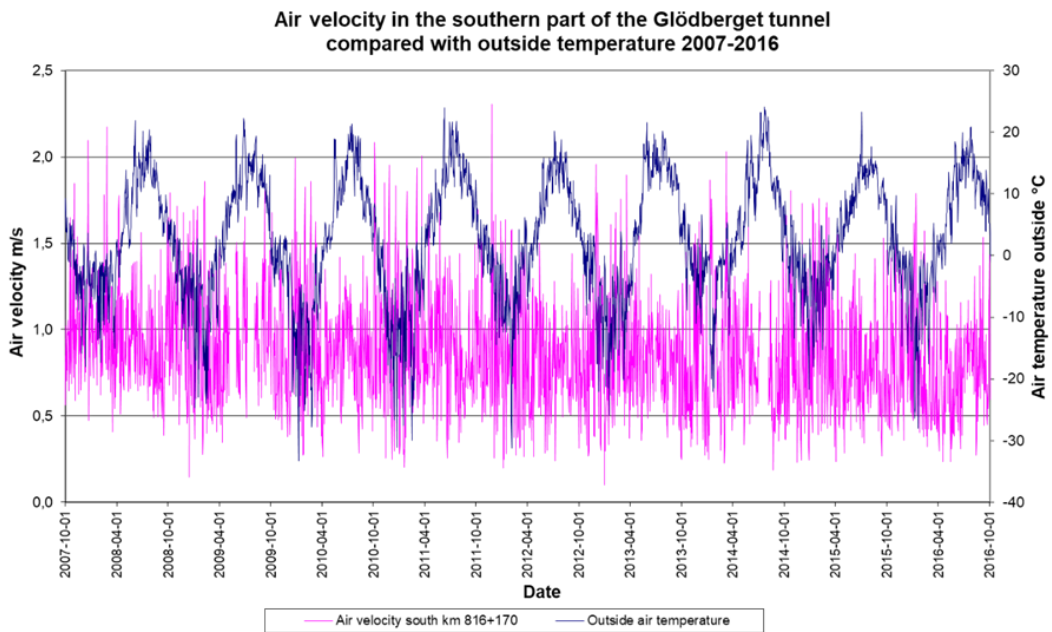
**Figure 36: Air velocity in the southern part of the Glödsberg tunnel, compared with outside temperature, 2007-2016.**

For the Glödsberg tunnel, it is even more apparent when plotting the air velocity versus the outside air temperature in the same chart. The air velocity of the southern (Figure 36) and northern (Figure 37) stations oscillates around 1 m/s throughout the year. For comparison, the air velocity at the middle measuring station is around 0.2 m/s during the summer and increases to about 0.5 m/s when the outside air temperature drops during the winter (Figure 38). There is clearly more air movement along the whole tunnel during the winter periods.

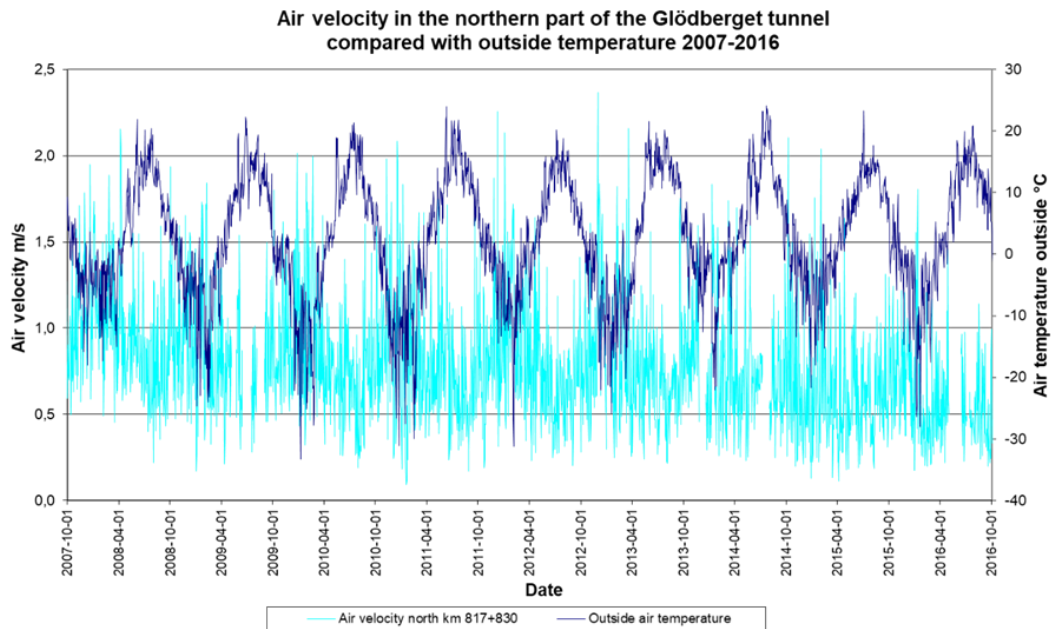
**Figure 37: Air velocity in the northern part of the Glödsberget tunnel, compared with outside temperature, 2007-2016.**

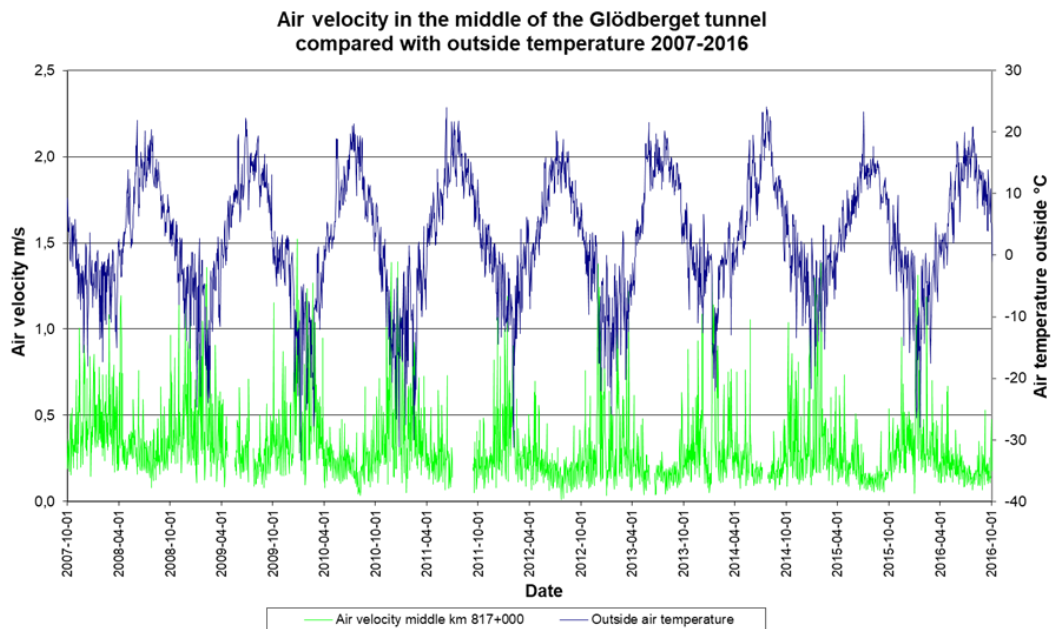
**Figure 38: Air velocity in the middle of the Glödsberget tunnel, compared with outside temperature, 2007-2016.**

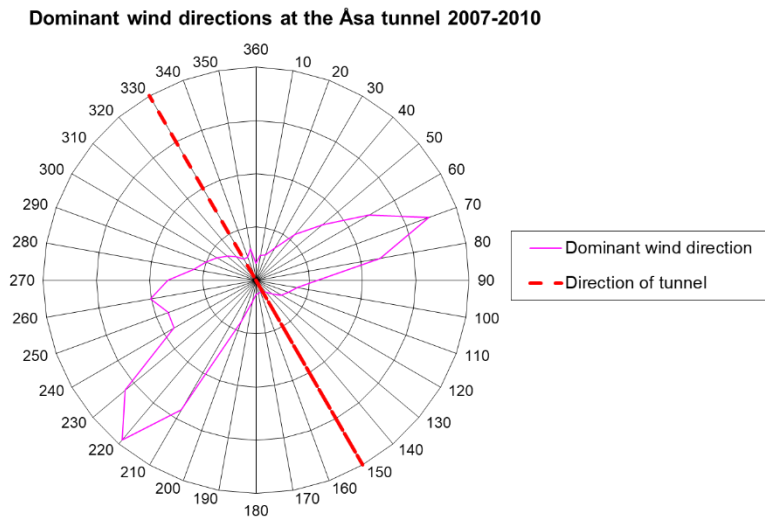
**Figure 39: Dominant wind directions at the Åsa tunnel 2007-2010.**

Figure 39 shows the dominant wind directions at the Åsa tunnel. The dominant wind direction is  $210^{\circ}$  -  $230^{\circ}$  (from southwest) and partly  $60^{\circ}$  -  $80^{\circ}$  (from northeast). The chart also shows the direction of the tunnel. The tunnel entrances are oriented  $150^{\circ}$  and  $330^{\circ}$  from the north. Since the dominant wind direction does not coincide with the direction of the tunnel entrances, it can be assumed that the outside wind does not affect the air movements in the tunnel to a large extent. This is confirmed by Figure 34 where the southern and northern measuring stations are slightly affected by the outside wind velocity (peaks following each other) but the air velocity in the tunnel is not of the same magnitude as the outside wind velocity.

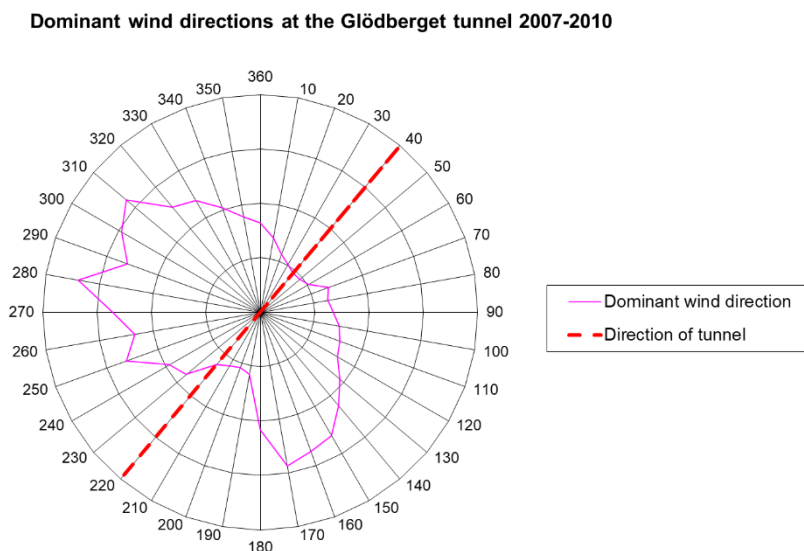
**Figure 40: Dominant wind directions at the Glödsberget tunnel 2007-2010.**

Figure 40 shows the dominant wind directions at the Glödsberget tunnel and the tunnel direction. The dominant wind directions are  $160^{\circ}$  -  $180^{\circ}$  (from southeast) and  $280^{\circ}$  -  $320^{\circ}$  (northwest). The tunnel entrances have an orientation of  $40^{\circ}$  and  $220^{\circ}$  from north. Since the dominant wind direction differs from that of the tunnel entrances, the outside wind does not significantly affect the air movements in the tunnel. In the few occasions when the wind direction coincides with the direction of one of the tunnel entrances, a small increase in air velocity at the measuring station nearest the entrance can be detected. However, it does not give any impact along most parts of the tunnel, as seen in Figure 35.
