Mystery of Mosul Dam the Most Dangerous Dam in the World: Karstification and Sinkholes

Nadhir Al-Ansari¹, Nasrat Adamo², Issa E. Issa³, Varoujan Sissakian⁴ and Sven Knutsson⁵

Abstract

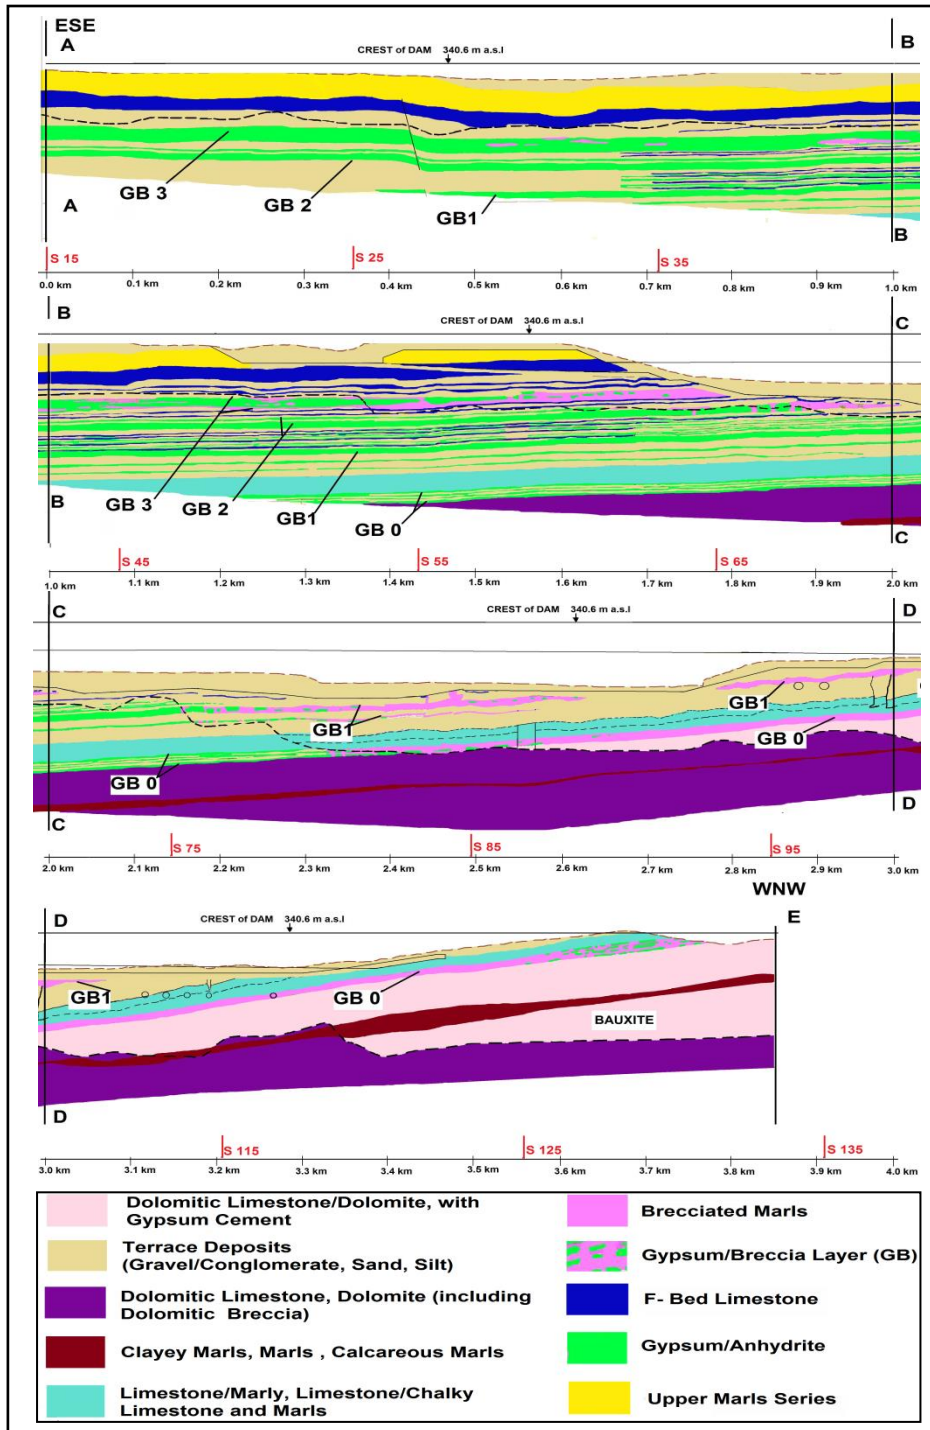
Figure 3: Geologic cross section along the axis of the dam.

It should be mentioned however, that karstic limestone and the development of solution cavities within the gypsum and anhydrite layers are the main geological features under the foundation of the dam. The bore holes data indicated that four significant gypsum units were identified during design and construction varying in thickness from 8 to 16m and identified as GB0 (Gypsum Breccia 0), GB1, GB2, and GB3 in ascending order (Fig.3) [7]. The development of voids requires continuous grouting is mainly due to the dissolution and erosion of gypsum by water seeping under the dam. [7] believes that the erosion and dissolution rates in gypsum are related to the seepage velocities and hydraulic gradient. When calcium sulfate saturation is lower than approximately 2,000 ppm in seepage water, gypsum dissolution continues this zone will move downstream as greater quantities of unsaturated water attack a gypsum bed.
