Dams Safety and Geology

**Nasrat Adamo¹, Nadhir Al-Ansari², Varoujan Sissakian³, Jan Laue⁴
and Sven Knutsson⁵**

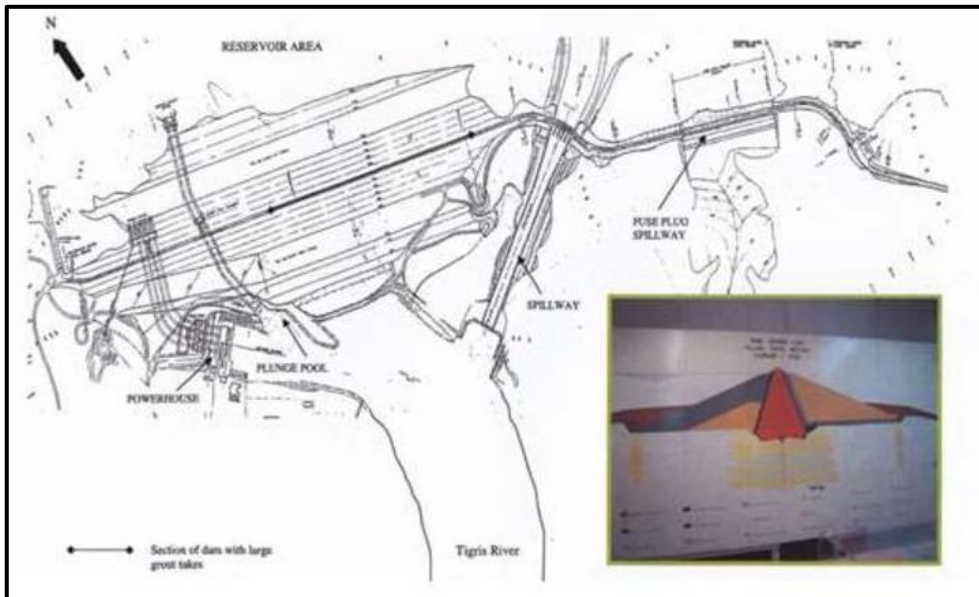
Figure 7: Mosul Main Dam – Layout and cross section.

The dam foundations itself is very complicated and the combination of gypsum/anhydrite layers with the cavernous limestone gave rise to very favorable conditions for seepage and dissolution environment by the formation of highly developed conduits and caverns for the flow of ground water. The result was extensive dissolution of gypsum and gypsum anhydrite rocks present above and below these limestone layers. These dynamics caused the collapsing of whole layers of clayey marls into the underneath cavities forming beds composed of brecciated gypsum particles and anhydrite blocks embedded into a loose clayey matrix as described before and shown in Figure 6. Four such layers were discovered during the geological investigations and were tagged as the (Gypsum-Brecciated) layers (GB0, GB1, GB2, GB3). These layers had thickness, which ranges between 8m and 16m; and were found at different depths, the last one was at depth of 80m below the river bed while the first day lighted in the excavation of the foundation of spillway

In spite of the repeated repairing and maintenance grouting of the deep grout curtain, it cannot put an end to the karst dissolution at the site around the dam and in the reservoirs. Many sinkholes have formed so far just downstream of the dam which forced the authorities to limit the maximum operational water level to elv. 319m. a.s.l. instead of the maximum designed water level of 330m a.s.l. and so losing sizable volume of the live storage and the benefits that are obtained from it with it. During the period 2014-2019, Mosul Dam problems and its safety risks became worlds' news on the media, and several hundred news reports and technical papers were published. Many such papers were written by the author and a technical team from Luleå Technical University of Sweden which give complete technical reviews and analyses of these problems; it is highly recommended to refer three such papers to the reader's attention for full understanding of this so far unique case of karst hazards in dam's construction. These papers appear in the references list, [17], [18], [19], [22]. Karst hazards in limestone are not less problematic than those in gypsum karst, as far as dam's safety and usefulness are concerned. One good example is the case of the Boljunčica reservoir in the Istria peninsula (Croatia).

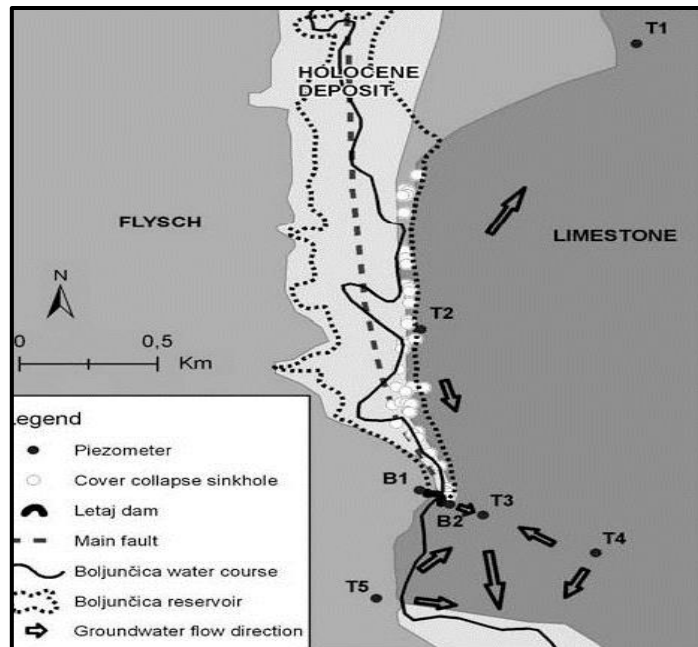
Figure 10: Map of reservoir with designated geological structure piezometers, cover collapse sinkholes and groundwater flow directions.

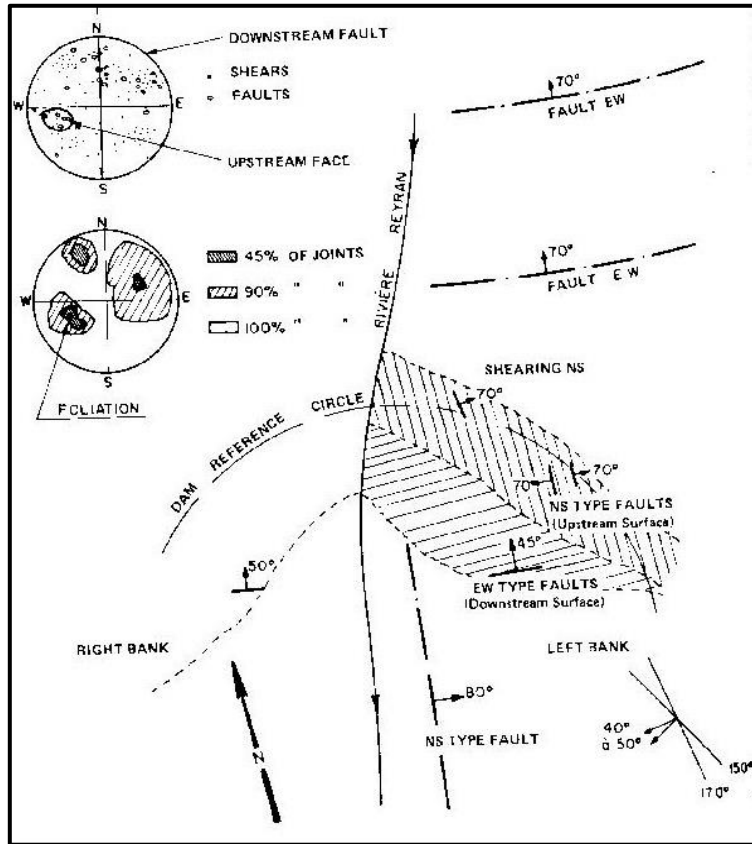
Figure 13: Geology of the Malpasset Dam Site (after Londe, 1987) [25].

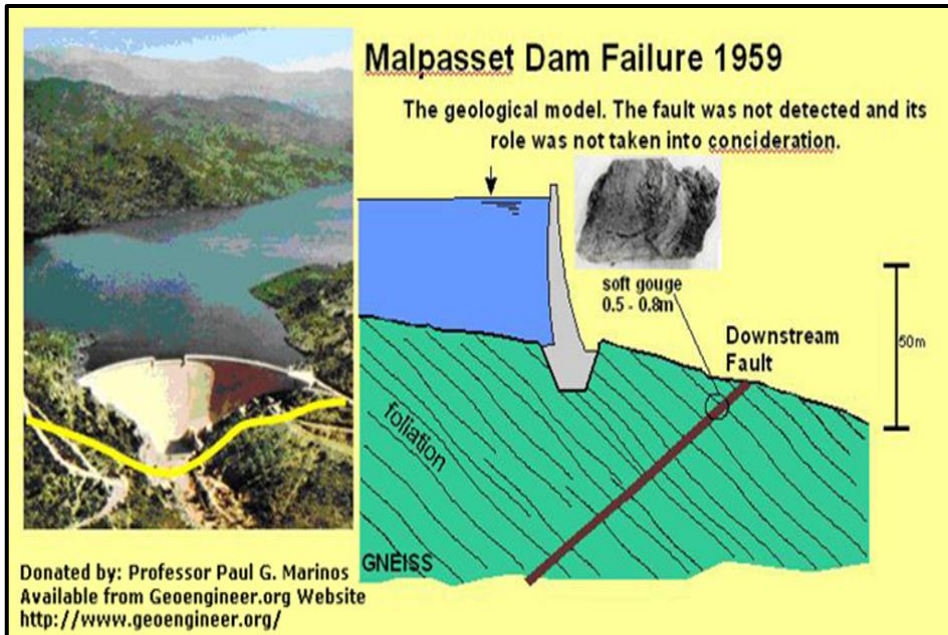
“The left abutment of this dam appears to have failed by sliding along a continuous seam of weak material covering a large area. A conventional site exploration, including careful examination of the rock outcrops and the recovery of cores from 2-inch boreholes by a competent driller, would show - and very likely has shown - that the rock contained numerous joints, some of which are open or filled with clay.”, he adds;

“From these data, an experienced and conservative engineer-geologist could have drawn the conclusion that the site is a potentially dangerous one, but he could not have made any positive statement concerning the location of the surface of least resistance in the rock and the magnitude of the resistance against sliding along such a surface...” The development of the failure process may be better understood with the help of Prof Paul G. Marinos visualization shown in Figure 16 and Figure 17 [27].

Figure 16: Malpasset Dam Geological Model [26].

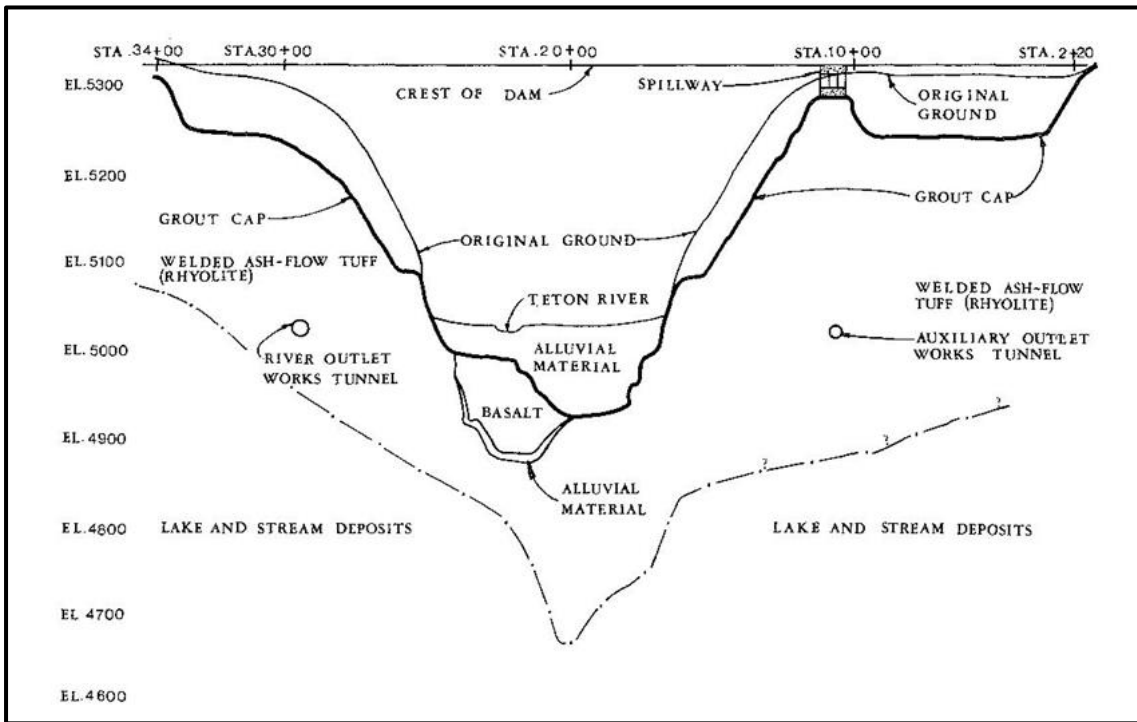
At the dam site, the Teton River occupies a steep-walled canyon incised in rhyolitic ash flow tuff, a hard rock derived from distant volcanoes now long extinct. Extensive joints are common in this rock and are particularly numerous near the surface of the abutments. A cross-section of the canyon approximately along the longitudinal axis is shown in Figure 26 [38], [39]. Figure 27 shows the same long section but in distorted scale for clarify of terms [34]. The walls of the canyon consist of later Tertiary rhyolite welded tuff, which is strongly jointed, with joint widths varying at different elevations typically between $\frac{1}{4}$ and 3 inches but with occasional joints up to 12 inches wide. Alluvium was deposited on the river channel to a depth of about 100ft. (30m) and the high lands near the ends of the dam are covered with an aeolian silt deposit up to about 30ft (9m) thick. The primary features of the site are the extensive joint system in the rhyolite-tuff, which makes it extremely permeable, and the abundance of the wind-blown silt deposit, which led the designers to use substantial quantities of this material in the dam cross-section.

Figure 26: Cross-section of the canyon approximately along the longitudinal axis (showing Grout Cap) [38, 39].

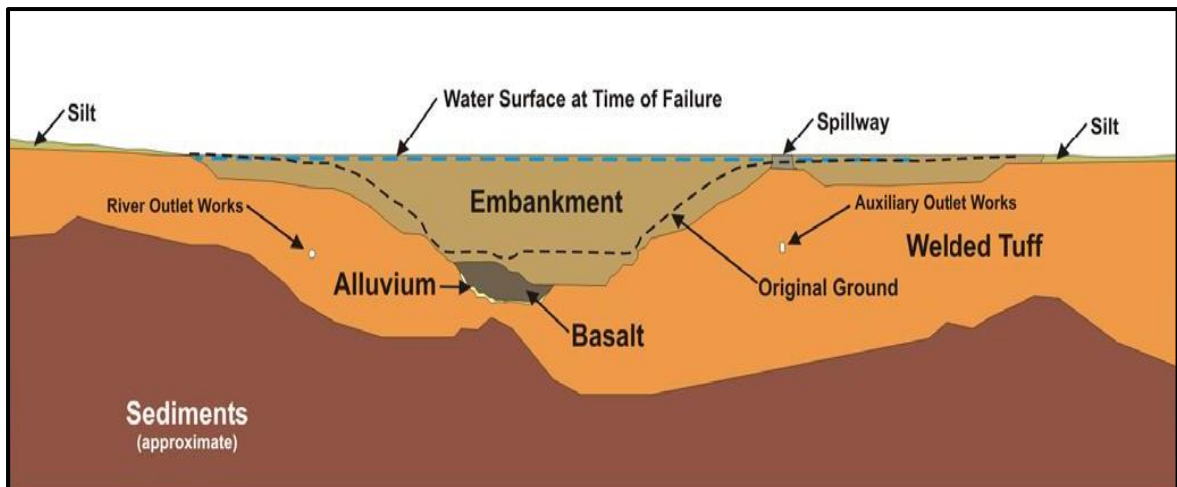
Figure 27: Cross-section of the canyon approximately along the longitudinal axis showing foundation materials (scale distorted) [34].
