Dam Safety: Technical Problems of Ageing Concrete Dams

**Nasrat Adamo¹, Nadhir Al-Ansari², Varoujan Sissakian³, Jan Laue⁴
and Sven Knutsson⁵**

Keywords: Dam Aging, Cracking, Expansion, Spalling, Scaling, Abrasion, Cavitation.

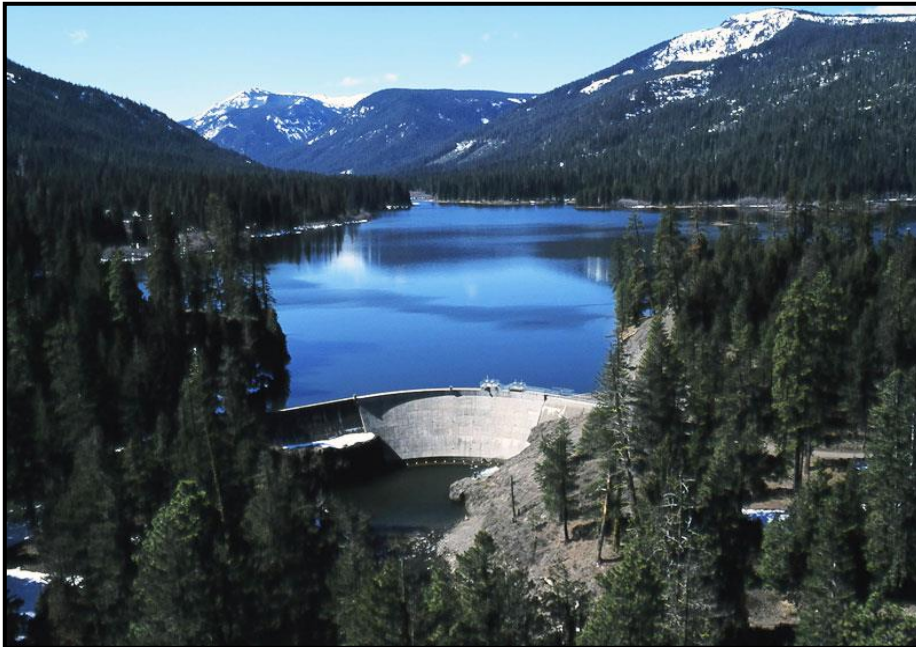
123m at the crest. In 1918 it was raised by 6.4m to its present height of 25m and it was partially rebuilt in 1964. The dam suffered from a variety of deterioration mechanisms and the concrete properties diminished. Analysis of the dam conditions identified a strong probability of failure under static, hydrologic, and dynamic loading.

Figure 1: Clear Creek dam (Washington) downstream view.

Rehabilitation work in 1964 consisted primarily of: placing new concrete in the arch section between elevation 2991m (a.s.l.) and the crest, repairing cracks and poorly consolidated concrete with neoprene and epoxies, and installing protective wire-mesh fences from the abutments to upstream areas. Resulting from investigations conducted in 1987-1989, the Bureau of Reclamation concluded there were horizontal bands of deteriorated concrete in the section replaced in 1964. These conditions could result in sudden failure of the dam, so early in 1990 the water level of Clear Lake was immediately lowered to reduce the likelihood of dam failure to less than 5% of its design capacity by drilling two holes through the dam to further drain the lake to a point that only 230 acre-feet ($283,700\text{m}^3$) could be stored out of the total original capacity of 5,300 acre feet ($6,500,000\text{m}^3$). Reconstruction works were accomplished and consisted of converting the dam into a gravity structure by buttressing the arch with a new concrete section immediately downstream. A new 48-inch outlet conduit was installed near the elevation of the breach (2,956.5 feet) to permit discharge whenever the lake was below the spillway crest. Clear Lake which has a water surface area of 260 acres (110ha) is used now primarily for recreation including boating and fishing and most of the discharge is through the spillway [2] and [3].

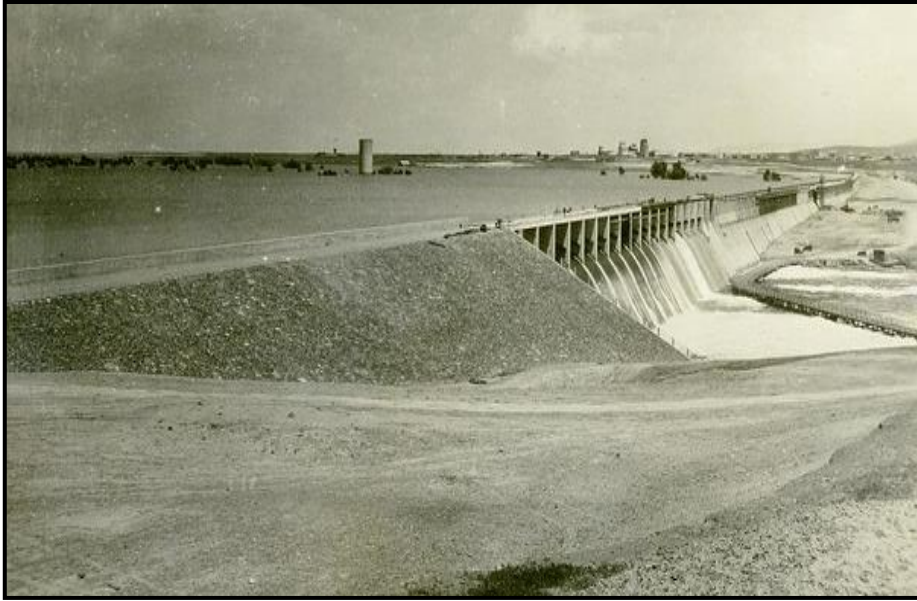
Figure 2: View of the old original American Fall Dam (1927).

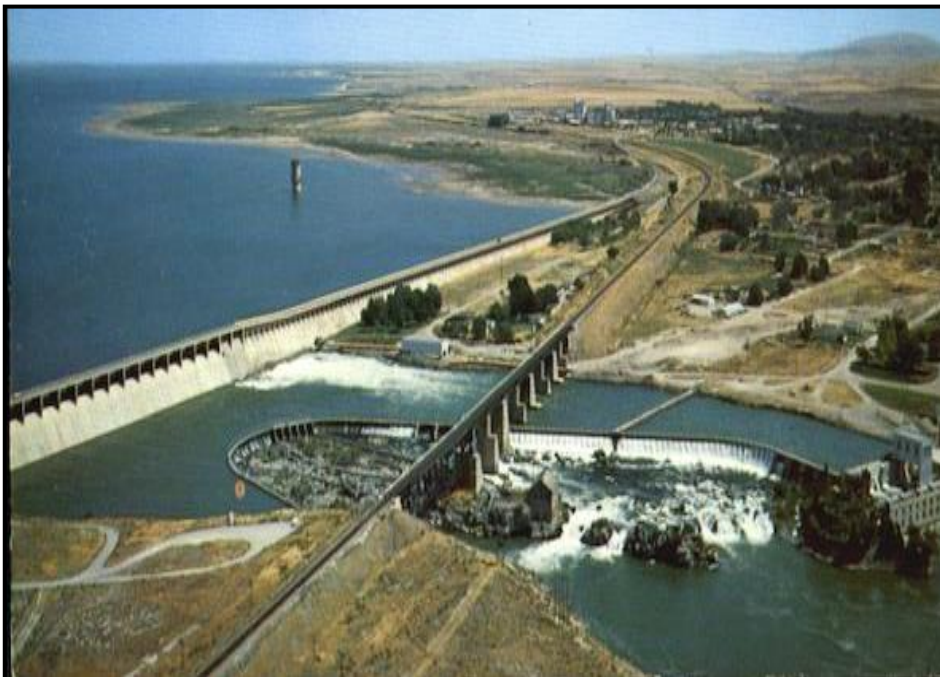
The planned construction activities will take place on the downstream portion of the dam. This project will address the need for replacement and repair of deteriorating concrete on the spillway, spillway gate operators' decks, downstream dam face, adits, and stilling basin structures, which have experienced degradation over 40 years of service, refer to Figures 2 and 3.

Figure 3: Aerial view of American Fall Dam after 1978.

- a. Removal and replacement of 6 inches of concrete on the spillway face and stilling basin floor.
- b. Repair of concrete on the upper spillway gate operator's decks and complete replacement of the spillway adits (access entryways).

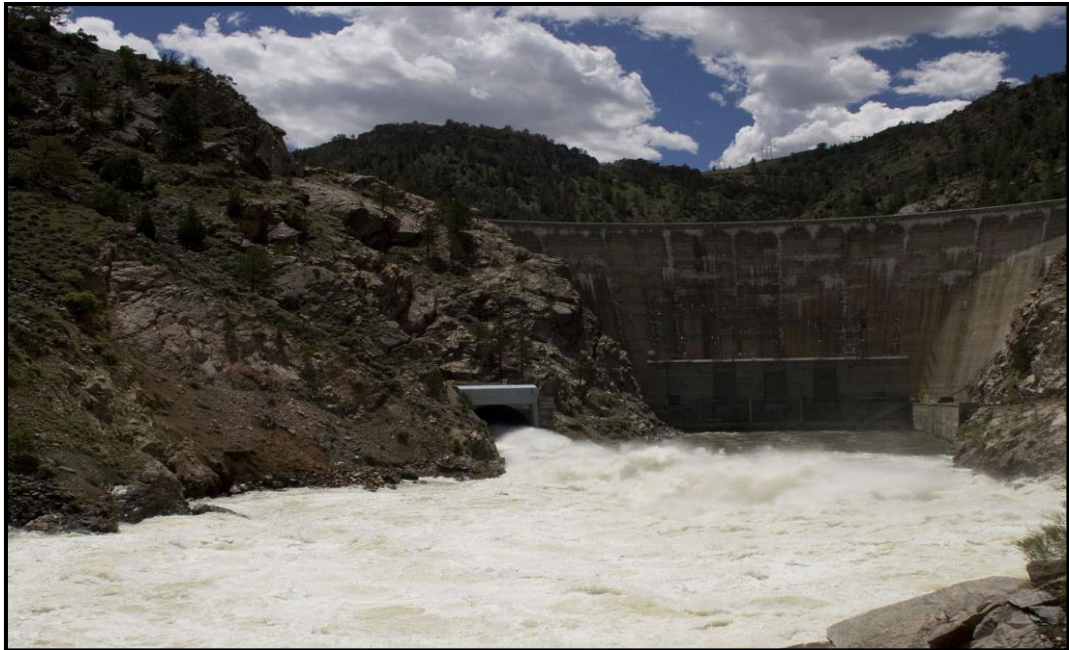
Downstream and upstream views of the dam are shown in Figures 7 and 8. Cracking and deterioration of concrete was chiefly observed along the upper parapet walls and power house walls. Although since the 1950s, ASR was suspected of causing some of the cracking visible at the top of the dam, ASR did not appear to be a major concern. In 1951, a petrographic examination of the concrete revealed indications of ASR along with freeze-thaw deterioration. It was not certain whether ASR or freeze-thaw deterioration was the main cause for this deterioration. The examination revealed the presence of about 4.5% reactive particles, chiefly cherts, andesites, and rhyolites, which were judged to be only marginally deleterious.

Figure 7: Downstream view of Seminoe Dam.

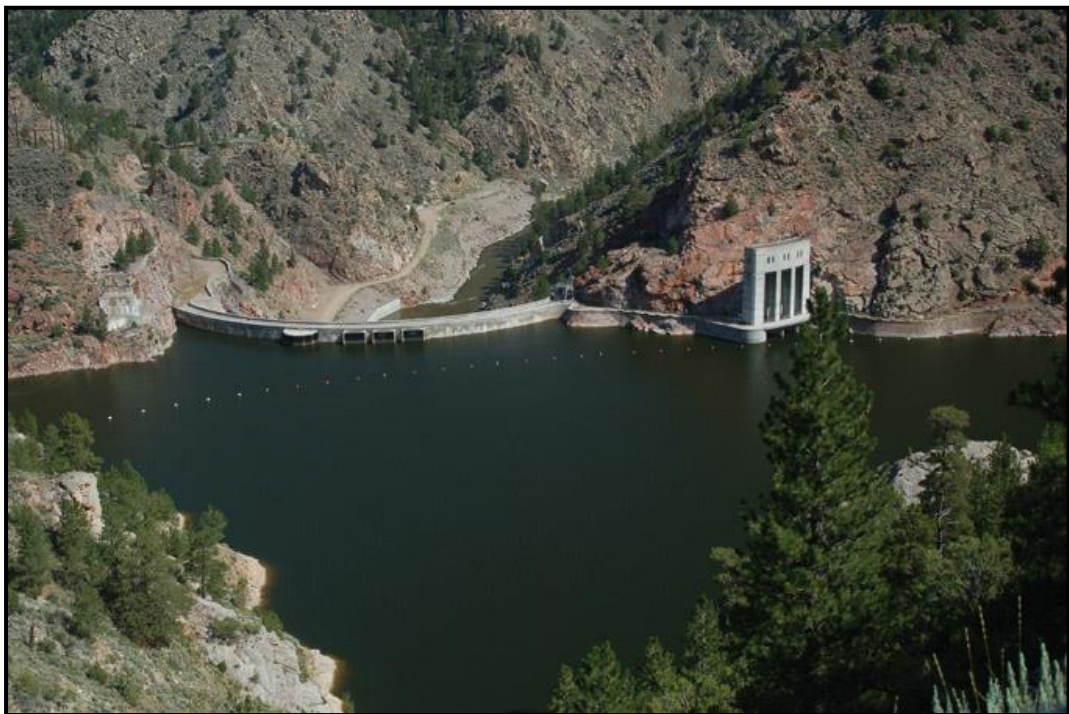
Figure 8: Upstream view of Seminoe Dam.

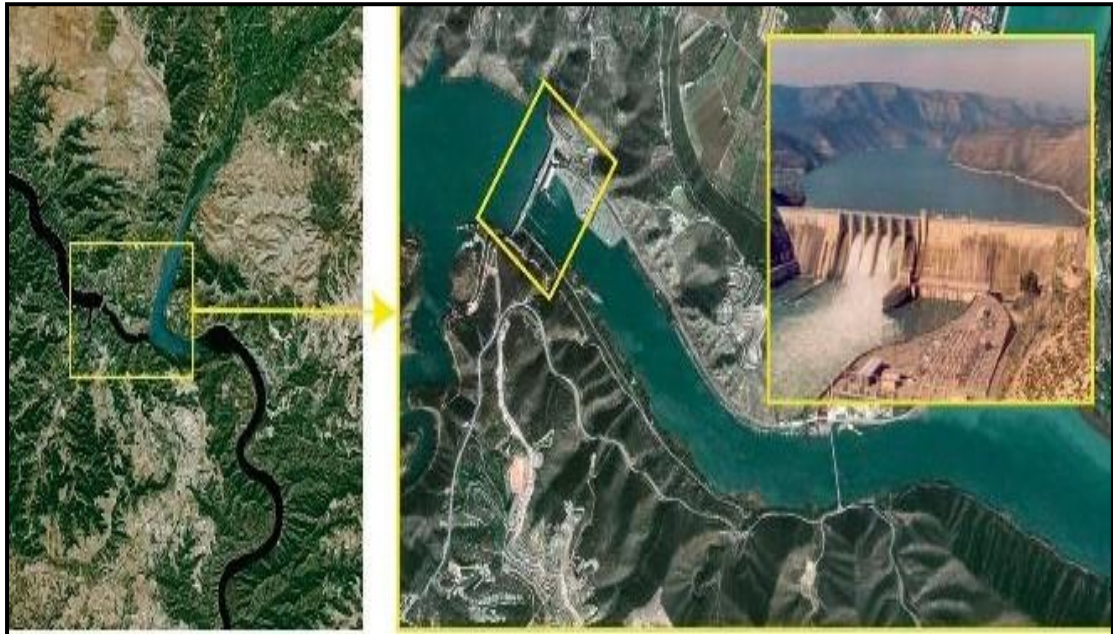
Figure 13: Left: Location of Mequinenza dam. Right: Downstream face of the dam.

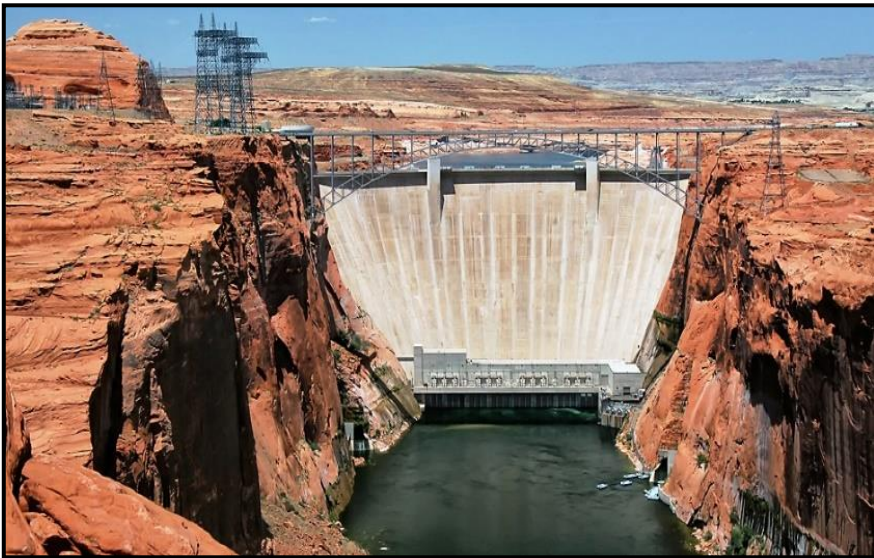
Figure 22: Downstream view of Glen Canyon Dam showing the Power Station and outlets of the two tunnel spillways.

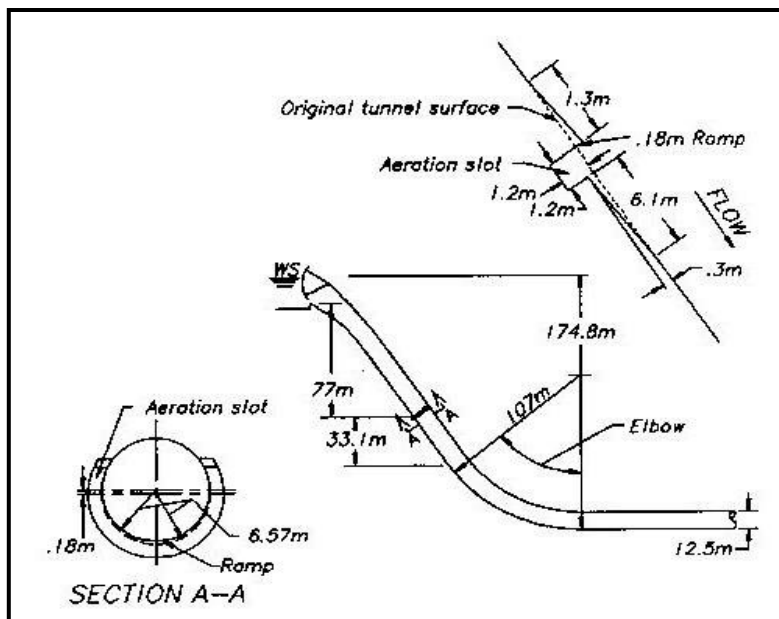
Figure 23: Glen Canyon, tunnel spillways-aerator slots. (Upper Right-hand Corner).

In 1981, an inspection revealed that deposits from cracks in the lining had initiated cavitation damage at several locations in the left spillway. Little damage had occurred in the right hand side spillway which was probably due to the shorter operating time. Following this inspection, surveys and studies were performed to document the damage and to identify the scope of work required for repair and to prevent future occurrence. It was recommended the damage be repaired and aerators be installed near station 6+86.0. These modifications were planned to begin in 1984, but high flows in the Colorado River occurring in the spring of 1983 had to be passed through the spillway.

The decision taken for repair was to construct aerators to inject air in the inclined portions of the spillways to stop future cavitation damage. After thorough study and modelling and design work, the aerators consisted of a ramp, a groove or slot, a downstream offset, and a transition back to the original tunnel diameter as shown on the earlier Figure 23 upper right corner. The ramp is 1295mm long and 180mm high at the centerline of the invert. The ramp feathers out to zero height at the springline. The groove is 1200 x 1200mm. The downstream edge of the slot is offset 305mm from the original tunnel diameter. The length of the transition to the original tunnel diameter is 6.1m. The end of the ramp is at station 6+86.5 which is 96.2m below the maximum reservoir elevation. The tunnels were ready for service after finishing construction on 10 October 1984.

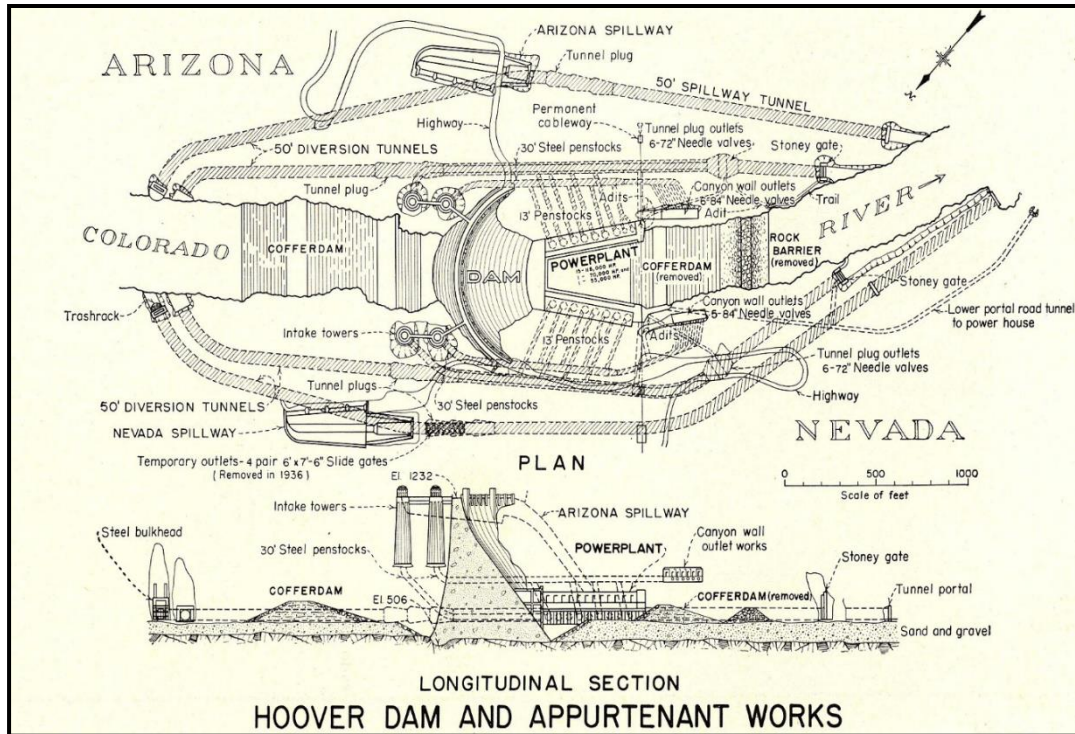
Figure 26: Hoover Dam Plan and Appurtenant Structures.

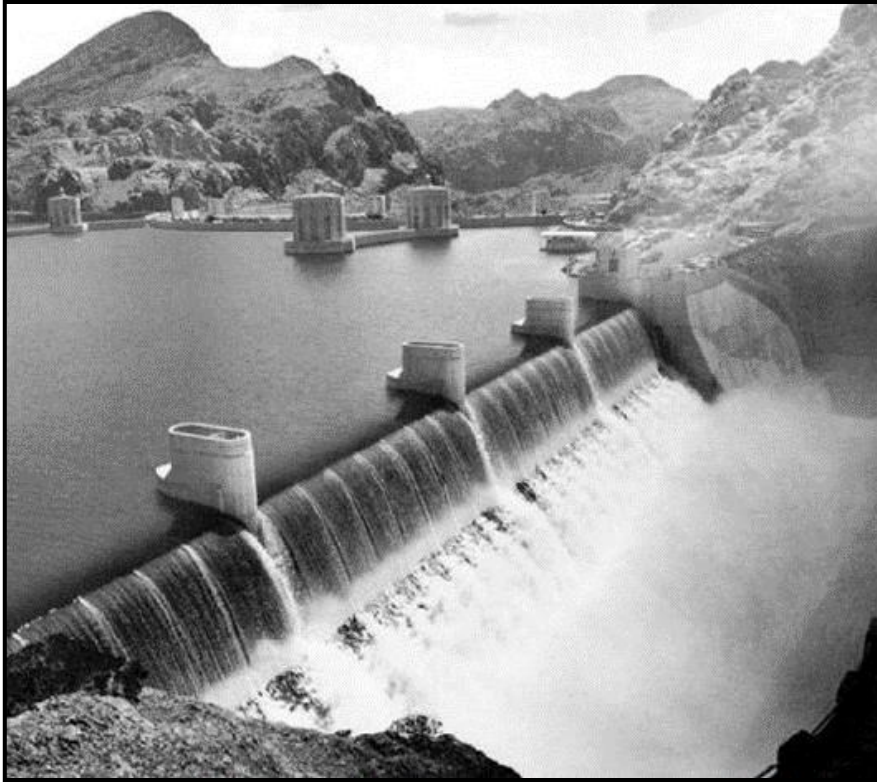
Figure 27: Water from Lake Mead discharging over the four drum gates of the Nevada spillway during spillway tests in August and October 1941.

Relatively modest flows, never exceeding 368 cubic meter per second were passed through both spillways for four months. Even with these modest flows, velocities at the elbows reached 175fps (53.3m/s) and cavitation damage ensued on both spillways. The cavitation was most severe on the Arizona spillway elbow, where a hole 112ft long, 35ft wide, and up to 36ft deep was eroded into the high strength reinforced concrete on this spillway; this is illustrated in Figure 28 [26].
