Field Observations of Water and Ice Problems in Railway Tunnels from a Maintenance Perspective

Anna Andrén¹, Lars-Olof Dahlström² and Erling Nordlund³

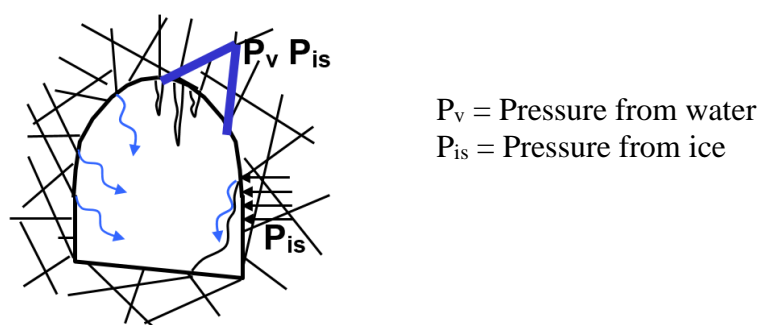
Water can cause problems when the leakage takes place in sections of the tunnel located in the frost zone. The magnitude of the ice problems is dependent on the freezing rate (e.g., Matsuoka, 2001 or Walder and Hallet, 1985), changes in the freezing periods and their duration (French, 1996). If a freezing period has a long duration, or if the freezing rate is rapid, the leaks become frozen. The water freezes and ice formations are created, which act like a plug for the leakage point; it ‘freezes dry’. If instead the leak is subjected to short periods of freezing and thawing, the joint will never become frozen and water will continue to leak, resulting in growing ice formations. Another factor in ice growth is that the leakage water transfers heat from inside the rock mass to the cold tunnel wall. The heat content of the water prevents the rock from freezing despite the freezing tunnel air temperatures. As a result the leak will continue causing ice formations to grow where the water meets the cold tunnel air. Ice developing in joints and cracks can exert a pressure on the joint or crack surface (P_{is}), which leads to frost shattering of rock and shotcrete (Figure 3).

Figure 3: Ice loads (P_{is}) arising when leakage occurs in the frost zone (Andrén, 2004).

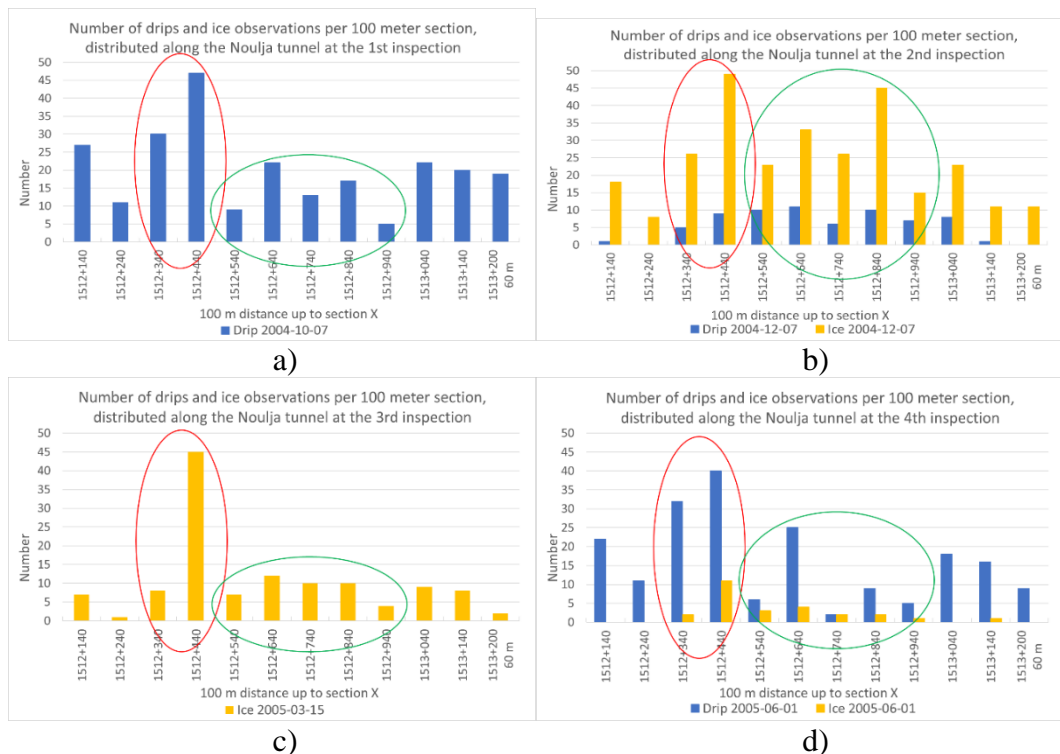
In the first inspection on 7 October 2004, the tunnel was very wet. The temperature had been above freezing and there had been a lot of precipitation in the area the month before the inspection (Figure 8). There were many damp and wet areas in the roof and on the walls of the tunnel. Drips from the roof and walls occurred along the entire tunnel, with an increased concentration between chainage km 1512+300 to 420 (red ellipse in Figure 9a). The green ellipse in Figure 9a shows an area that had only a slight leakage of water in the first inspection. In the second inspection, many ice observations were made (compare the green ellipses in Figure 9a and b). In the second inspection on 7 December 2004, the temperature had been just below freezing (Figure 8). The freezing rate had been slow, which had caused the leakage to continue at the same time as the temperature had been low enough for ice to form. Many icicles and ice layers were observed, and large ice pillars had formed at the leakage points in the walls (Figure 10).

Most observations were made at the same location as in the first inspection, between chainage km 1512+300 to 420 (red ellipse in Figure 9b), but also between chainage km 1512+500 to 900, which had an increased concentration of ice formations. These ice formations had been formed despite the fact that, in the first inspection, there were not so many drip observations or as much moisture in this area (compare the green ellipses in Figure 9b and a). Some leakage from the roof and walls remained in the inner parts of the tunnel, despite the cold temperature outside the tunnel. According to the maintenance worker present, the beginning of the winter had been unusually mild and problems with icicles and ice layers had been relatively minor.

The most severe problems often occur at the entrances, where many icicles grow when the cold period starts around the beginning of November. These problems decrease when the leakage points at the entrances 'freeze dry'. Compare the numbers of ice observations in the outer parts of the tunnel to the inner parts during the inspection in December (Figure 9b).

In the third inspection on 15 March 2005, the temperature had been below freezing for a long time (Figure 8). All drips had stopped and there were no moist surfaces along the tunnel. The concentration of ice formations between chainage km 1512+300 to 420 was similar to that in the previous inspection (red ellipse in Figure 9c). Ice formations had grown in several sections and become more extensive (Figure 12). In total, the number of ice observations had decreased from the second inspection, especially the concentration between chainage km 1512+500 to 900 (compare green ellipse in Figure 9c and b). Since the second inspection, ice had been removed during maintenance work and no new ice growth had taken place during that time.

In the fourth inspection on 1 June 2005, the temperature had been above freezing for a long time (Figure 8). There were still a few ice formations that had not yet melted. The tunnel was once again exposed to many drips, as well as moist areas on the walls and roof. The concentration of drips was again between chainage km 1512+300 to 440 (red ellipse in Figure 9d). Between chainage km 1512+500 to 900 (green ellipse in Figure 9d) only a few areas of dripping water were observed.

Figure 9: Number of drips and ice observations per 100 m section for the Noulja tunnel, 2004/2005.

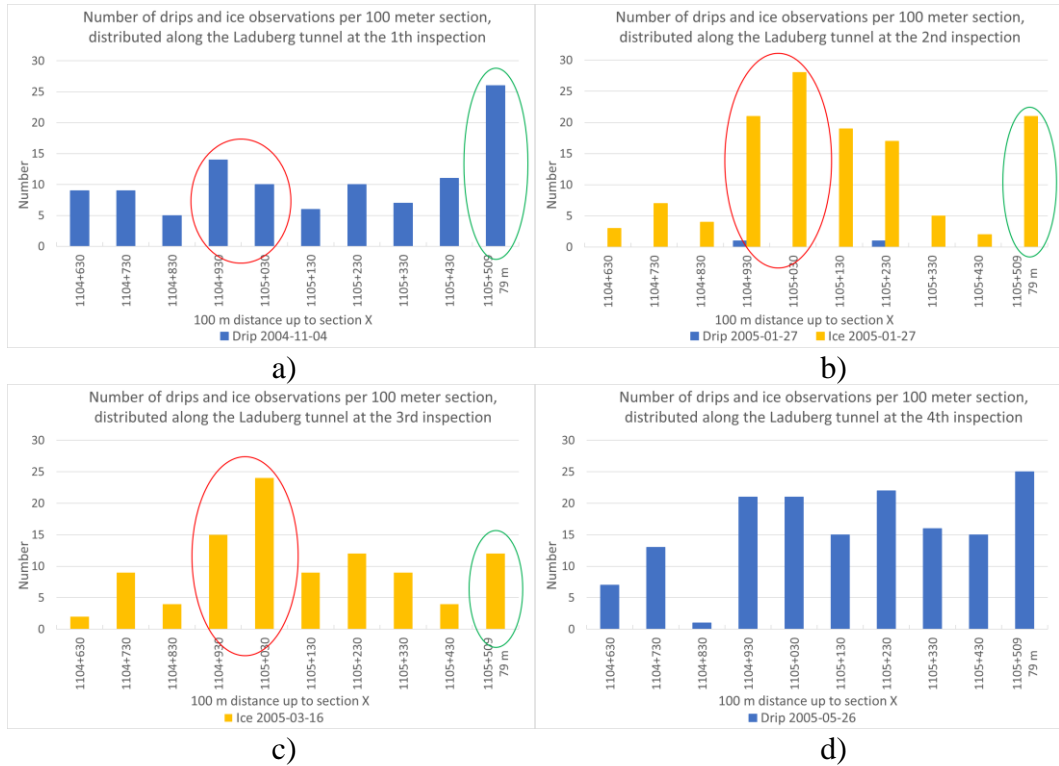
In the second inspection on 17 January 2005, the outside temperature had been negative for a long time, but the temperature had fluctuated between -20°C and $+3^{\circ}\text{C}$. The tunnel was relatively dry but a few leaks in the inner part of the tunnel were still active. The temperature changes might have caused many ice formations in the tunnel (Figure 14). Icicles, ice pillars and ice layers occurred in large parts of the tunnel. Most ice observations were made in the inner parts of the tunnel at chainage km 1104+870 to km 1105+030 (red ellipse in Figure 15b). A large number of ice observations were also made between chainage km 1105+450 to 509 (green ellipse in Figure 15b).

In the third inspection on 16 March 2005, the temperature had been between -5 to -25°C for a long time (Figure 14). All the drips had stopped and there were no damp or wet surfaces along the tunnel. The ice formations were found in almost all the same places as during the second inspection, but slightly fewer in number and even smaller in volume (compare green ellipses in Figure 15c and b).

In the fourth inspection on 26 May 2005, the temperature had been positive for a long time (Figure 14). All the ice had melted, and the tunnel walls were again very wet. There were some drips from the roof, but otherwise the roof was relatively dry. The number of drip observations had increased in almost every section along the tunnel compared to the first inspection (compare Figure 15d and a).

Figure 15: Number of drips and ice observations per 100 m section for the Laduberg tunnel, 2004-2005.

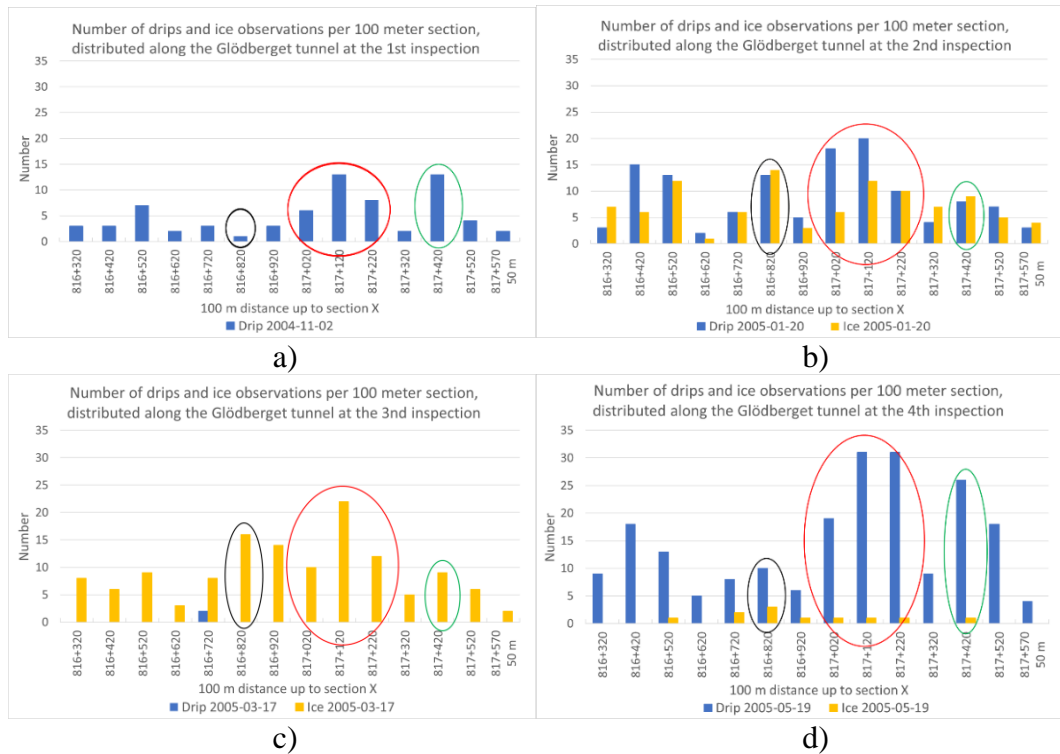
the third inspection on 17 March 2005. The surface of the tunnel was dry and only one leak was still active, a known problem at chainage km 816+665. A large ice pillar was applying load to a cable in the left shoulder (Figure 21, date 2005-03-17). Incidentally, there were many large ice pillars along the walls and large areas of ice layers on the ballast and tracks. Ice formations were found in approximately the same places as in the second inspection (Figure 18c). In the section around the black ellipse, many ice formations had formed, while at the green ellipse, fewer ice formations had formed than might have been expected taking into account the number of drip observations in the first inspection (compare Figure 18a and c). After the third inspection, the temperature was above freezing almost all the time until the fourth inspection on 19 May 2005 (Figure 17). In that inspection, the tunnel had thawed and was very moist. A few ice formations were observed in the tunnel. These examples were from sections where the ice pillars had been very large and had not had time to melt down. Otherwise, the ice had melted away and the tunnel was very moist. The number of drip observations had increased significantly compared to the first inspection, see especially the red and green ellipses in Figure 18a and d. In the section around the black ellipse, the wall was completely wet and there were drips of water from the roof. This was completely different from the conditions observed in the first inspection as, at that time, that section did not have much moisture or many drips.

Figure 18: Number of drips and ice observations per 100 m section for the Glödborget tunnel, 2004/2005.

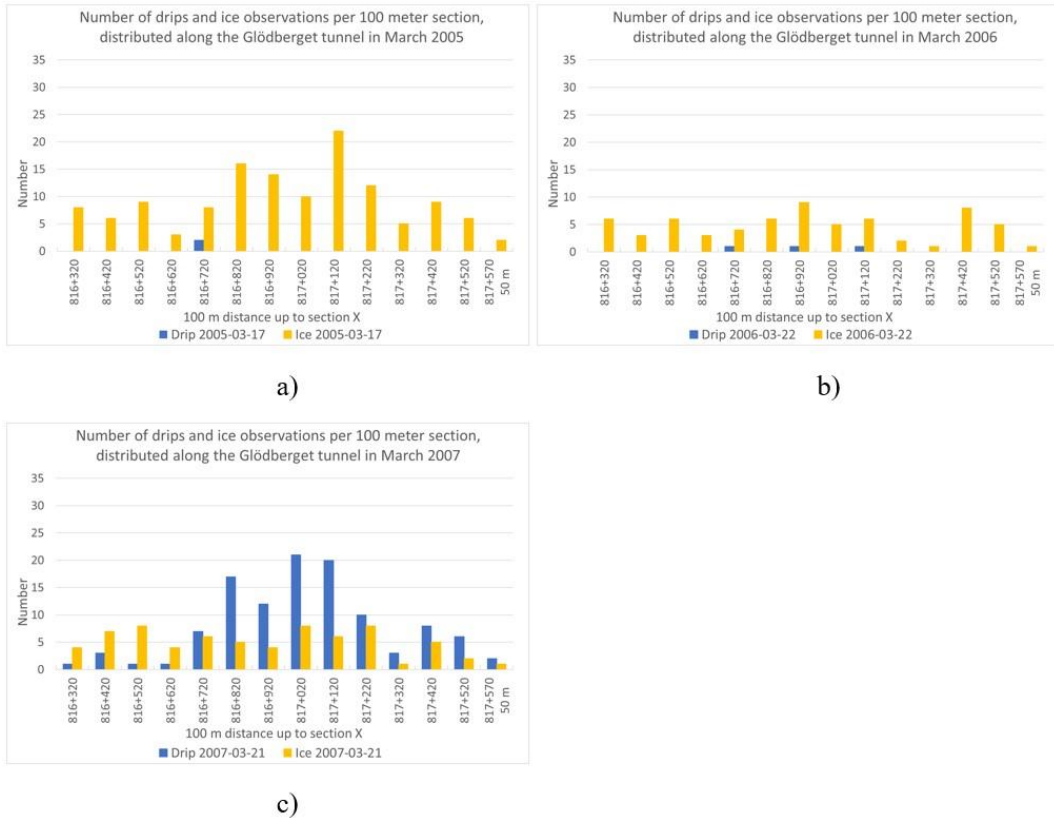
Figure 24 shows the number of drips and ice observations along the Gl dberget tunnel in March during the three years 2005, 2006 and 2007. The number of drip observations during the 2007 inspection was significantly more than during the previous two inspections, which probably reflects the temperature conditions before each inspection. Differences in the number of ice observations, and also the extent of the ice formations, can be explained by the fact that in 2004/2005 the beginning of winter was relatively mild and there were many temperature fluctuations around 0 C (Figure 23). The tunnel air was too warm to freeze the rock surface around the source of the leak, but cold enough to produce ice formations when the water reached the cooled tunnel wall or ballast surface. In 2006, the temperature fluctuations around 0 C were significantly fewer, and the temperature was relatively low for longer periods (Figure 23). This caused the leakage points to freeze, which led to fewer ice formations (compare yellow bars in Figure 24a and b). In 2007, the temperature fluctuated around 0 C until the beginning of January, when the temperature dropped rapidly, and a longer period of freezing temperatures started (Figure 23). The tunnel probably froze quickly, which led to fewer ice formations and the ice pillars were not so extensive (Figure 24c).

Figure 24: Number of drips and ice observations per 100 m section in the Glödsberget tunnel, March 2005, 2006 and 2007.

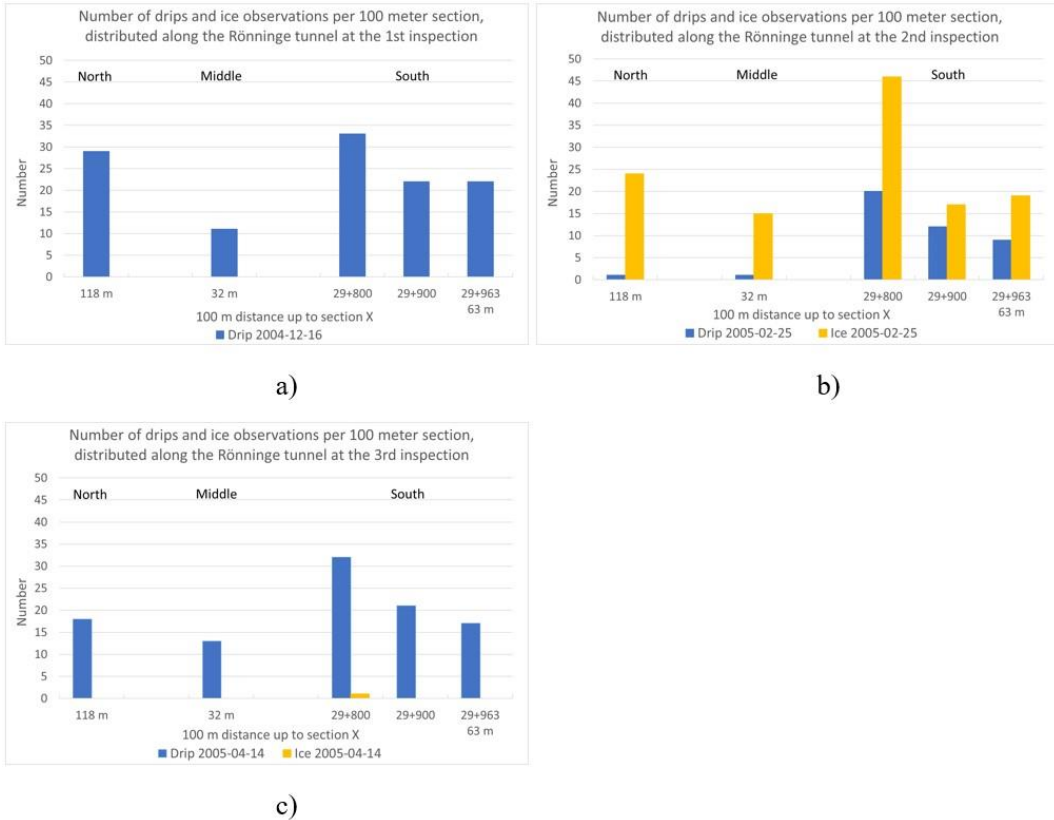
In the first inspection on 16 December 2004, the temperature had been below freezing. However, in the days before the inspection, the temperature had risen above 0°C. There had not been much rainfall (Figure 27). The tunnels had moist surfaces, often where the rock mass and the concrete arches connected. There were several leakage points from the roof. In some places, attempts had been made to direct the water away from the roof with steel plates lying on beams between the concrete arches (Figure 26). These were rusty and broken, resulting in leaks on to the track area. For the north and south tunnel, the concentration of drips and moist surfaces was at the northern entrance (Figure 29a).

entrance of the south tunnel, where there were leakage points along the entire roof and walls. Many icicles had formed here, as well as a large layer of ice on the track area (Figure 28). The concentration of ice formations matched closely the areas that had the most drip observations in the first inspection, compare Figure 29a and b.

At the time of the third inspection on 14 April 2005, all the ice had melted in the two shorter tunnels, while in the southern tunnel there was still one ice formation. All tunnels were again moist with concentrations of water in the same places as in the first inspection, but to a somewhat lesser extent than before. According to the maintenance worker present, it had not rained for several days, which resulted in the tunnel not being as wet as it usually was (Figure 27). When comparing Figure 29a and c, the leakage in the northern entrance of the south tunnel is similar to the conditions that were observed in the first inspection.

Figure 29: Number of drips and ice observations per 100 m section for the Rönninge tunnels, 2004/2005.

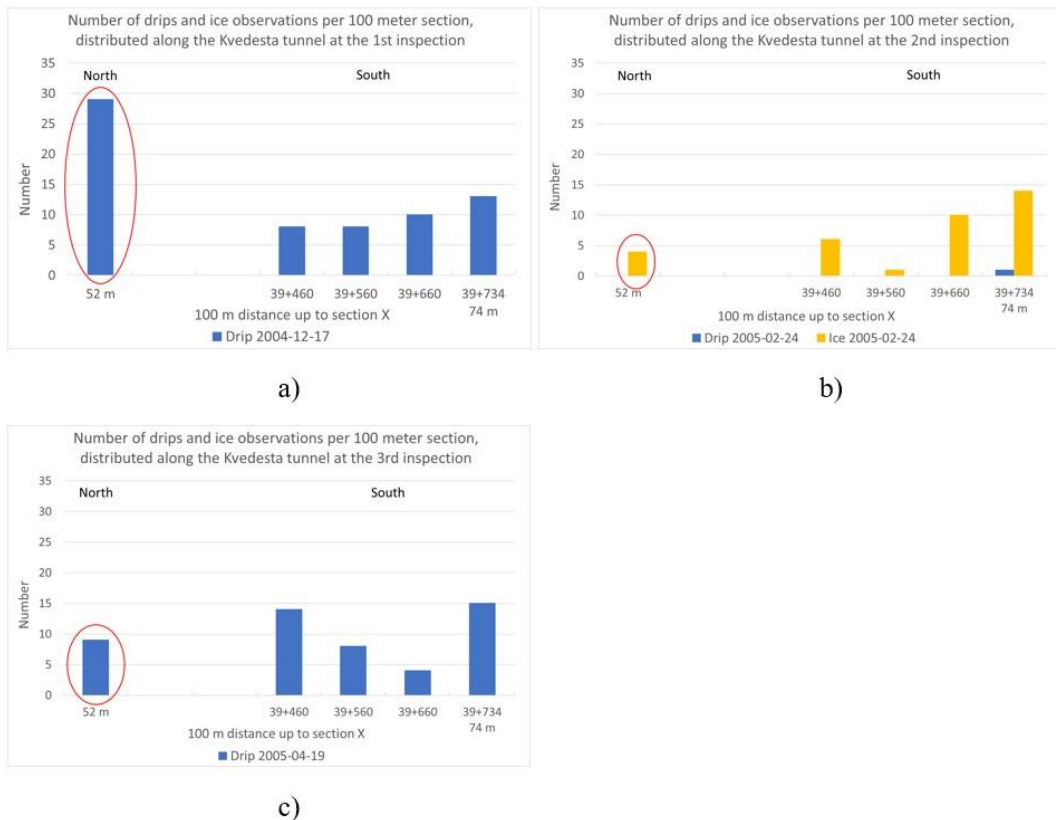
Between the first and the second inspections, the temperature had fluctuated around 0°C (Figure 33). Under these temperature conditions, maintenance inspections must take place every night to remove icicles and ice layers on the tracks. In the second inspection on 24 February 2005, only one leak was still active in the southern tunnel. In the northern tunnel, only four ice formations were observed, despite the fact that this tunnel had many leakage points during the first inspection (compare red ellipse in Figure 34a and b). In the southern tunnel, some ice formations were observed and they occurred, as the leakage points in December, near both the northern and southern entrances.

Before the third inspection on 19 April 2005, the temperature had been over 0°C and there was no ice left in the tunnels at the time of inspection. In the northern tunnel, there were leakage points in the roof and on the walls, but not to the same extent as in the first inspection (compare red ellipse in Figure 34a and c). In the southern tunnel, the concentration of leakage points was similar to the first inspection, near both the northern and southern entrances (compare the South tunnel in Figure 34a and c).

Figure 34: Number of drips and ice observations per 100 m section for the Kvedesta tunnels, 2004/2005.
