## **Dam Safety and Overtopping**

### **Abstract**

Overtopping is one of the most serious modes of failures for all dams causing great numbers of human fatalities and material damages. Statistics show that overtopping failures are the highest, especially for embankment dams. The main reason for this is the erroneous prediction of the inflow design discharge, which has resulted from lack of realistic flow data and imperfect hydrological procedures. Failure in most cases occurs when the inflow exceeds the spillway design capacity, but to a lesser extent from the buildup of very high wave setup and runs up. This has led to active efforts in upgrading dams for such occurrences, by either upgrading spillways, adding auxiliary spillways, increasing freeboard by either heightening the dams or the parapet walls on the crest. Advancement in predicting the safe inflow discharges are also made by adopting such procedures as the calculation of the Probable maximum flood based on predicting the Maximum Probable Precipitation or using statistical methods by treating long records of available flow data. Recently, another challenge has come up facing dam owners and builders who are represented b

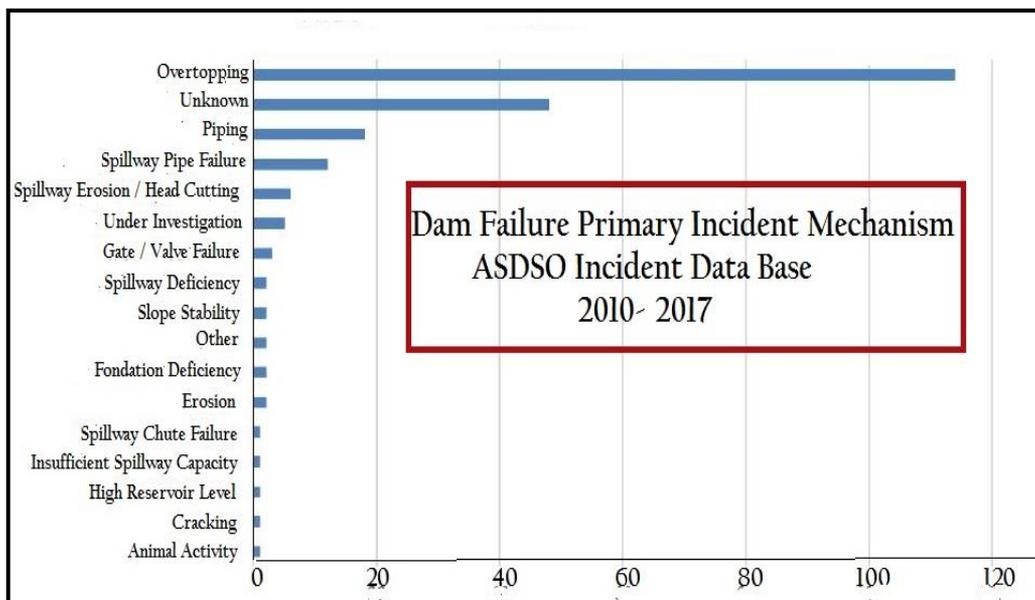
**Figure 1: Overtopping vs. other Failure Mechanism (ASDSO), USA [1].**

Overtopping of a concrete, masonry or an embankment dam is the flow of water over their crest leading in the majority of cases to failure. In many events, during the long world history of dams; overtopping has been one of the major modes of failure. Most failures were caused by floods, which had exceeded the spillway capacity as a result of insufficient knowledge of the hydrological conditions of the region leading to incorrect assessment of the proper inflow design discharge. Many other overtopping failures, however, have resulted from a variety of reasons; such as failures of gates to operate properly as a result of total or partial jamming due to mechanical or electrical problems or operational errors on the part of the operators, jamming of the outlet structures by excessive quantities of floating debris reducing the discharge capacity of the outlet, landslide in the upstream reservoirs (artificial or natural) causing a surge wave over the dam crest. Excessive settlement and loss of freeboard after earthquakes have contributed in some cases to overtopping failures while in some other events the action of very strong waves resulting from violent storms caused overtopping failures due to abrasive process causing the failure of insufficiently lined upstream faces of dams. Moreover, human failings may have been behind some failures due to not observing the rule curves and operation instruction due to insufficient expertise on the part of the operators. According to statistics related to overtopping failures in the USA which have resulted from inadequate spillway design, debris blockage of spillways, or settlement of the dam crest account for approximately 34% of all U.S.A. dam failures, while the Association of Dam Safety Officials (ASDSO) data base shows that failure cases due to overtopping in the USA for the period 2010- 2017 exceeded by far all the other failure mechanisms, as shown in Figure 1.

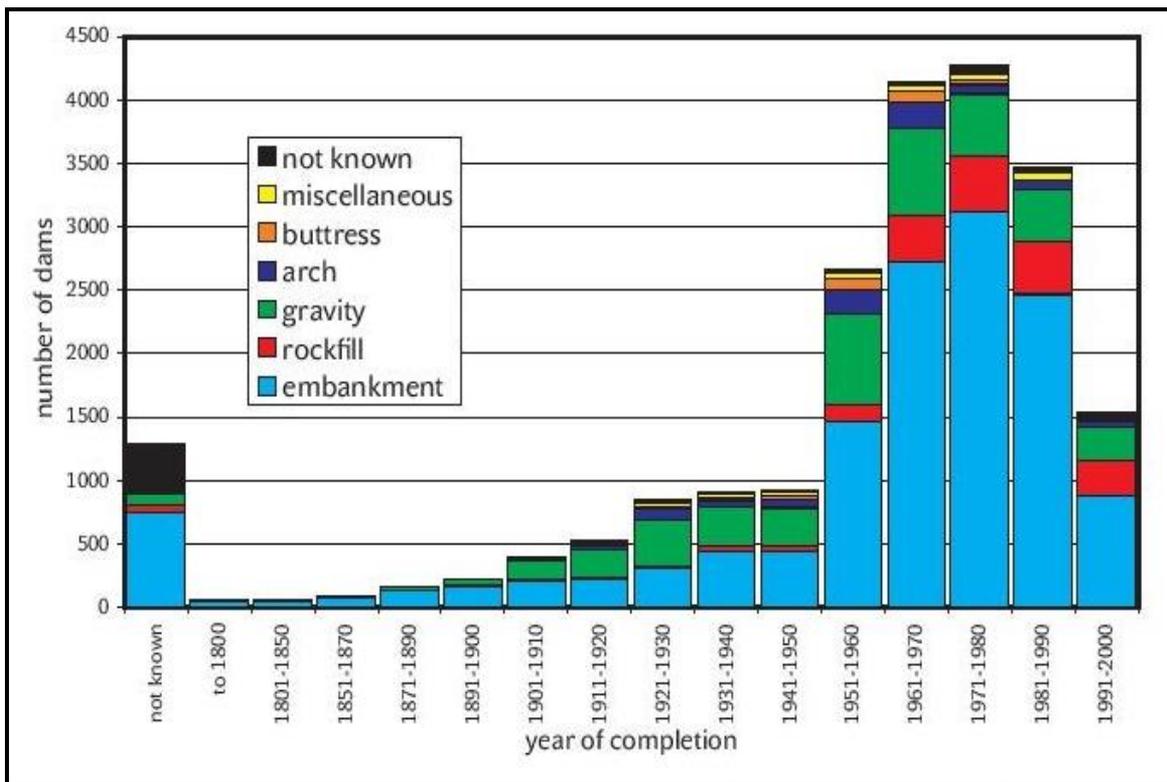
**Figure 2 : Number of dams constructed in the world by decades and with reference to dam type, according to the World Dam Register (ICOLD) (not including dams in China and Russia) [2].**

The high rate of fatalities due to hydrological reasons reflects that, even with improved hydrological methods and measurements, failures have continued to happen as a direct result of the high growth rate in dam construction and the sharp increase in their number during the last decades of the last century. To illustrate this point, Figure 2 gives the number of dams constructed in the world (by decades) up to the year 2000 according to their type, and Figure 3 indicates the number of dams constructed per given decade up to the year 2000 depending on dam height (hd). The source of these data is World Dam Register (ICOLD); in both cases not including dam failures in China and Russia [2].

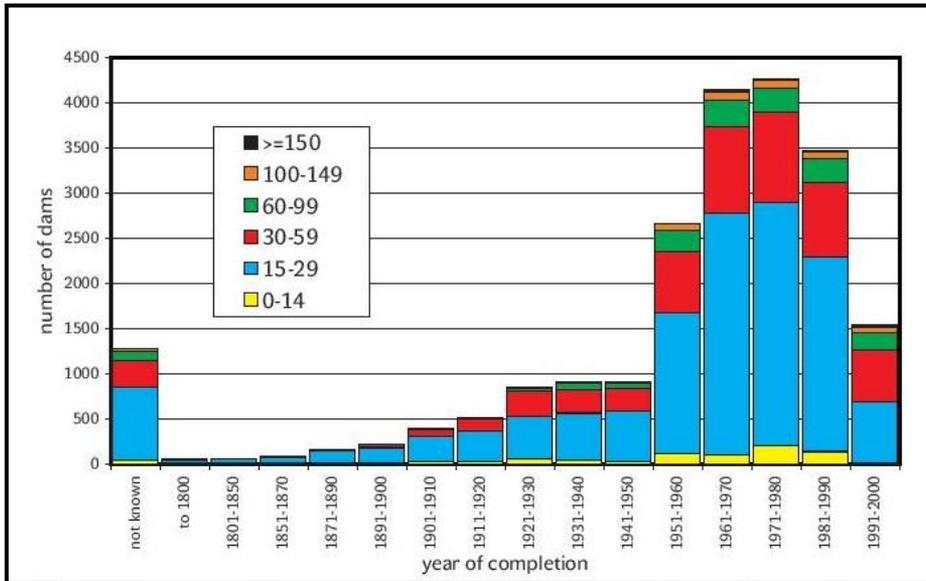
**Figure 3: Number of dams constructed per given decade depending on dam height hd, according to World Dam Register (ICOLD) (not including dams in China and Russia) [2].**

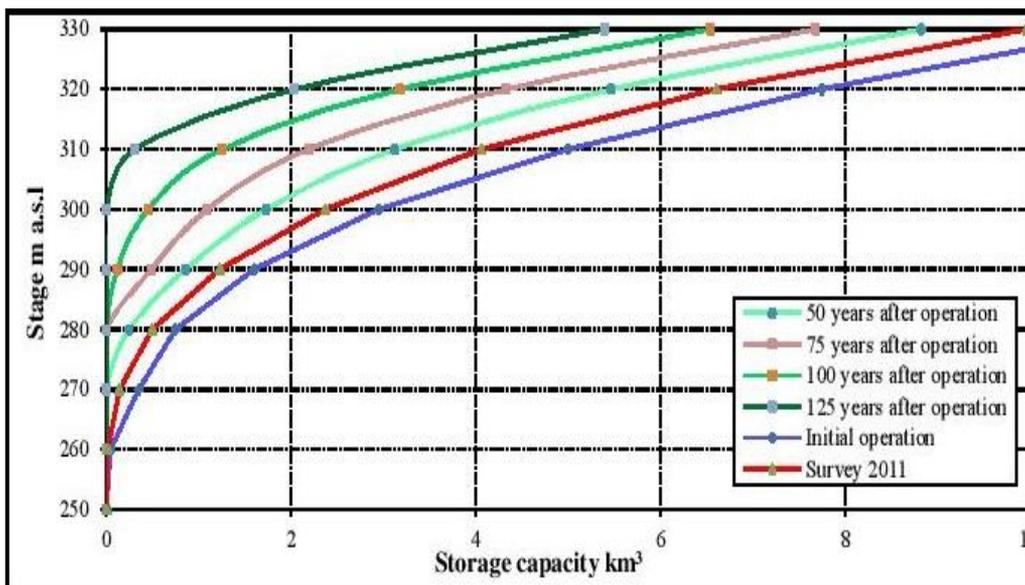
**Figure 4: Storage- Discharge curve variation with time of Mosul Dam Reservoir.**

- or increase the height of the dam. In some cases, a combination of one or more of these solutions may prove more practical and cost effective.
- b. Change of hydraulic conditions during the reservoir life time can have pronounced impact on the operation of the spillway leading to danger of overtopping by reducing the discharge capacity of the spillway from the previously calculated design discharge. Spillway discharge curves used in passing the floods during operation are often based on idealized discharge curves obtained from hydraulic modeling, and so it may be advisable; therefore, to check these curves immediately after commissioning and more than once during operation of the dam. Another factor which has its impact on the routing of floods is the possible changes that occurred in the flow conditions of approach due to natural or artificial changes throughout the life of the dam. New conditions which can arise that are less than the ideal assumed ones during design that may reduce the discharge of the spillway from what was originally stipulated. Moreover, sedimentation of the reservoir normally alters the stage-volume curve used in the flood routing equations to arrive at the size of the reservoir and the corresponding spillway design discharge during the design stage. These again warrants the revision and alteration of the operation rules for higher safety of operation. A good example of such change is illustrated in Figure 4 which shows the stage-volume curve of Mosul dam reservoir in 2011 after 25 years of operation (in red) as compared to the original curve (in blue). The red curve was obtained by an actual bathymetric survey, and it shows a considerable change. More expected changes are calculated for future periods (50yr, 75yr, 100yr and 125 yr) as shown in the other curves [4].

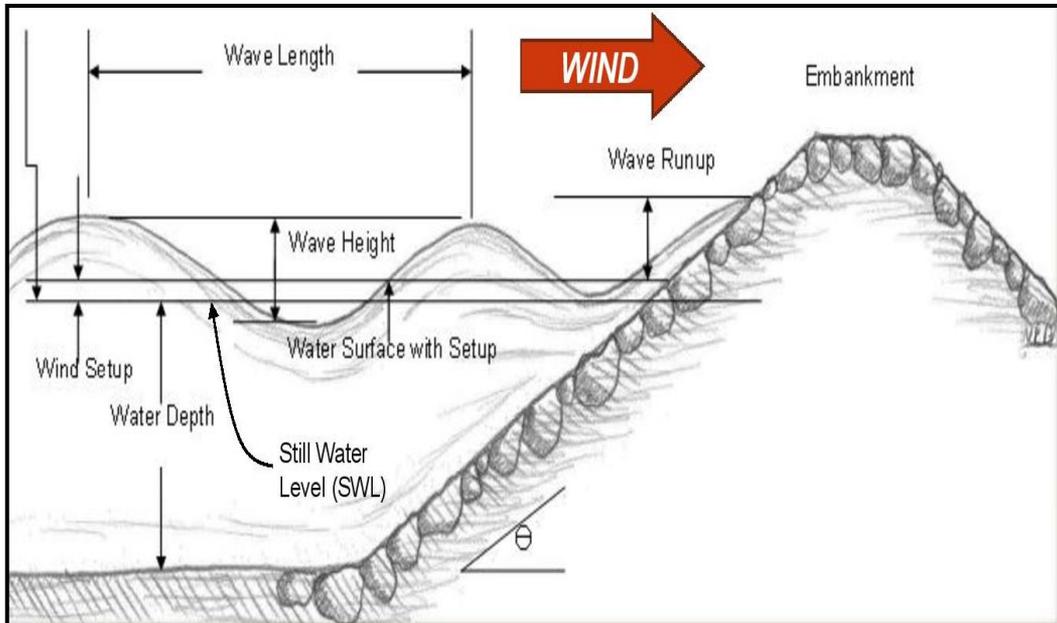
**Figure 5: Definition of terms for wind action [6].**

- f. It is interesting to note that overtopping can happen also from the combination of the still water level (SWL) and wind setup exceeding the crest of the dam. For over-wash, wind setup and wave run-up intermittently may combine to produce water level exceeding the crest of the dam. Typically, however, a significant surface area upstream (fetch) is required to allow wind to develop waves that would be directed towards the embankment and overtop it, Figure 5, [7].

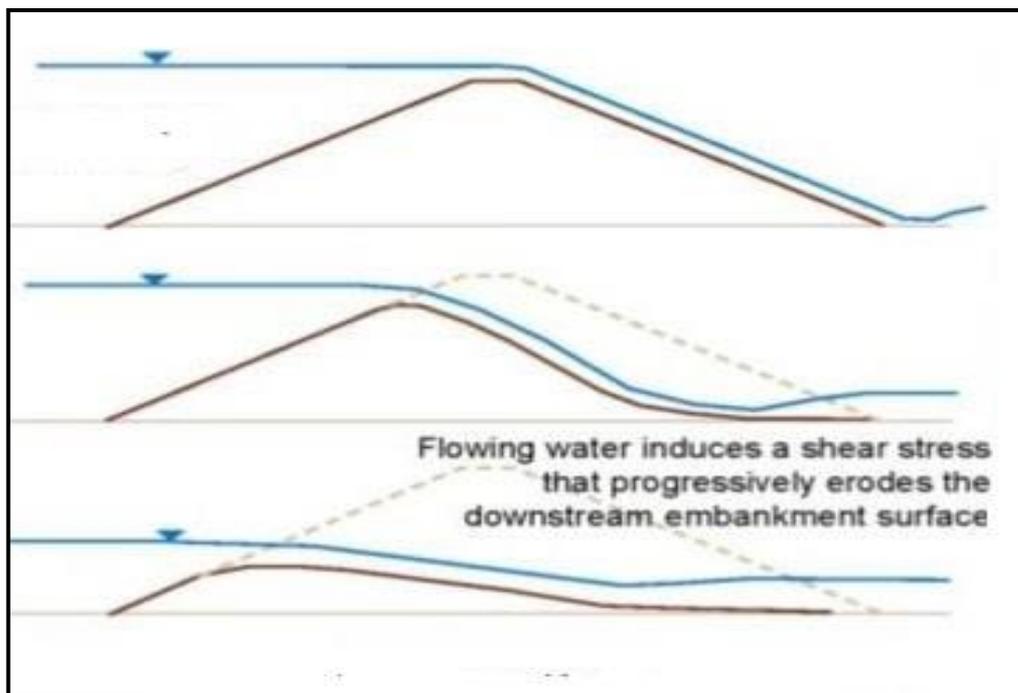
**Figure 6: Stages of failure of earth fill dam due to overtopping. (Cohesionless material) [7].**

The development of this process is initiated by a flood which causes the reservoir level to rise above the crest, then the slope protection is removed after reaching its critical shear stress and therefore, erosion of the body of the dam itself would begin by the erosion of the embankment. First along the top of the downstream slope of a cohesionless embankment, or at the downstream end of the crest of a cohesive embankment and headcut forms, as soil particles continue to be washed the headcut advances to the upstream end of the crest (and can deepen and widen at the same time) and eventually the embankment crest is lowered, and breach occurs leading to washing away the dam, refer Figure 6 and Figure 7 [7].

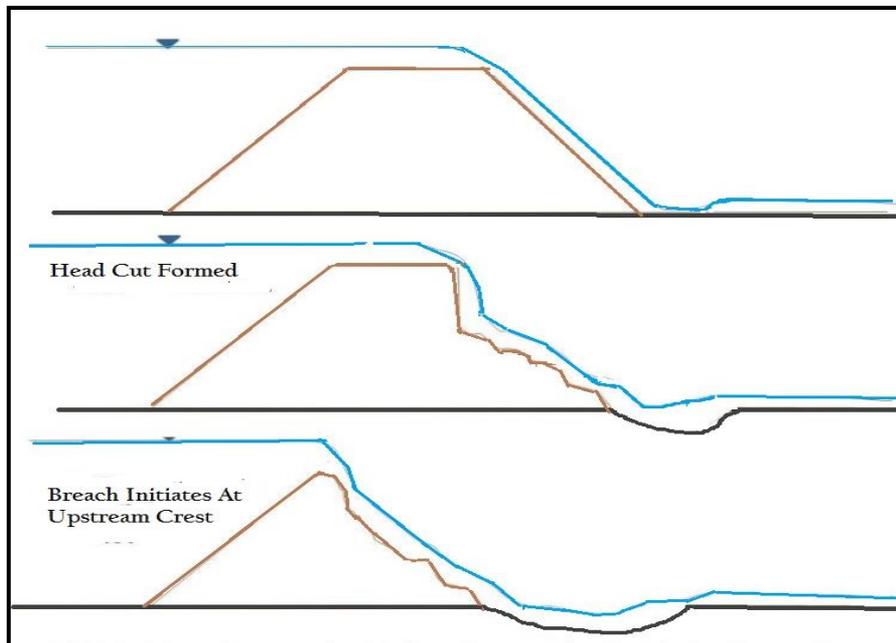
**Figure7: Stages of failure of earth fill dam due to overtopping. (Cohesive material) [IV2].**

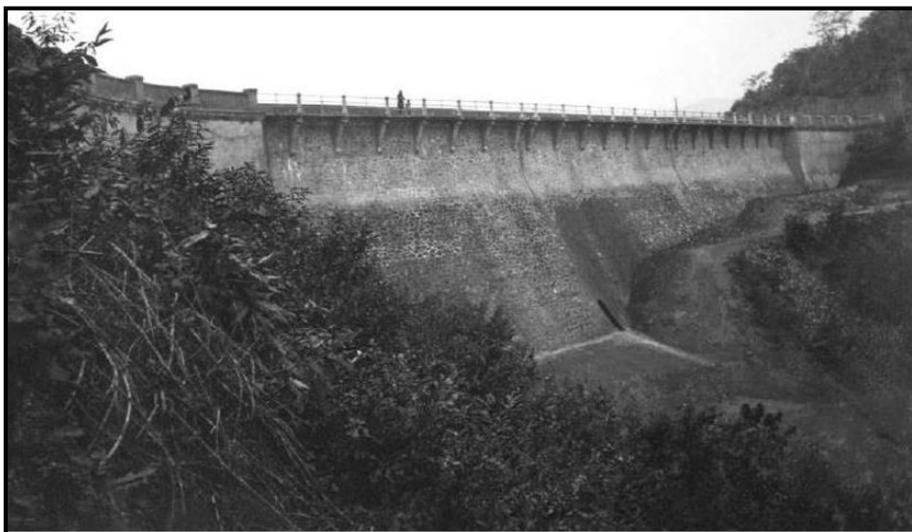
**Figure 8: Downstream face of Sella Zerbino secondary dam**

On the continent, similar failures did occur, one example was the Sella Zerbino secondary dam on the Orba River in Italy. This dam was completed in 1935, and it was a straight concrete gravity dam which had a height of 46 feet and a crest length of 360 feet, Figure 8. This dam was a secondary saddle dam which together with the Bric Zerbino main dam formed the Orteglieto reservoir with a total storage of 14,600 acre- ft (18 million m<sup>3</sup>). Depending on the discharge capacity of the main gated chute spillway and a pressure valved outlet of the main Bric Zerbino Dam no spillway was provided for the Sella Zerbino secondary dam. On the 13<sup>th</sup> of August 1935, the dam failed after several hours of very heavy rain, which had generated inflow discharge of about 100,000 cfs far exceeding the combined outflow discharge capacity of the main dam which was only 31,000 cfs that was based on very limited rainfall data, which may have corresponded to only 20 year discharge.

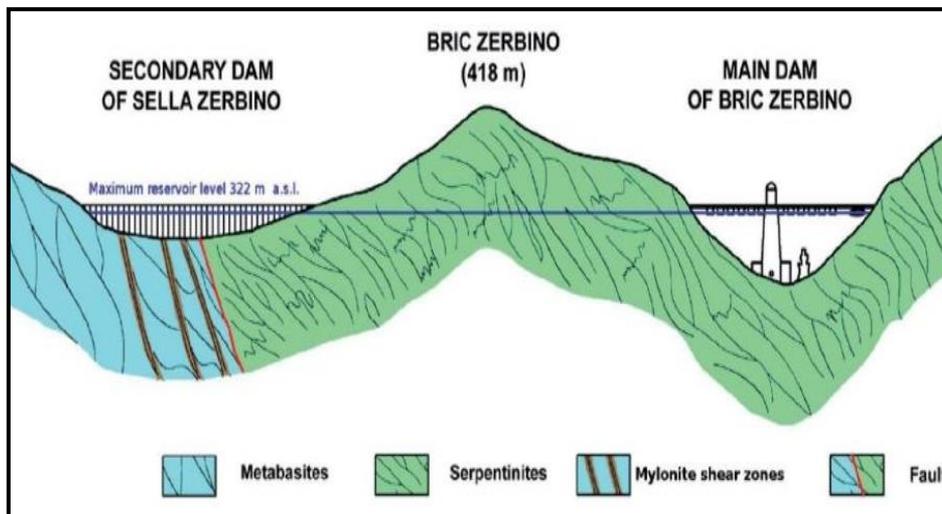
**Figure 9: Geological section developed After the Dam failure.**

The apparent mode of failure was overtopping, resulting in erosion of the rock at the toe of the dam, in turn causing, sliding and overturning failure. As further evidence of the low quality of the geologic formation, little remained of the secondary dam and its foundation after failure, and geologic investigations after the failure indicated that while the main dam was found on compact serpentinites, the secondary dam was found on highly- jointed schistose rock with intense foliation and slaty cleavage, which many experts concluded were inadequate for dam foundation Figure 9.

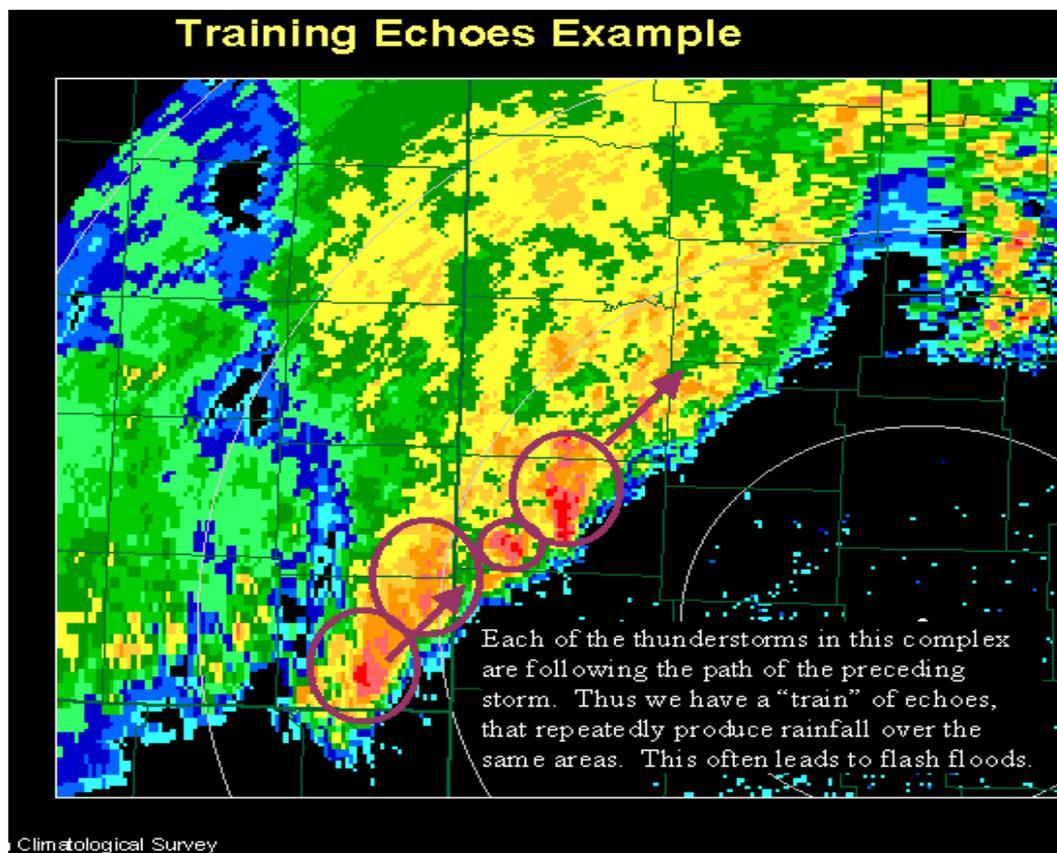
**Figure 10: Example of training echoes of a series of thunderstorms.**

Figure 10 shows radar echoes of a series of thunderstorms following the same path one after the other which can cause flash floods.

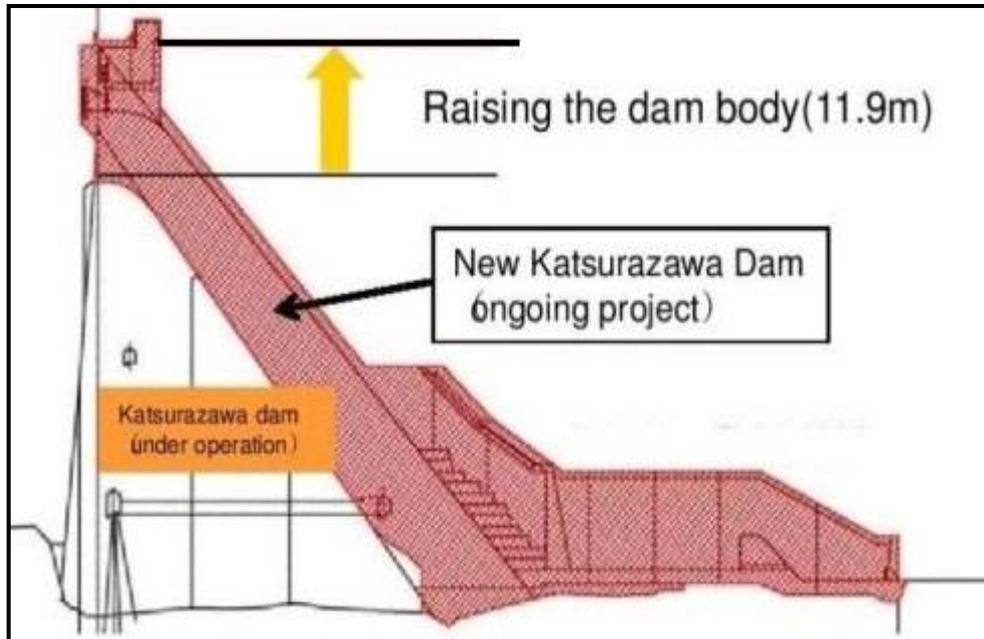
**Figure 11: New Katsurazawa Dam (Major Heightening of Dam) [23].**

Constructed in the upper reaches of the Ikushunbetsu River was completed in 1957. The height of the dam is currently being raised by 11.9m to improve its flood control capacity, irrigation and other functions. It will be reopened as the New Katsurazawa dam. The dam is 63.6m high and 334.3m long concrete gravity dam. Raising the dam crest was under way during 2018, and Figure 11 shows the dam during this stage of construction clearly indicating the extra height being added, while Figure 12 shows the dam after completing the raising operations [23], [24].

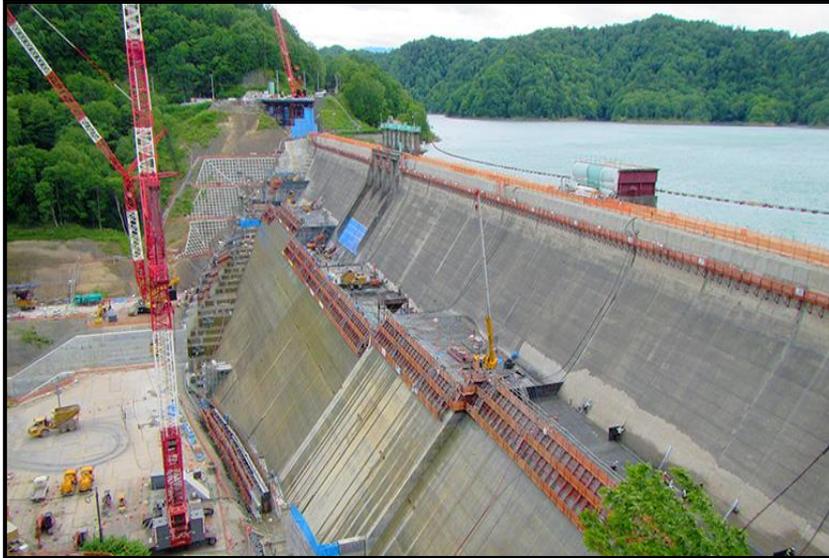
**Figure 12: New Katsurazawa Dam during heightening operation in 2018 [24].**

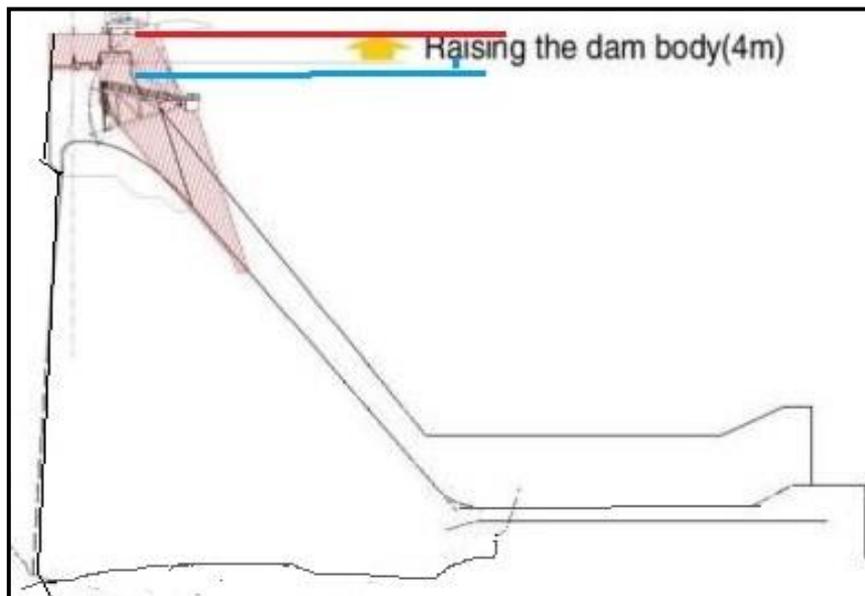
**Figure 13: Kasabori Dam (minor raising) [23].**

On the other hand, is a concrete gravity dam completed in 1964 to serve flood control, fresh water supply and hydroelectric power generation. The height of the dam is 74.5m and has a crest length of 225.5m, and the reservoir's capacity is 15,4 million m<sup>3</sup>. This dam has already been raised by 4m to be 78.5m high to improve its performance and increase its safety, Figure 13 and Figure 14 show this dam after increasing its height [23], [25], [26].

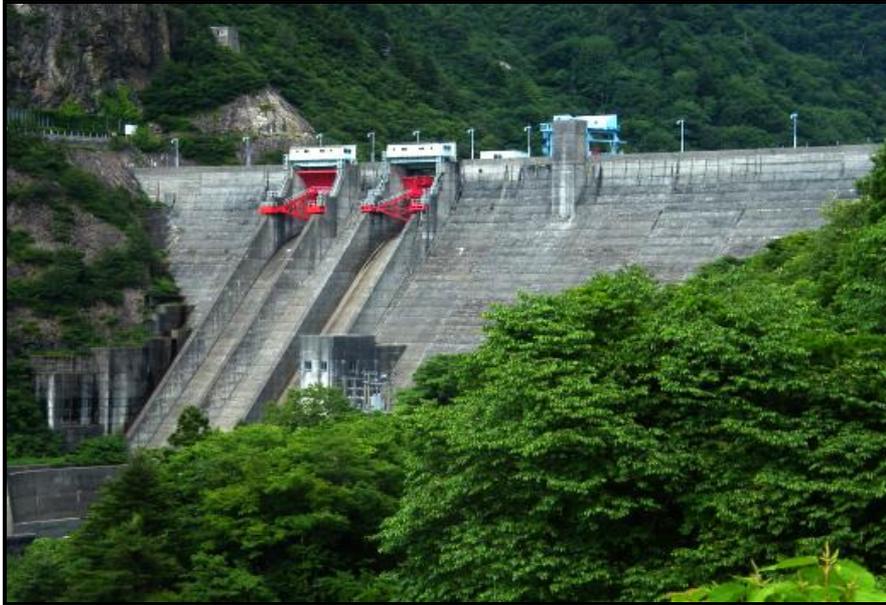
**Figure 14: Kasabori Dam before heightening-[25].**

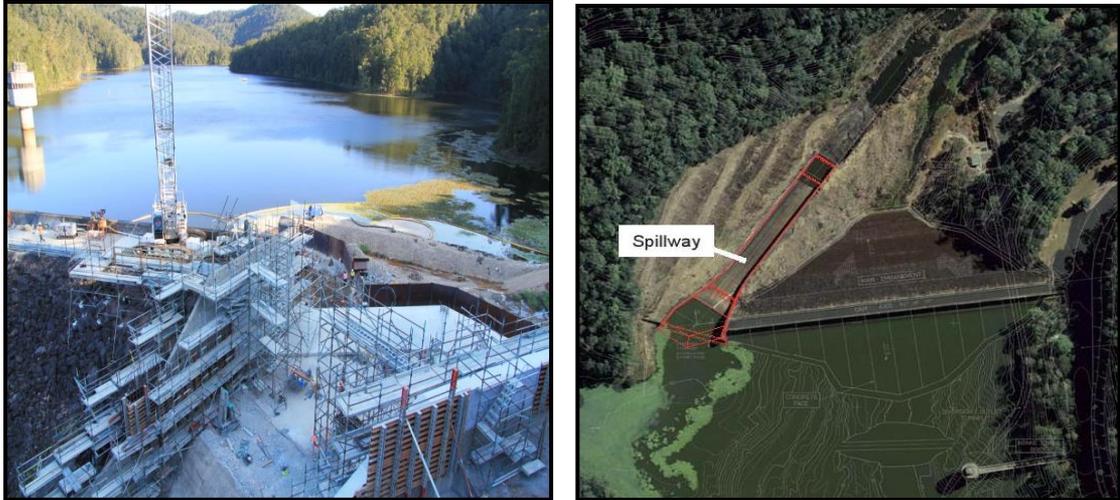
**Figure 15: Clarrie Hall Dam (Left) aerial view showing spillway and embankment; (Right) spillway upgrading work.**

This example is from New South Wales, which is the 45m high Clarrie Hall rockfill dam completed in the early 1980s. This dam was planned and designed in compliance with the engineering standard of the day. Since the dam was constructed, however, the ability to predict rainfall and understand extreme weather patterns have improved. The revision of the dam safety according to the new requirements of the NSW Dam Safety Committee showed that, although the dam's spillway can pass safely floods many times greater than the largest flood on record, it will, however, not be able to do the same in extreme rainfall events, even that the probability of such events may be very small. The upgrading works, which were to be completed in 2018, consisted of widening and extending the entrance of the existing spillway chute, constructing a parapet wall across the dam crest to increase freeboard and prevent water from flowing over the dam in an extreme flood event and enable the water to be released safely through the spillway, refer Figure 15 [27].

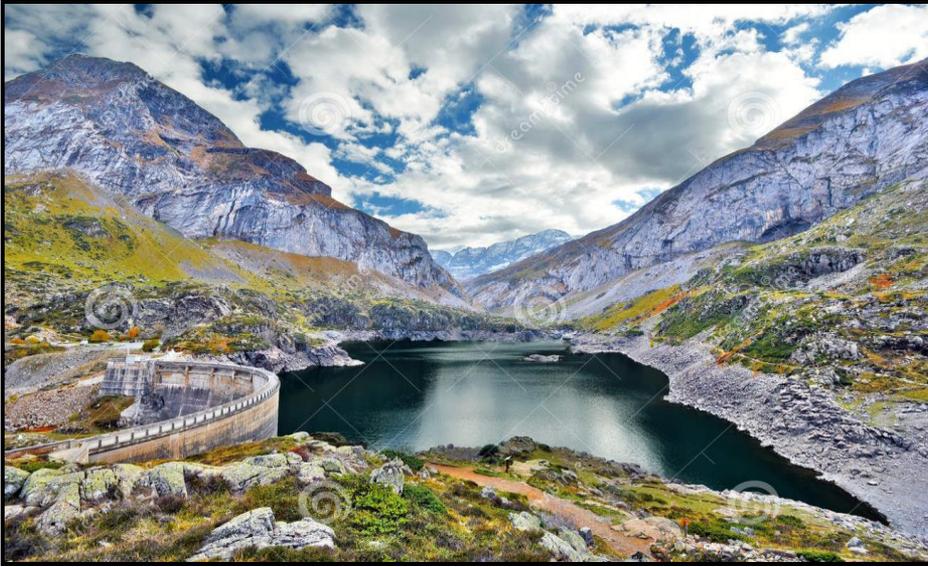
**Figure 16: Gloriettes Dam upstream view.**

This dam was built in the French Pyrenees Mountains, which is 40 m high concrete arch structure, Figure 16 and Figure 17. The dam was completed in 1951 and it had then a flood discharge system consisting of four over-flow sluices on the dam crest at elevation 1667m. Its capacity was  $70\text{m}^3/\text{s}$  at a maximum operating water level at elevation 1667.8m. As hydrological data records increased and new methods for flood discharge estimation were developed it became necessary to increase the spillway capacity to meet the new standards of dam safety with respect to the risks to society. A new design discharge flood with 1000 year return period and peak discharge of  $150\text{m}^3/\text{s}$  was defined. To compensate for the deficit of  $80\text{m}^3/\text{s}$ , a complementary new spillway on the right bank was to be constructed. For this purpose, a labyrinth weir, known as the Piano Key Weir (PKW) was selected. For the design of the chute of this new spillway, a solution was adopted after carrying out hydraulic modeling and it consisted of two stepped reaches and an intermediate stilling basin allowing  $120^\circ$  change of direction in order to accommodate the whole chute in the narrow gorge downstream [28].

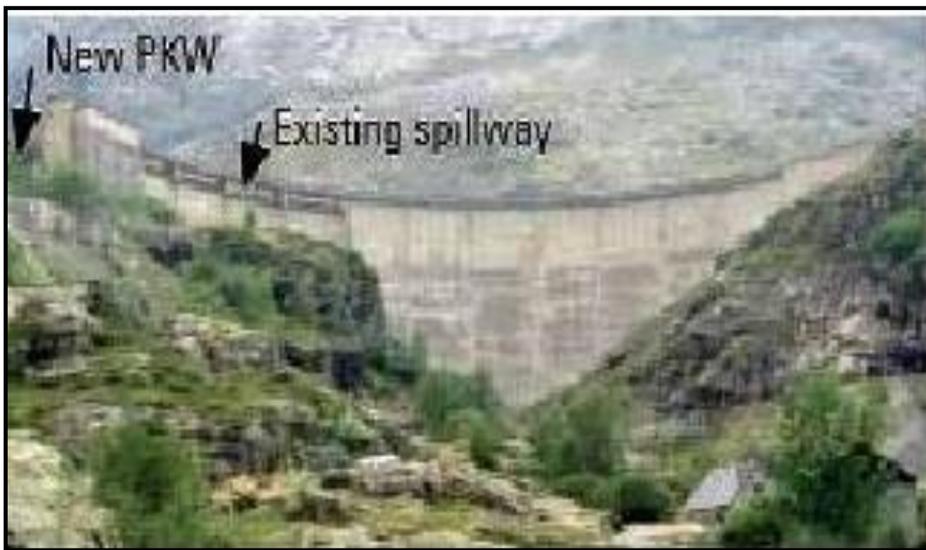
**Figure 17: Gloriettes Dam downstream view showing location of the new Piano Key Weir spillway.**

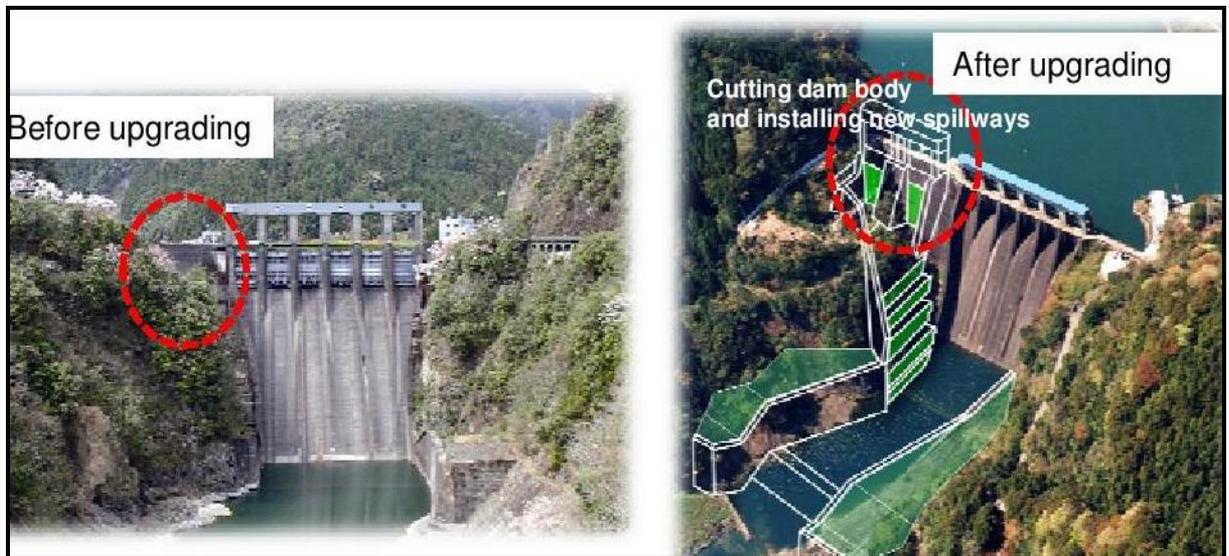
**Figure 18: Nagayasuguchi dam before and after upgrading [23].**

This is a concrete gravity dam which was completed in 1955 to serve power generation and flood control in Tokushima prefect in Japan. The dam has a dam crest of 200m length, height of 85.5m and a reservoir volume of 54,278,000m<sup>3</sup>. The spillway was enlarged to increase its discharge capacity by adding two additional new bays with crest gates, as shown in Figure 18 [23].

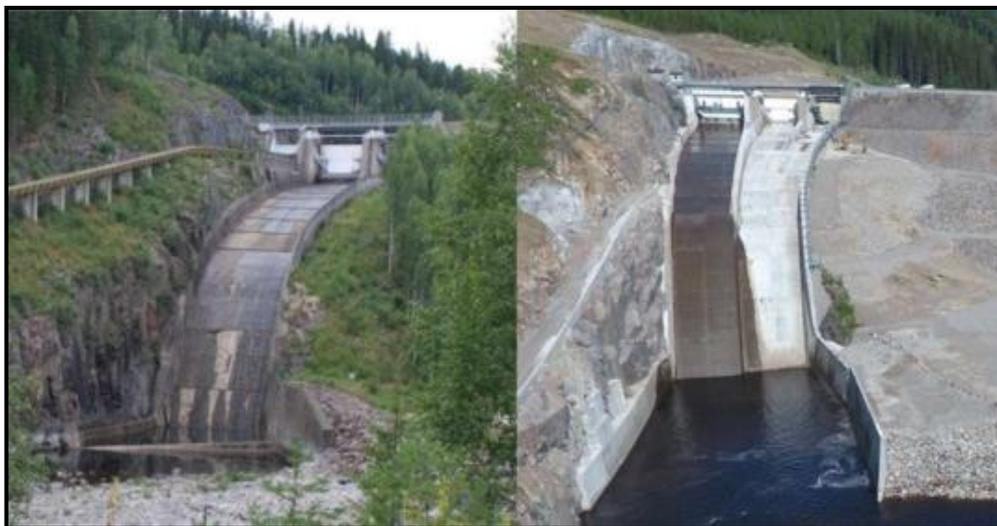
**Figure 19: Höljes dam spillway: (Left) Original layout with two gated openings and a timber flume (Right) After refurbishment, with a 17m new gated opening added adjacent to the existing ones.**

Based on the new flood determination criteria recommended by the revised dam-safety guidelines, many existing dams are found to have higher design floods than constructed for. The recent revision of the flood criteria was made in 2015. Among other dams the Höljes Dam spillway design capacity was increased to accommodate the increased revised discharge. The final solution is a new 17m wide spillway opening with an upward-going radial gate. The abandoned timber flume located to the right of the existing openings was removed to give place to the new gate, the width of the spillway channel downstream was doubled, and the stilling basin was also enlarged. These works were completed in 2016. Figure 19 shows the dam's spillway before and after rehabilitation [29].

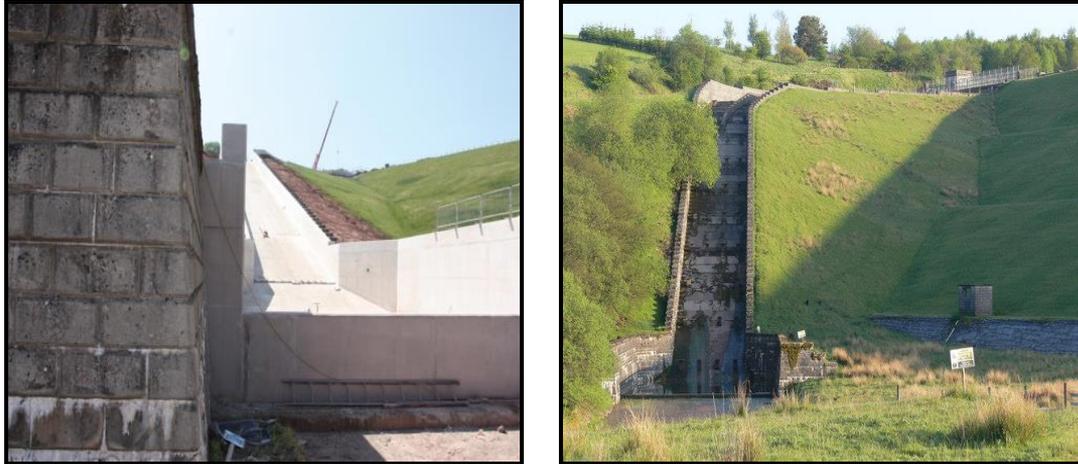
**Figure 21: Usk Reservoir Dam Spillway views from downstream, after renovation (Left), before renovation (Right) (Photo by Mat Fascione) [32].**

- 1) Construction of a reinforced concrete watertight spillway lining to fully contain design flows, including localized wall heightening,
- 2) Removal of the existing baffle blocks and guide wall,
- 3) The addition of shear keys for spillway chute stability,
- 4) Grouting works to close voids and to enhance the existing grout curtain,
- 5) Addition back of wall drainage along the right side of the spillway chute,
- 6) Earthworks to achieve the required finished ground profile adjacent to the spillway walls, and
- 7) Remedial/repair works to the existing wave wall and spillway approach the wall, [30].

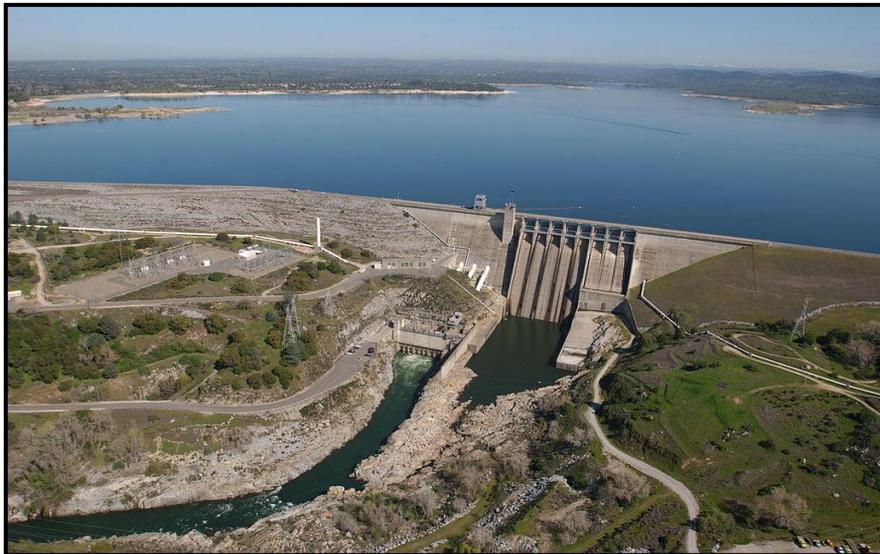
**Figure 22: Folsom Dam General View [33].**

Folsom Dam is a concrete gravity dam on the American River of Northern California in the United States. It was completed in 1955, officially opened the following year. The concrete dam is 100m high and 430m long, flanked by earthen wing dams, refer Figure 22 [33].

The reservoir is held in place by additional nine saddle dams in the west and southeast sides. The wing dams total a length of 2,700m, while the saddle dams measure 5,040m long combined. The dam and appurtenant dikes total a length of 8,150m. Floodwaters are released by a spillway located on the main dam, controlled

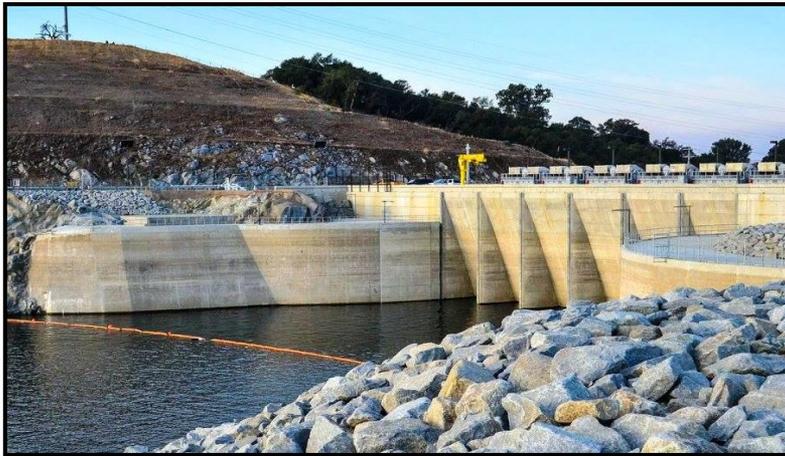
**Figure 23: (Left) Auxiliary Spillway before completion [35].  
(Right) Auxiliary Spillway after completion [36].**

snowmelt floods that might cause damage in the region. The new spillway is built with gates 15m lower than the existing spillway, allowing for more efficient evacuation of reservoir storage before flooding events. The auxiliary spillway was constructed adjacent to Folsom main concrete dam, and it was substantially completed in 2017. It includes a 1,100-foot-long approach channel beginning in Folsom Reservoir, a concrete control structure with six bulkhead and six radial gates, a 3,100-foot-long auxiliary spillway chute, and a stilling basin that acts as an energy dissipation structure as water discharges and enters the American River, refer Figure 23 (Left) [35] and Figure 23 (Right) [36].

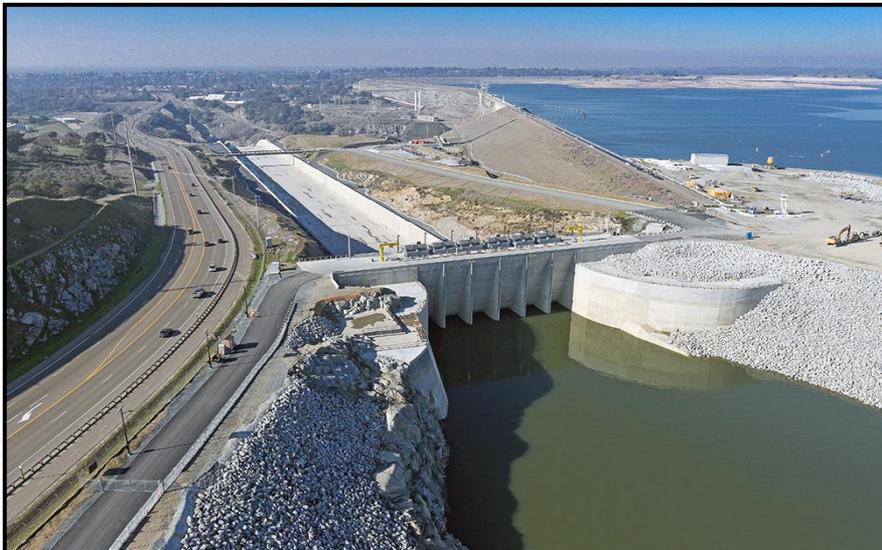
**Figure 24: View of Folsom Dam Auxiliary Spillway after completion showing head works and chute [37].**

The spillway was substantially completed in October 2017, refer Figure 24.

With the ability to operate the new spillway, the USBR is able to better manage large floods by safely releasing more water from Folsom Reservoir earlier in a storm through both the spillway gates on Folsom Dam and the new control structure's radial gates (which sit 15m lower), reducing hydrologic risk and leaving more storage capacity in the reservoir.
