Dam Safety: Use of Seismic Monitoring Instrumentation in Dams

**Nasrat Adamo¹, Nadhir Al-Ansari², Varoujan Sissakian³, Jan Laue⁴
and Sven Knutsson⁵**

Abstract

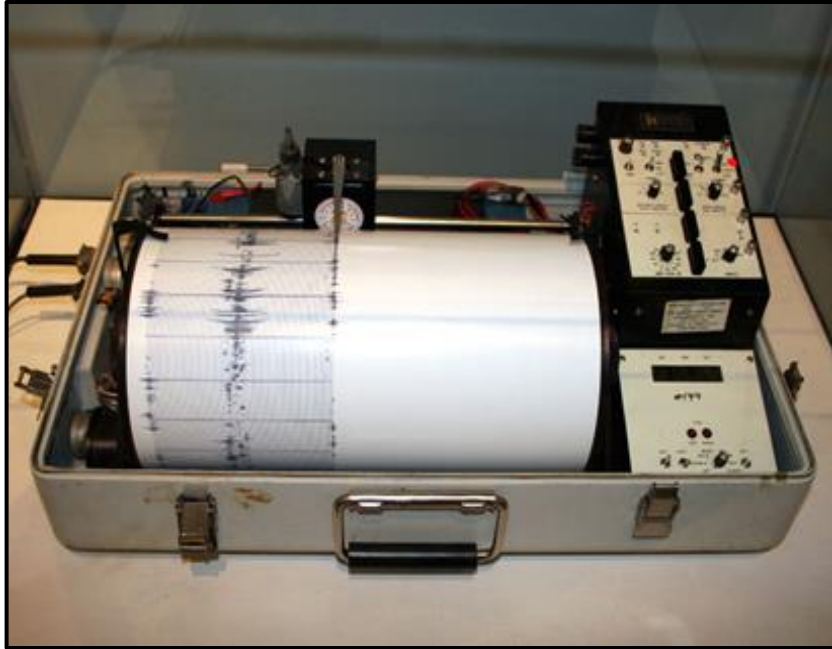
Figure 1: Kinemetrics seismograph, formerly used by the United States Department of the Interior [6] and [7].

An example of seismograph is shown in Figure 1, which is of Kinematics seismograph, formerly used by the USBR [6, 7].

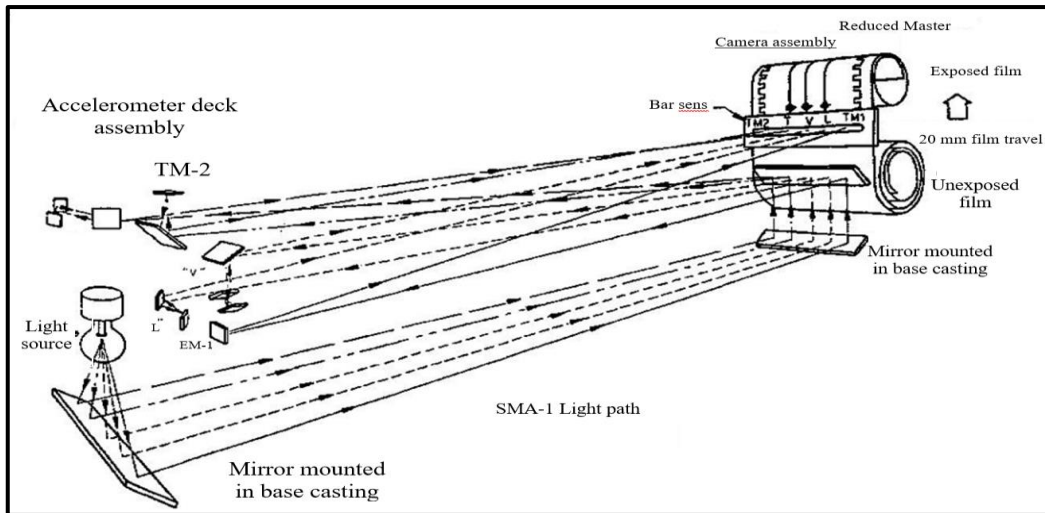
Figure 3: Analog/accelerograph component diagram showing working principles [12].

units. The analog type record data on 70 mm film which must be recovered under low light conditions and chemically processed to develop the film. A component diagram of such recorder is shown in Figure 3 [12].

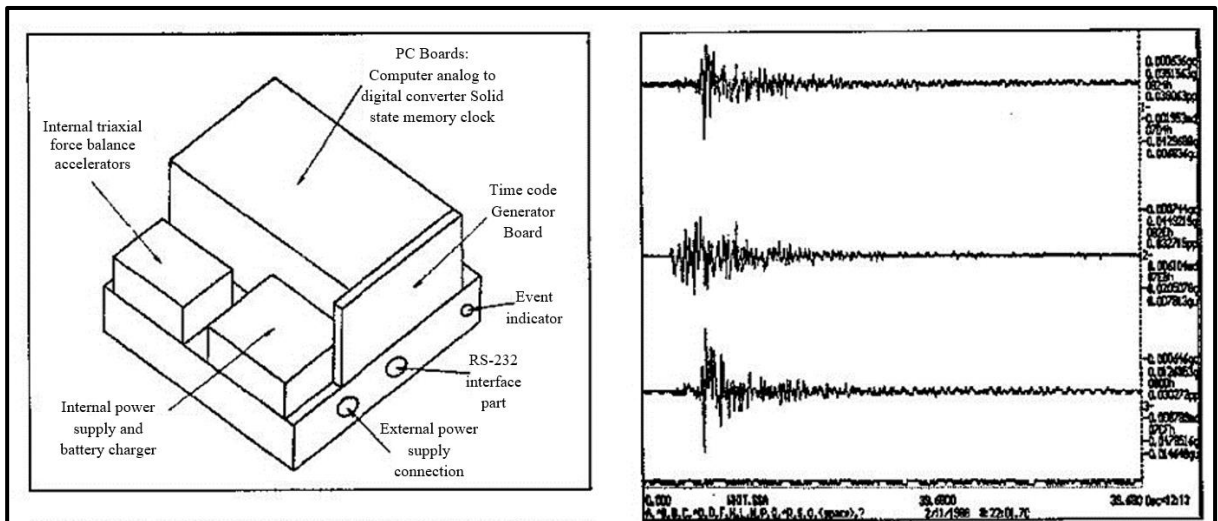
Figure 4: (a) On the left shows the general arrangement of a digital accelerograph. (b) On the right is a typical plot of such accelerograph [12].

Digital recorder continuously digitalizes the three internal force balance accelerometers and stores data in solid state memory. The general arrangement of a digital accelerograph box is presented in Figure 4a, and a typical plot of such accelerograph is shown in Figure 4b [12].

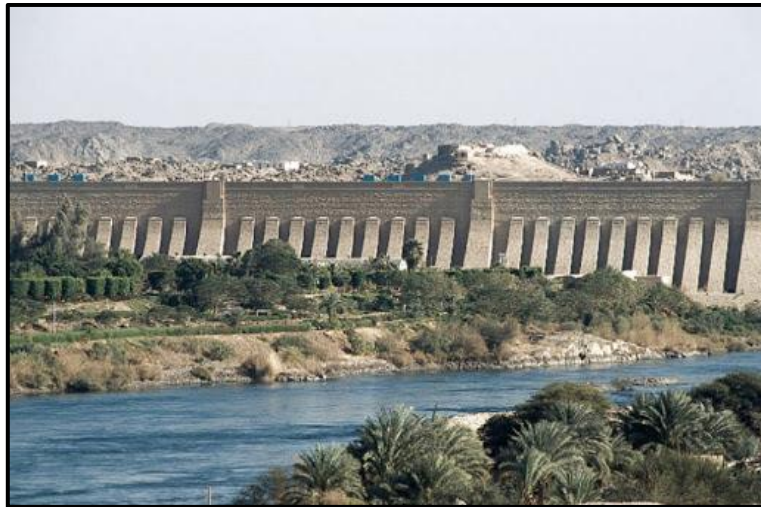
Figure 5: Downstream view of the old (low) Aswan Dam [13].

When the dam almost overflowed in 1946, it was decided to build a second dam, which is the High Aswan Dam in the upstream rather than raise the dam for the third time, see Figure 5. With the construction of the High Aswan Dam upstream, the Old Dam's ability to pass the flood's sediments was lost, as was the serviceability provided by the navigation lock. Aswan High Dam, is a huge rockfill dam, located on the Nile River north of the border between Egypt and Sudan. The Dam, known as Saad el Aa'li in Arabic, was completed in 1970 after ten years of work.

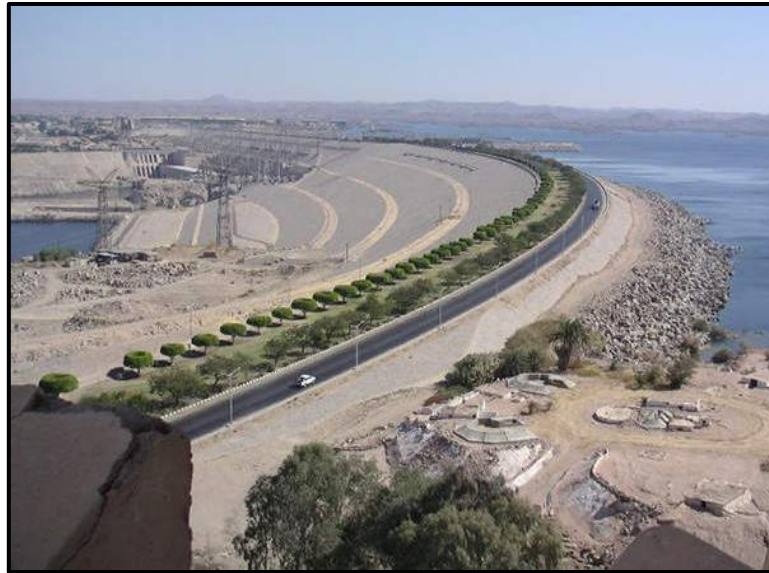
Figure 6: An overview of the High Aswan Dam (Water Technologies) [14].

The dam is a massive structure containing 18 times the material used to build the famous Pyramid of Cheops at Giza. It is 3,600 meters long 980 meters wide at the base and 111 meters high above the river level. Figures 6 and 7 show some views of the dam and the power station.

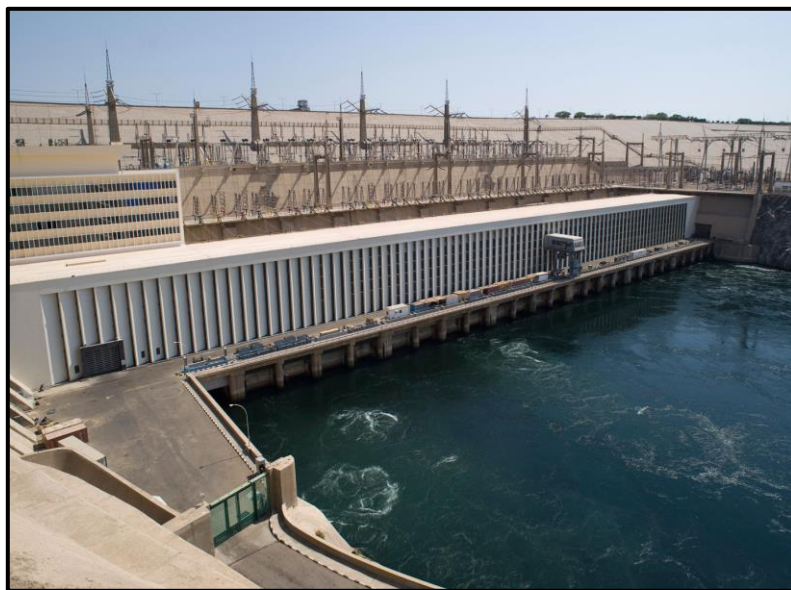
Figure 7: Downstream view of the power station at High Aswan Dam [15].

The two Aswan Dams benefit Egypt by controlling the annual floods on the Nile River thus preventing the damage which used to occur along the flood plain. The High Aswan Dam increased cultivable land by 30% and provides about a half of Egypt's electrical power. The total installed capacity in its power station is 2100 MW provided by 12x175 MW Francis type turbines.

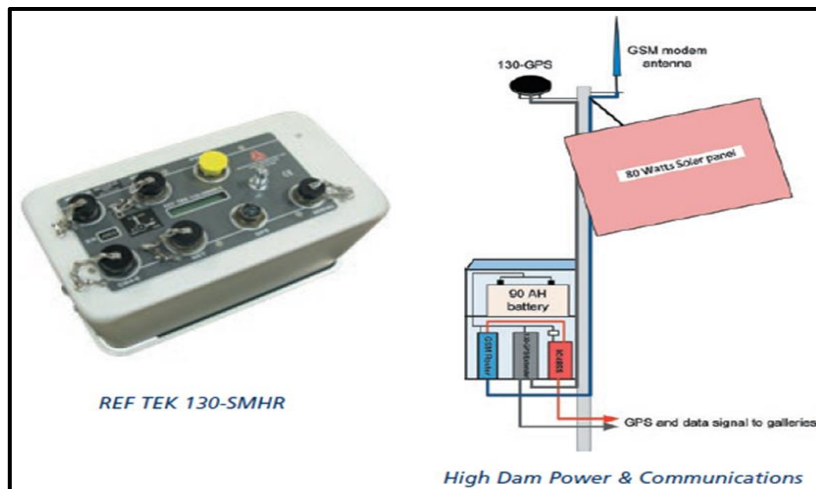
Figure 8: Illustration of the power and communication equipment at the entrance of the two galleries at the High Aswan Dam [16].

The 130-SMHRs installed inside the dam body are powered by 220VAC mains power. The free field station at the North side of the dam base and dam crest are supplied by a solar energy system. The diagram in Figure 8 illustrates the power and communication equipment at the entrance of the two galleries at the High Dam.

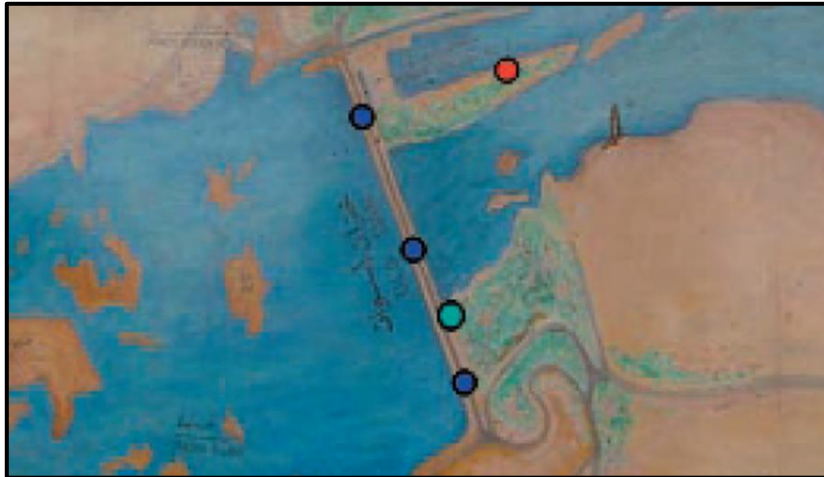
Figure 9: Old Aswan Dam instrumentation location [16].

In the Old dam, and as this dam does not contain galleries, a total of five 130-SMHRs were installed near the structure; one on bedrock on the ridge of the river; one at the Dam base; three at the Dam crest, with power supplied by a solar energy system. The illustration in Figures 9 and 10 shows the location of the instrumentation.

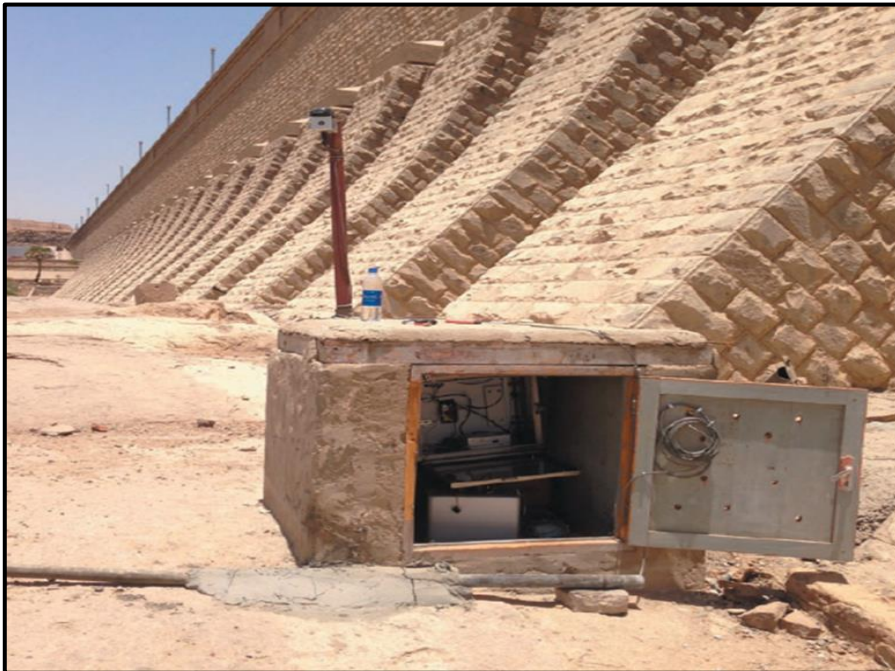
Figure 10: Old Aswan Dam field station [16].

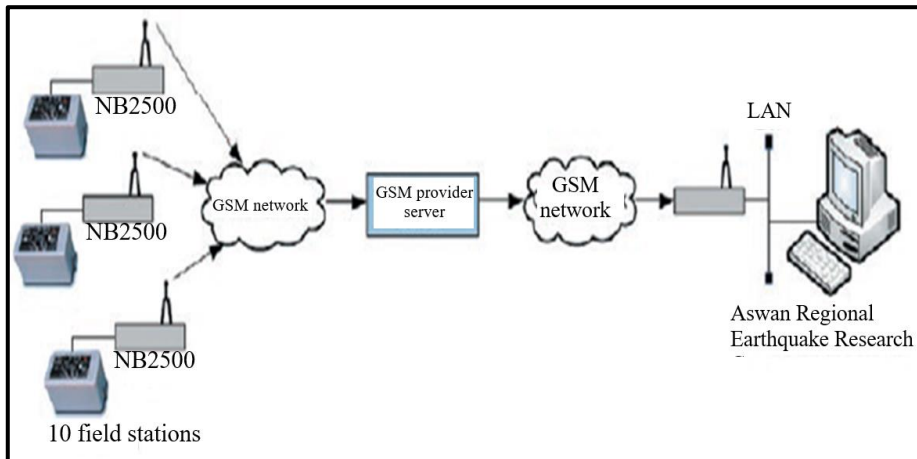
Figure 11: Illustration of GSM network [16].

GSM is a proven technology for both temporary and permanent seismic telemetry network communication media. Net Module Wireless Routers are used to connect networks and sites, see Figure 11.

Data processing equipment supplied to the processing center included two servers equipped with advanced software for data acquisition, data analysis and data archiving. The acquisition software is capable of downloading data from remote instruments automatically on trigger, and on-demand. This software is also capable of configuring, controlling, synchronizing the 130-SMHRs remotely as well as monitoring the state-of-health. Mission critical computers and peripherals were installed at the processing center, as indicated in Figure 11.

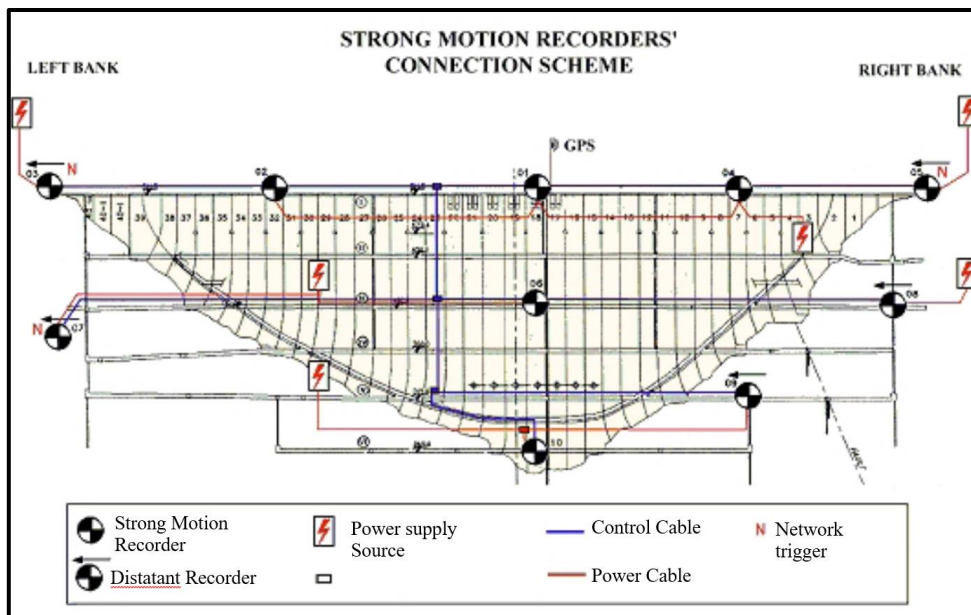
Figure 13: Strong motion recorders connection scheme [17].

The solution was to install 10 (AC-63) force balanced accelerometers, 10 (GSR-18) strong motion recorders, an interconnecting cabling and modem system (GRX- ICC interconnection set), and a central processing system center with processing and reporting software, Figure 13.

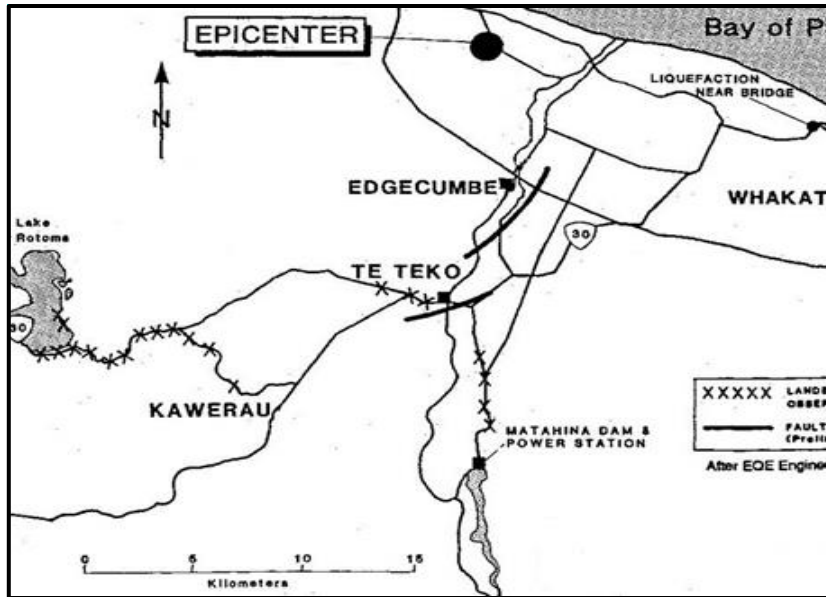
Figure 15: Location of Fault Rupture [19].

In the two weeks preceding the main event, there were earthquake swarms in the region; these are culminated in the main shock at 00.01hr 42m 34s on 2 March 1987 UT. The epicenter location was 8 km NNW of Edgcombe, Figure 14 and Figure 15, and the focal depth was estimated to be 12 km. The magnitude of the main shock was 6.3.

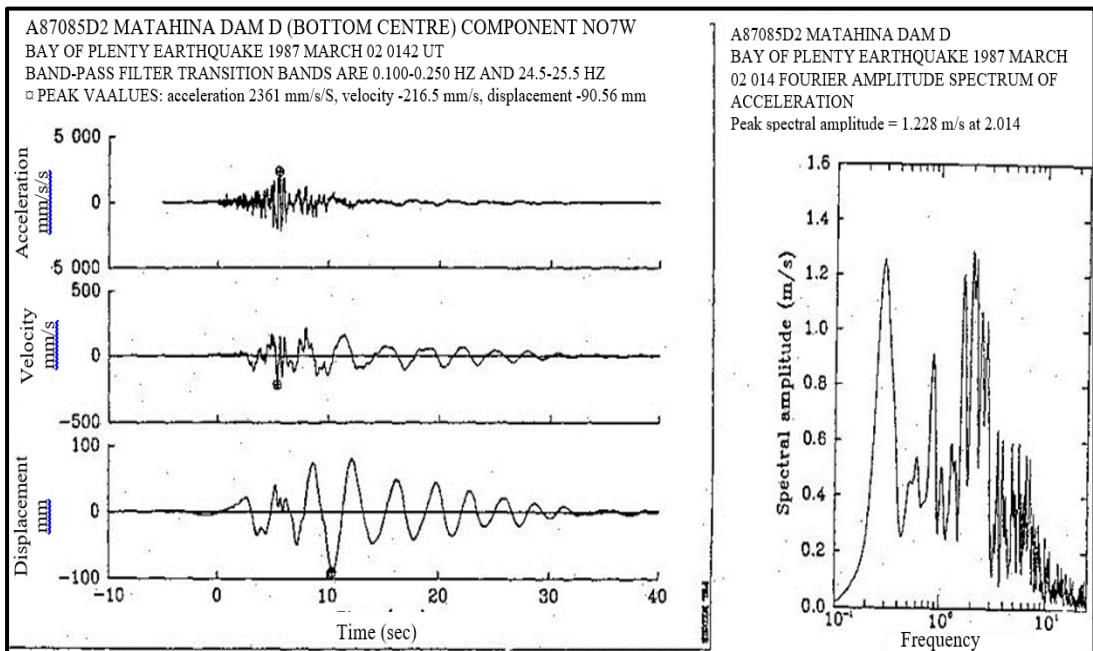
Figure 15a: Acceleration, velocity and displacement at the base of Matakina Dam [19].

A foreshock and four aftershocks had magnitudes of over 5.0 with epicenters within a few kilometres of the main shock. The accelerometer at the base of the dam recorded M5.2 foreshock, the M6.3 main shock and the largest aftershock, the M5.5 event 8 minutes after the main shock. The transverse (upstream-downstream) acceleration, velocity and displacement record from the base of the dam and the 5% damped acceleration response spectra are shown in Figure (15a). The El Centro 1940 (N-S) response spectra is shown for comparison Figure (15b).

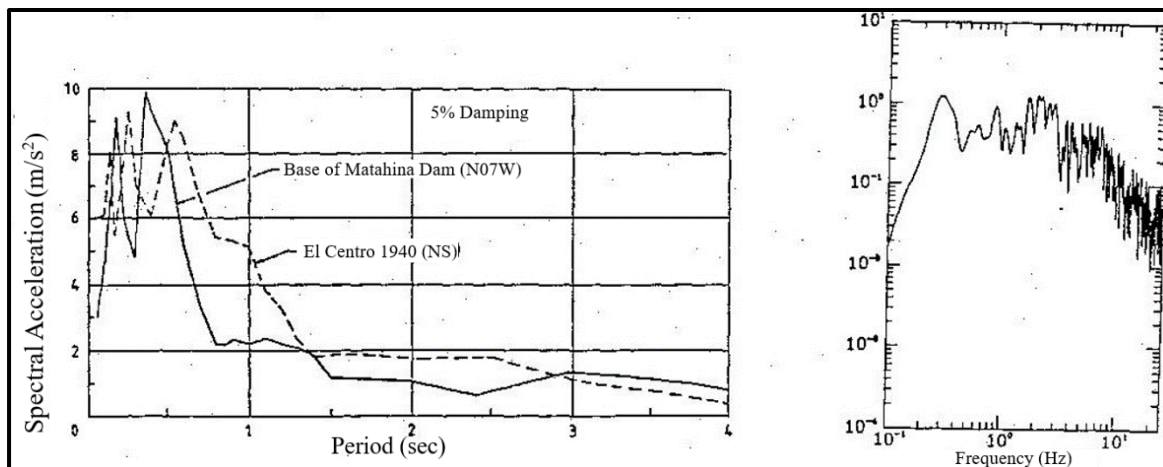
Figure 15b: El Centro earthquake (1940) 5% damped acceleration response spectra (for comparison) [19].

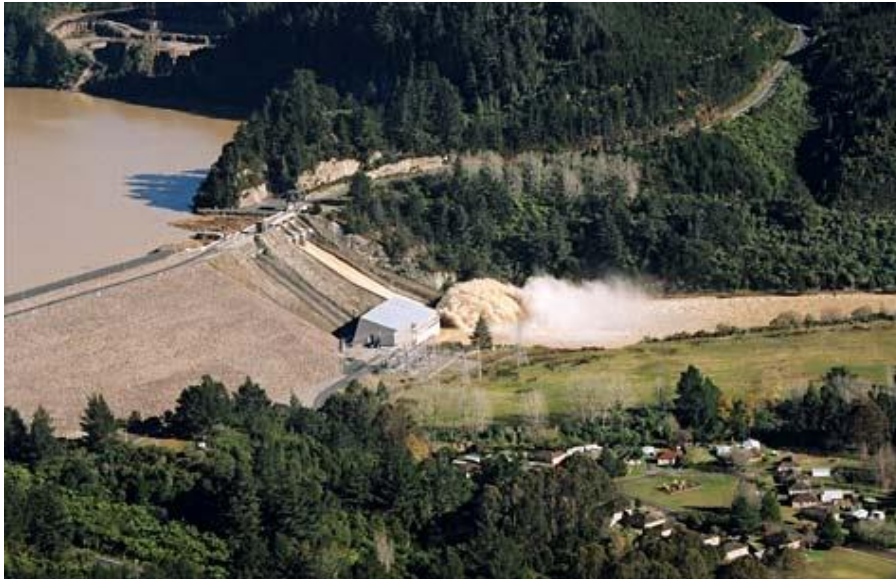
Figure 16: View of Matahina Dam [20].

The dam (Figures 16 and 17) stands 86 m high above foundation level and has a crest length of 400 m. It has an upstream sloping core of moderate width. The core material is weathered greywacke with a low plasticity gravelly clay grading. The dam shoulders are of hard ignimbrite rockfill compacted by heavy tractor track rolling. The transition zones between the core and shoulders comprise the fines and softer stripping from the ignimbrite rock quarry.

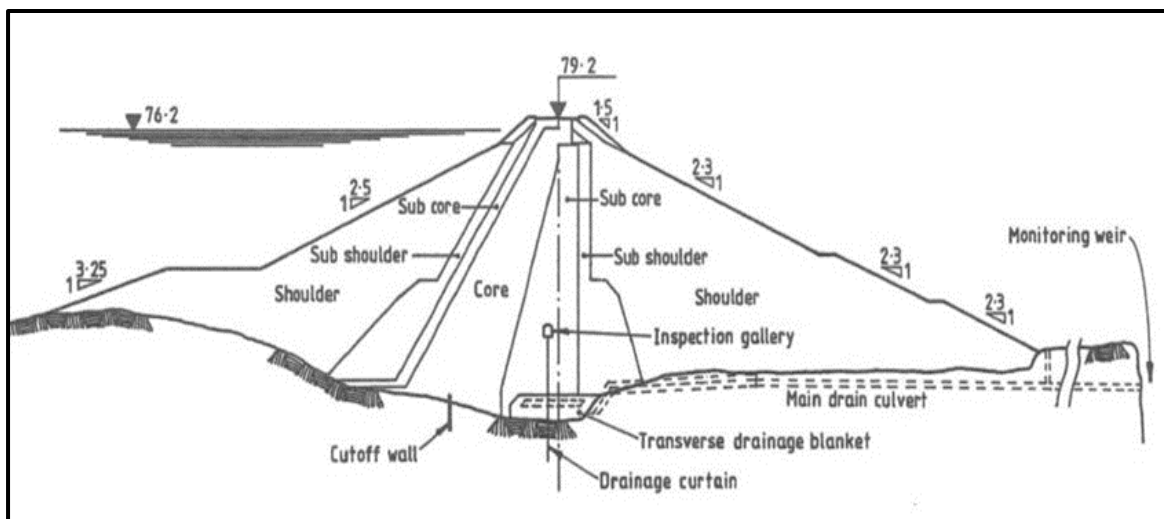
Figure 17: Cross section of the Matahina Dam [21].

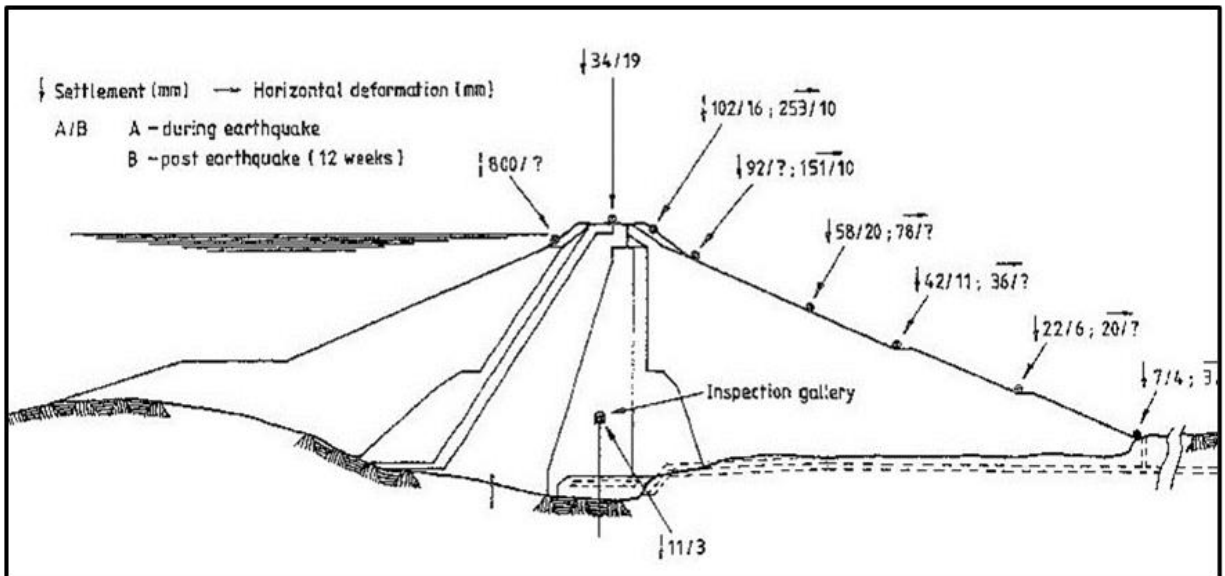
Figure 19: Deformations at the center of the dam [21].

Settlement of the dam continued for several weeks. During this time, the crest settlements were less than the rock fill settlements as would be expected. Measurements from the inspection gallery did not suggest significant foundation settlement, Figure 19. The long term settlement of the left abutment spur was unexpected, Figure 19. The results indicate a fairly uniform settlement without tilting. The settlement caused increased leakage into the powerhouse.

The displacement of the downstream rockfill shoulder is shown in Figure 19. The maximum displacement of 253 mm compares with about 220 mm during the lake filling period.

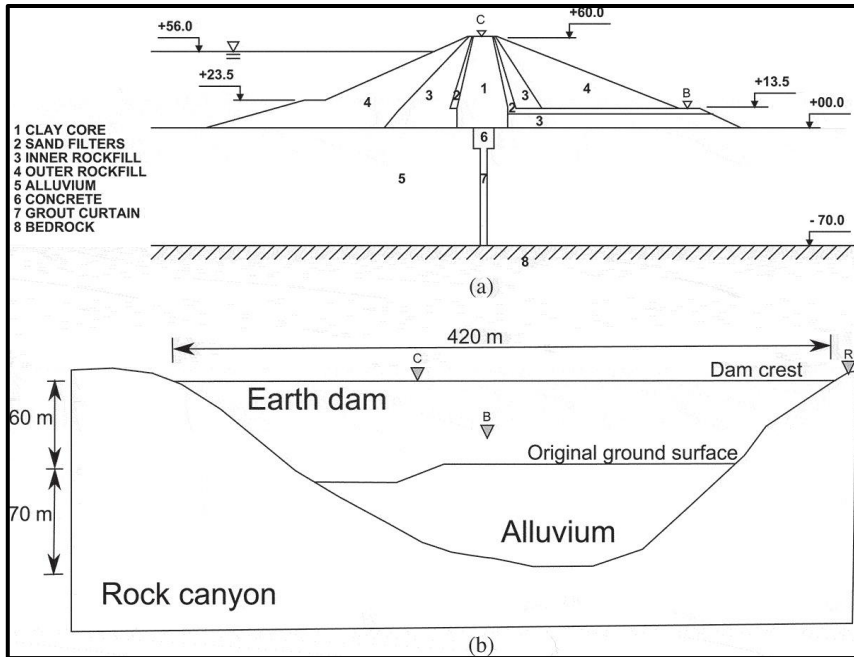
Figure 20: (a) Typical cross section; (b) Long section at La Villita Dam, showing location of the strong motion accelerometers (C), (B), and (R) [23].

La Villita Dam is a 60 m high zoned earth dam in Mexico with a crest about 420 m long, constructed on a 70 m thick alluvium layer. The dam was the principal component of a 304 MW multi-purpose hydroelectric, irrigation and flood-control development. It was designed with symmetrical cross-section with a central impervious clay core, well graded filter and transition zones and compacted rock fill shells. The alluvial layer beneath the clay core was grouted below the dam, while there is also a 0.6 m thick concrete cut-off wall to control seepage through the alluvium below the dam. Figure 20a and 20b shows a schematic representation of the transverse cross section of the dam and a longitudinal section. Both sections show the location of three functioning strong motion accelerometers (C), (B), and (R).

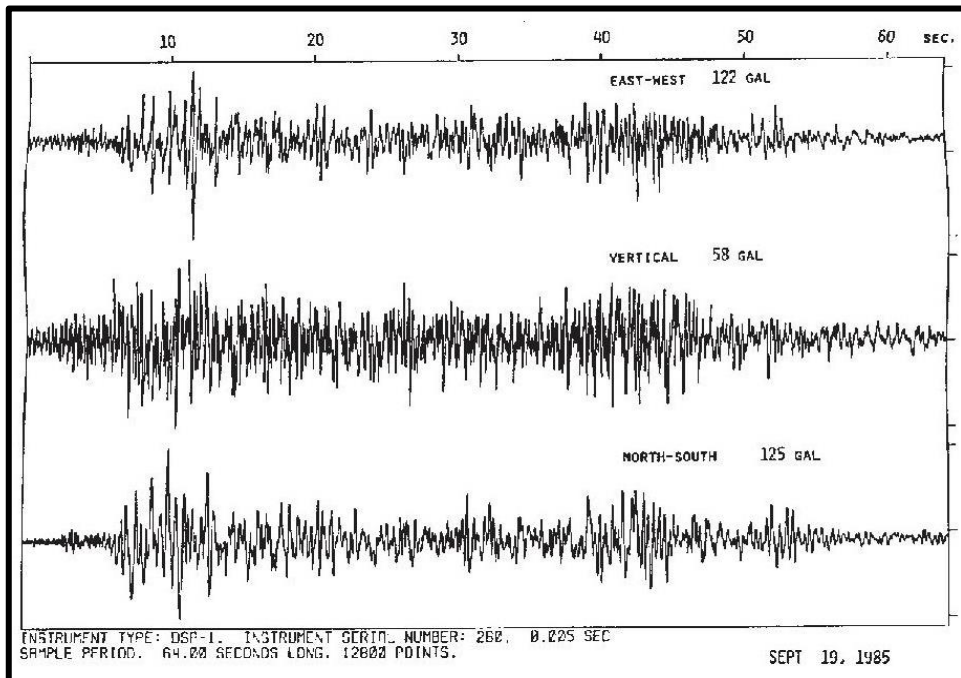
Figure 21: Bedrock acceleration records [22].

On September 19, 1985 earthquakes, the accelerometer at the center of the crest of the dam recorded a peak horizontal acceleration of 0.45 g and, on the following day, a peak acceleration of 0.16 g was measured during the strongest aftershock. Peak horizontal bedrock acceleration was recorded at 0.13 g for the main event and 0.04g for the aforementioned aftershock. Post-earthquake seismological research studies showed that the September 19, 1985 earthquake resulted from two distinct bursts of energy lasting about 16 seconds each and separated by about 25 seconds. This dual rupture mechanism was more conspicuous on records from other strong motion stations closer to the epicenter than from the La Villita instruments. Bedrock records for the main event are shown in Figure 21.

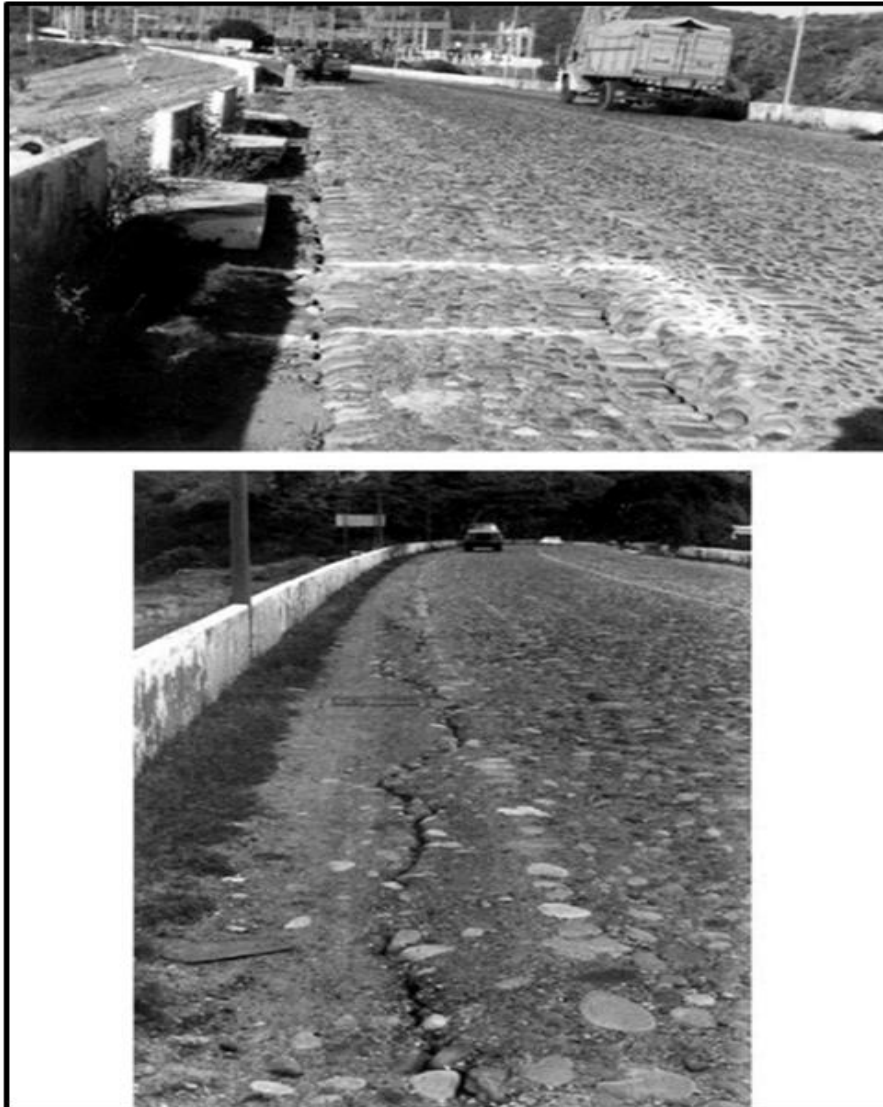
Figure 23: Photographs showing longitudinal cracking at dam crest [22].

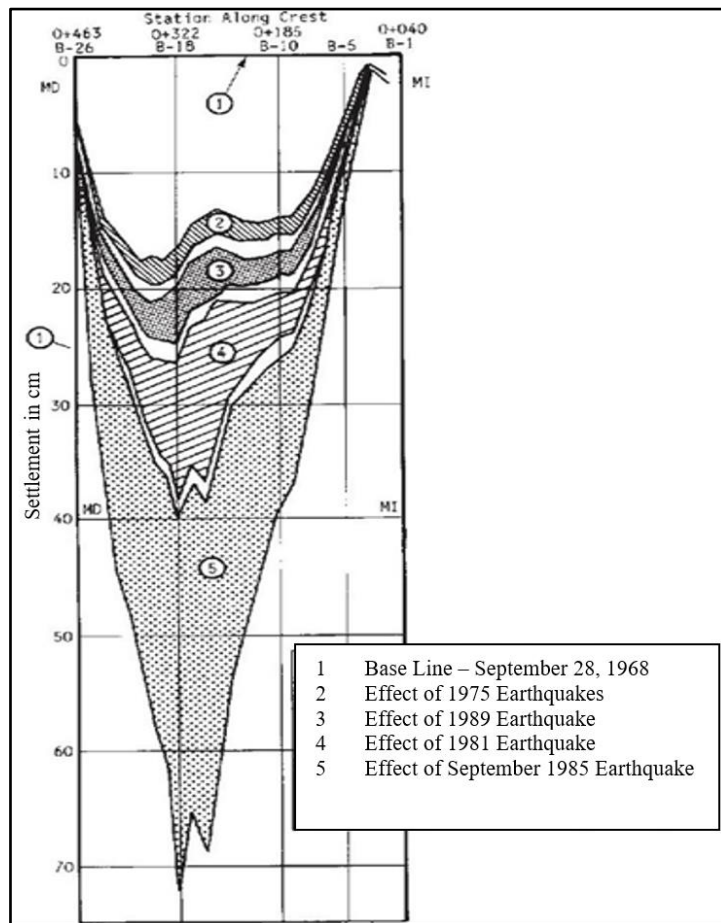
Figure 24: Historical crest Settlements record showing crest settlements from 1968 to 1985 [22].

Figure 24 gives the accumulated settlement of the dam due to the earthquakes to which the dam was subjected in previous years. Earthquake-induced settlements have been found to exceed static postconstruction settlements and appear to increase in magnitude from one earthquake to the other, perhaps indicating a change in stiffness of the dam materials or a slow, cumulative, deterioration of part of the embankment. Inclinometer records confirmed that permanent deformations

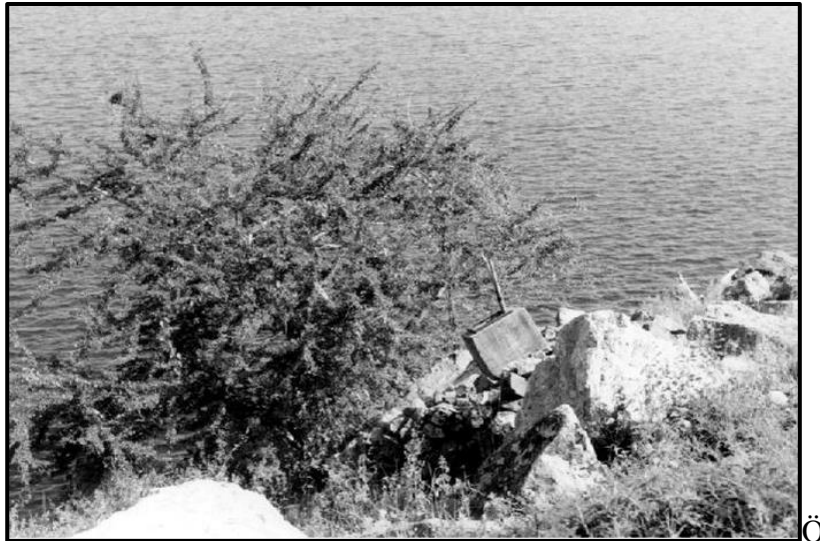
Settlements were particularly noticeable at several piezometer locations, where the piezometer tubes which extend down 80m to deep within the embankment remained in place, while their protective concrete boxes settled along with the face of the dam, Figure 25.

Figure 25: Settlement at piezometer box [22].

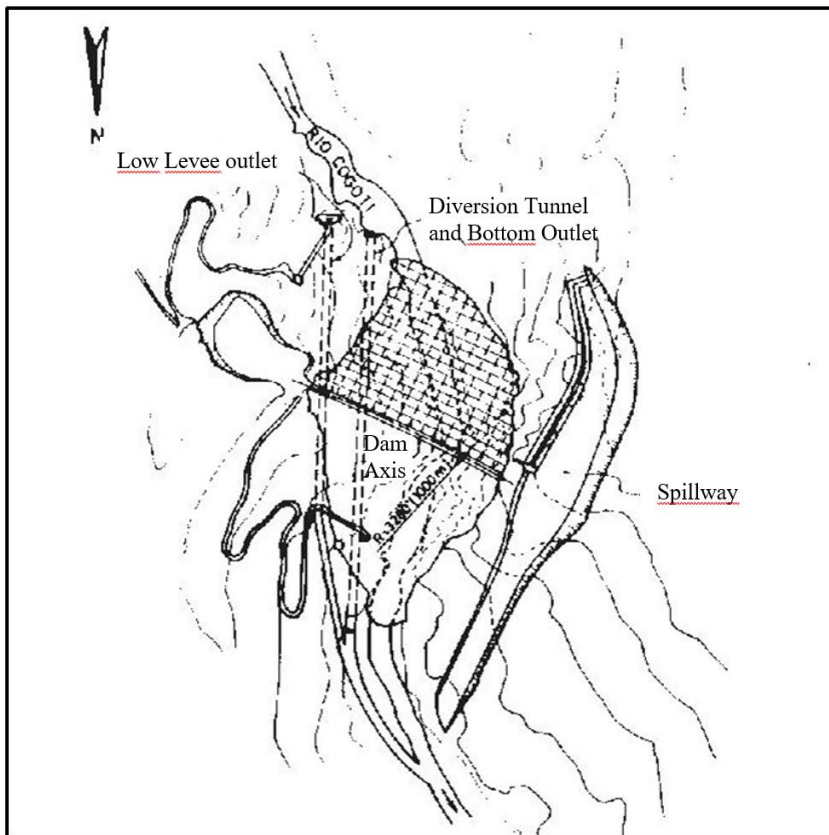
Figure 26: Site plan and layout of Cogoti Dam [24].

This dam is a concrete face rockfill dam built in 1938, it is located about 47 miles (75 km) from the City of Ovalle, Chile. The dam site is situated downstream from the confluence of the Pama and Cogoti rivers, and in a deep gorge naturally carved by the Cogoti River. Cogoti Dam, shown in plan and cross section in Figures 26 and 27, has a maximum height of 85 m, a crest length of 160 m. The upstream slope averages 1.4H : 1V and the downstream slope is about 1.5H :1V. The dam is

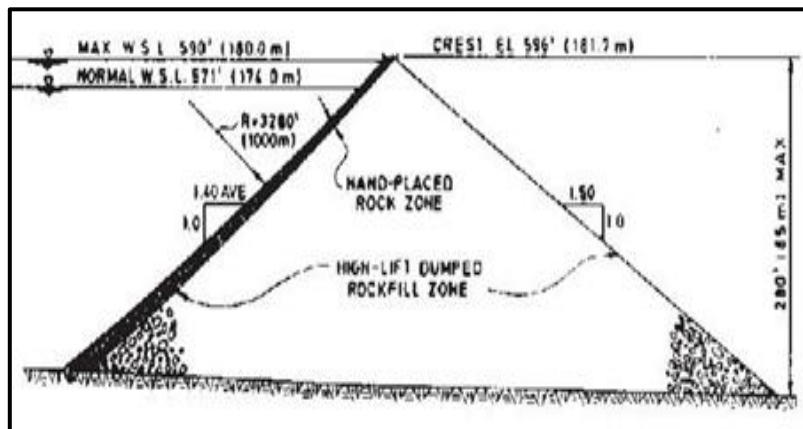
Figure 27: Typical cross section of Cogoti Dam [24].

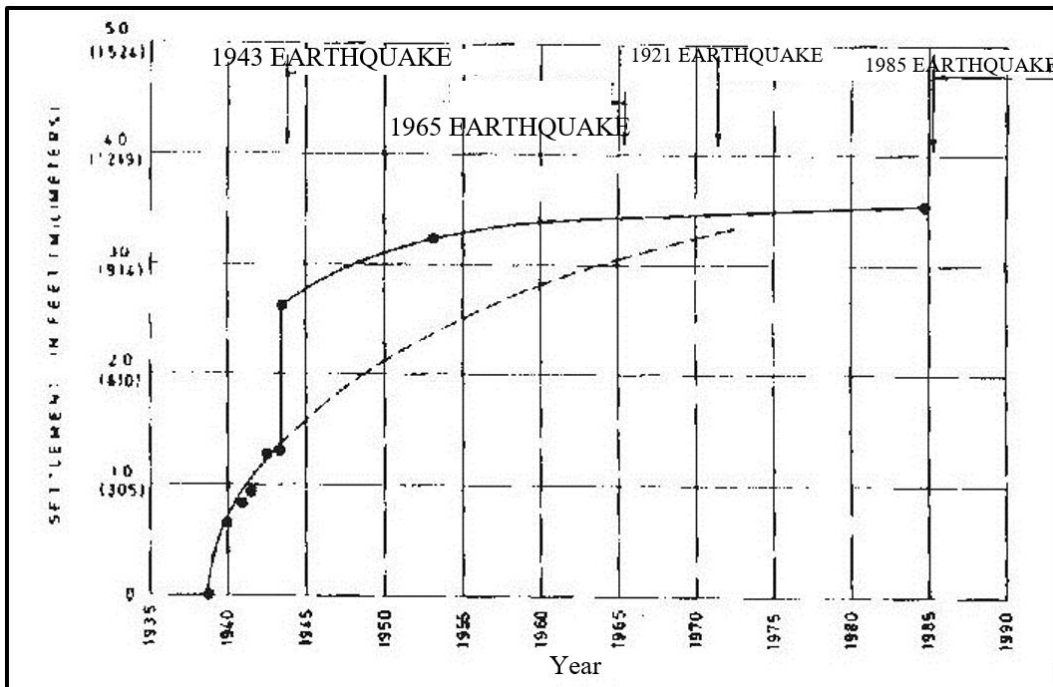
Figure 28: Crest settlement curve [24].

Leakage had been observed at Cogoti Dam since the reservoir's first filling in 1939. Intermittent records have been kept over the years, which indicate leakage to be directly related to the elevation of the reservoir and probably coming through the abutment or foundation, rather than the dam itself. No significant increase in dam leakage was observed as a result of the 1943 earthquake. No face cracks were caused by the earthquake. Yearly settlement and leakage data at Cogoti Dam are presented in Figures 28 and 29.

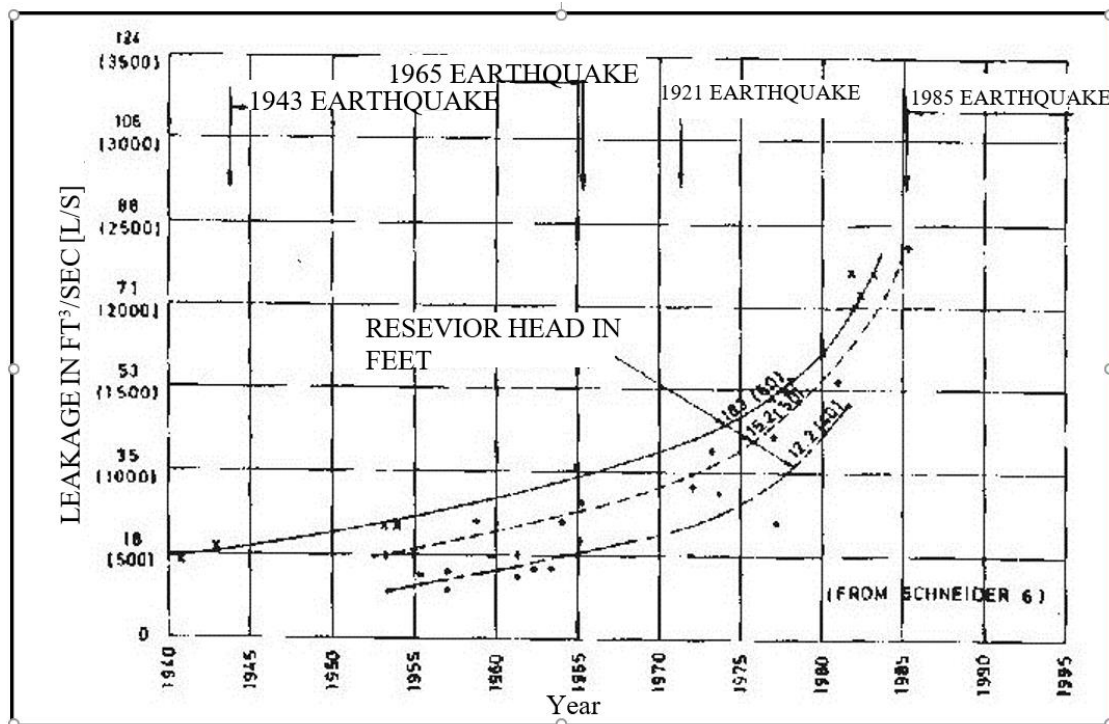
Figure 29: Leakage at Cogoti dam [24].

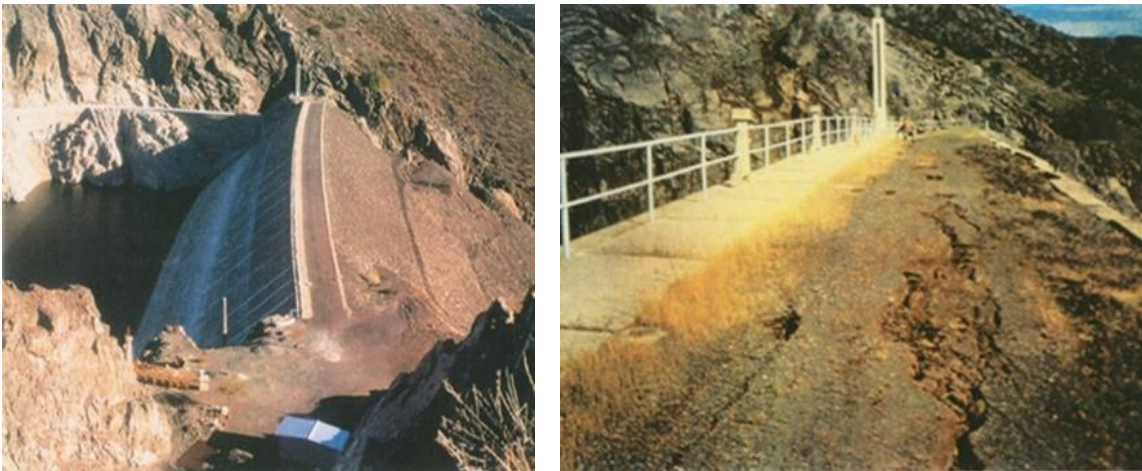
On 14 October 1997, the magnitude M6.8 Punitaqui Earthquake with epicentral distance of 20 km and focal depth of 30 km, produced a PGA of 0.19 g and a crest settlement of 15 cm. No damage was reported from the concrete face, but some cracking did occur at the downstream face of the dam, Figure 30.

Figure 30: (Left) General view of the dam. (Right) A close up view of the dam crest showing longitudinal cracking [25].

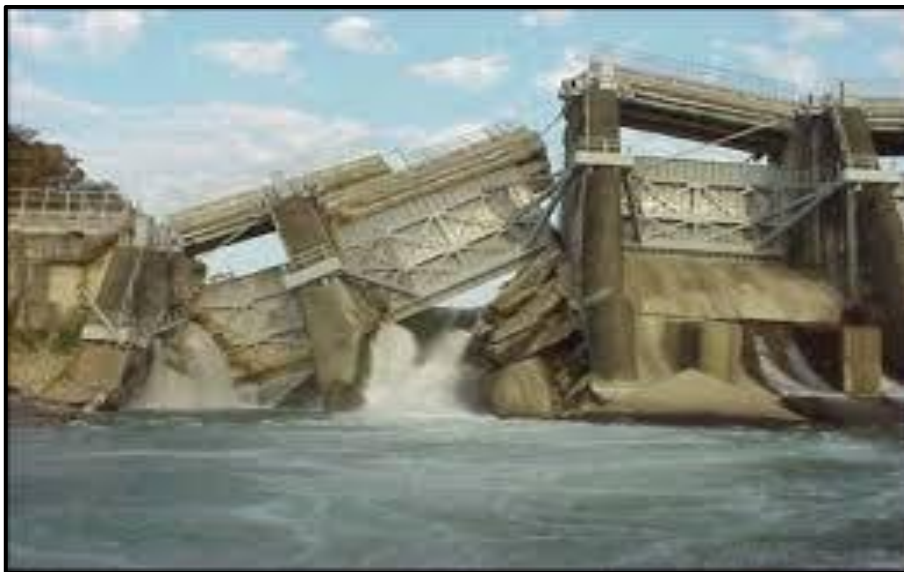
Figure 31: Shih Kang gravity dam immediately after the Chi-Chi Earthquake on September 21st, 1999 [27].

The only recorded case of concrete dam failure is the case of Shih Kang gravity Dam (Taiwan) which was completed in 1977. The dam suffered of vertical left side displacement of 36 ft, a vertical right side displacement of dam 7 ft and a diagonal offset of 23 ft. The line of fault produced by Chi-Chi Earthquake, M7.6 September 21, 1999, passed exactly under the dam and peak acceleration recorded 0.3 miles away was horizontal 0.51 g and vertical 0.53 g. The dam suffered of cracking along the ogee crest, along lift lines at point of changes in geometry and the dam separated from foundation. This case, however, may be considered the most extreme case due to the fact that the distance of the dam from the line of fault was zero, and the PGAs were so high, Figure 31 [27].
